"PROCEEDINGS OF A COURT OF ENQUIRY AND A REPORT BY
MAJOR F L NATHAN, RA., ON THE CIRCUMSTANCES ATTENDING
AN EXPLOSION WHICH OCCURRED AT THE ROYAL GUNPOWDER
FACTORY WALTHAM ABBEY ON THE 15TH DECEMBER, 1902".

Circumstances Attending an Explosion

ROYAL GUNPOWDER FACTORY,

ON THE 15th DECEMBER, 1902.

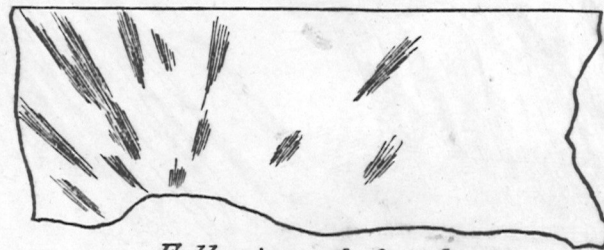
Full size of face A.

- (5) A piece of cast iron, belonging to the lower half of the body of the machine, was found in Group E, Bay 6. The shape of this piece is roughly thus:—

There is evidence from dark markings on the inner face of this piece, which is the inside face of the machine, of an origin of the propagation of an explosion from a point below the planed edge on which the top half of the incorporator rests. The radial condition of the markings points to a centre of explosion lying at least a short distance below the fracture. Microscopically, the darkened portions of the inner surface appears to be carbonaceous. These effects could only have been produced by an explosion occurring in the machine itself.

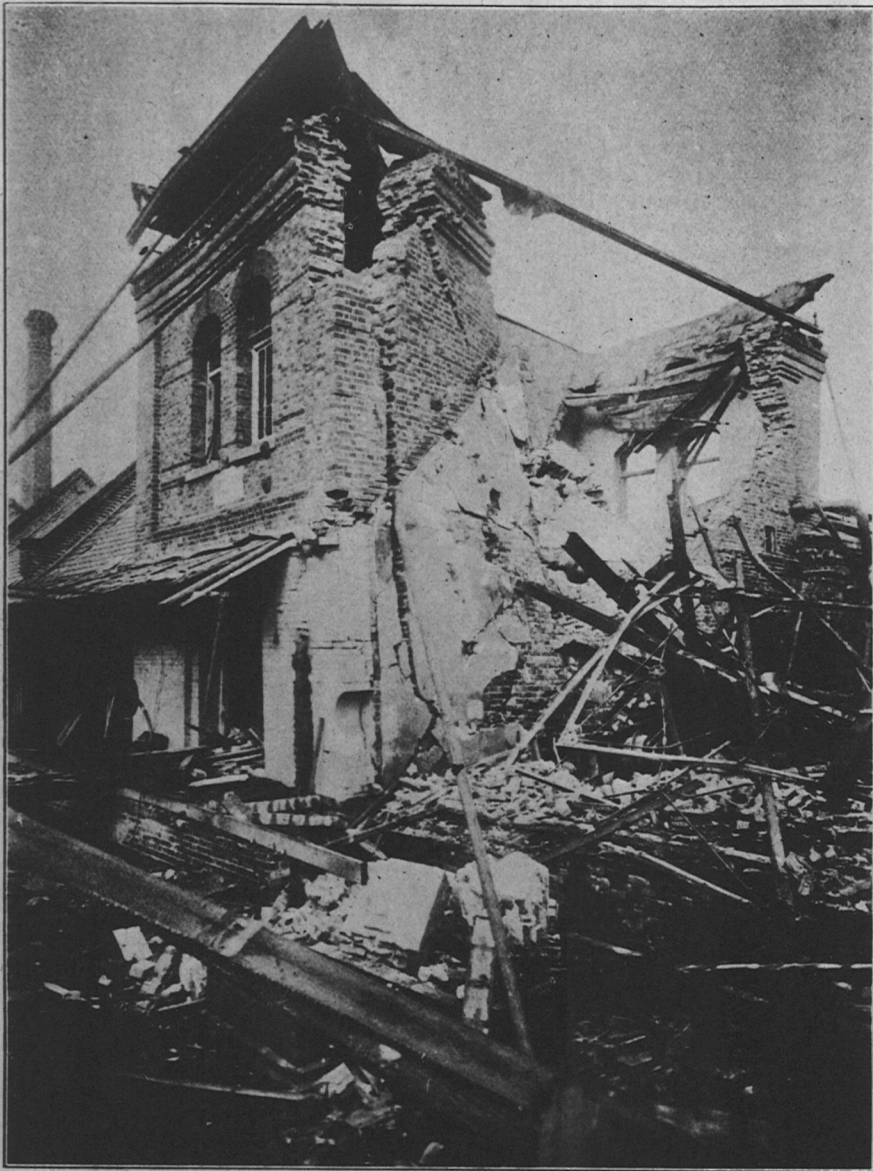
No. 1.

BAY 3 AND ENGINE HOUSE, GROUP G.

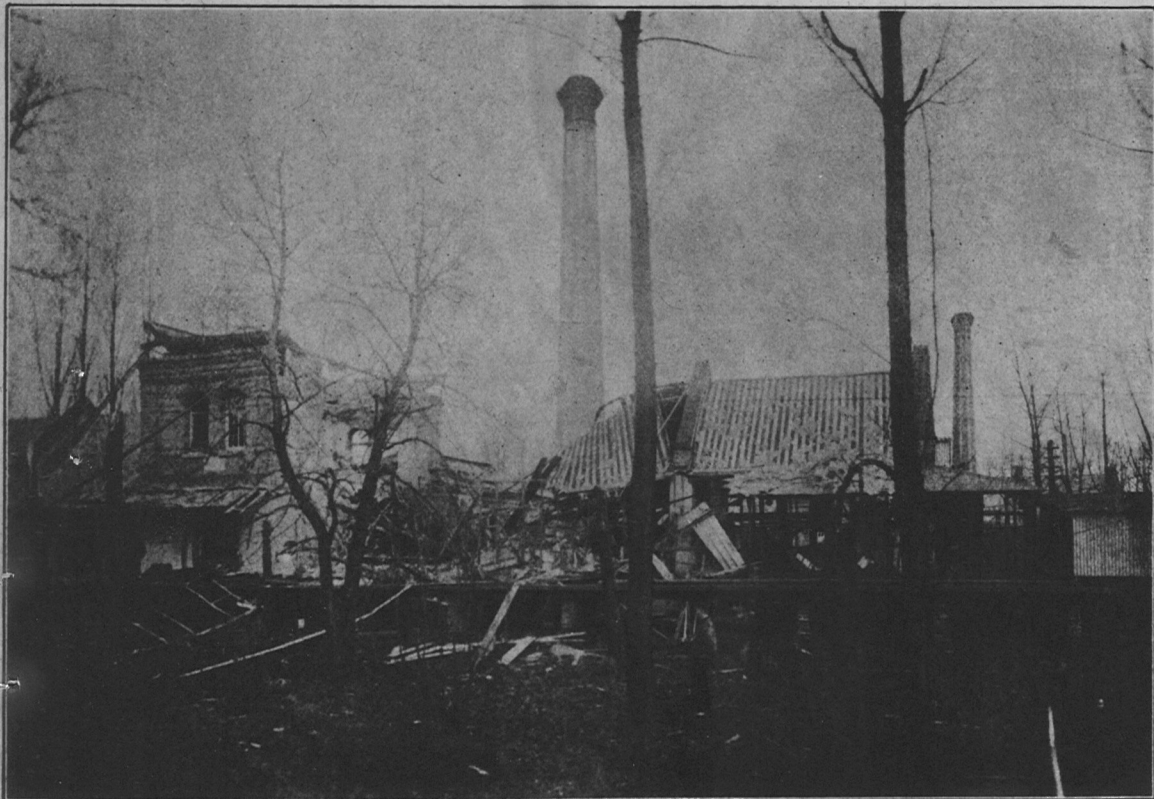
No. 2.

ENGINE HOUSE AND BAYS 3, 2, 1, GROUP G.

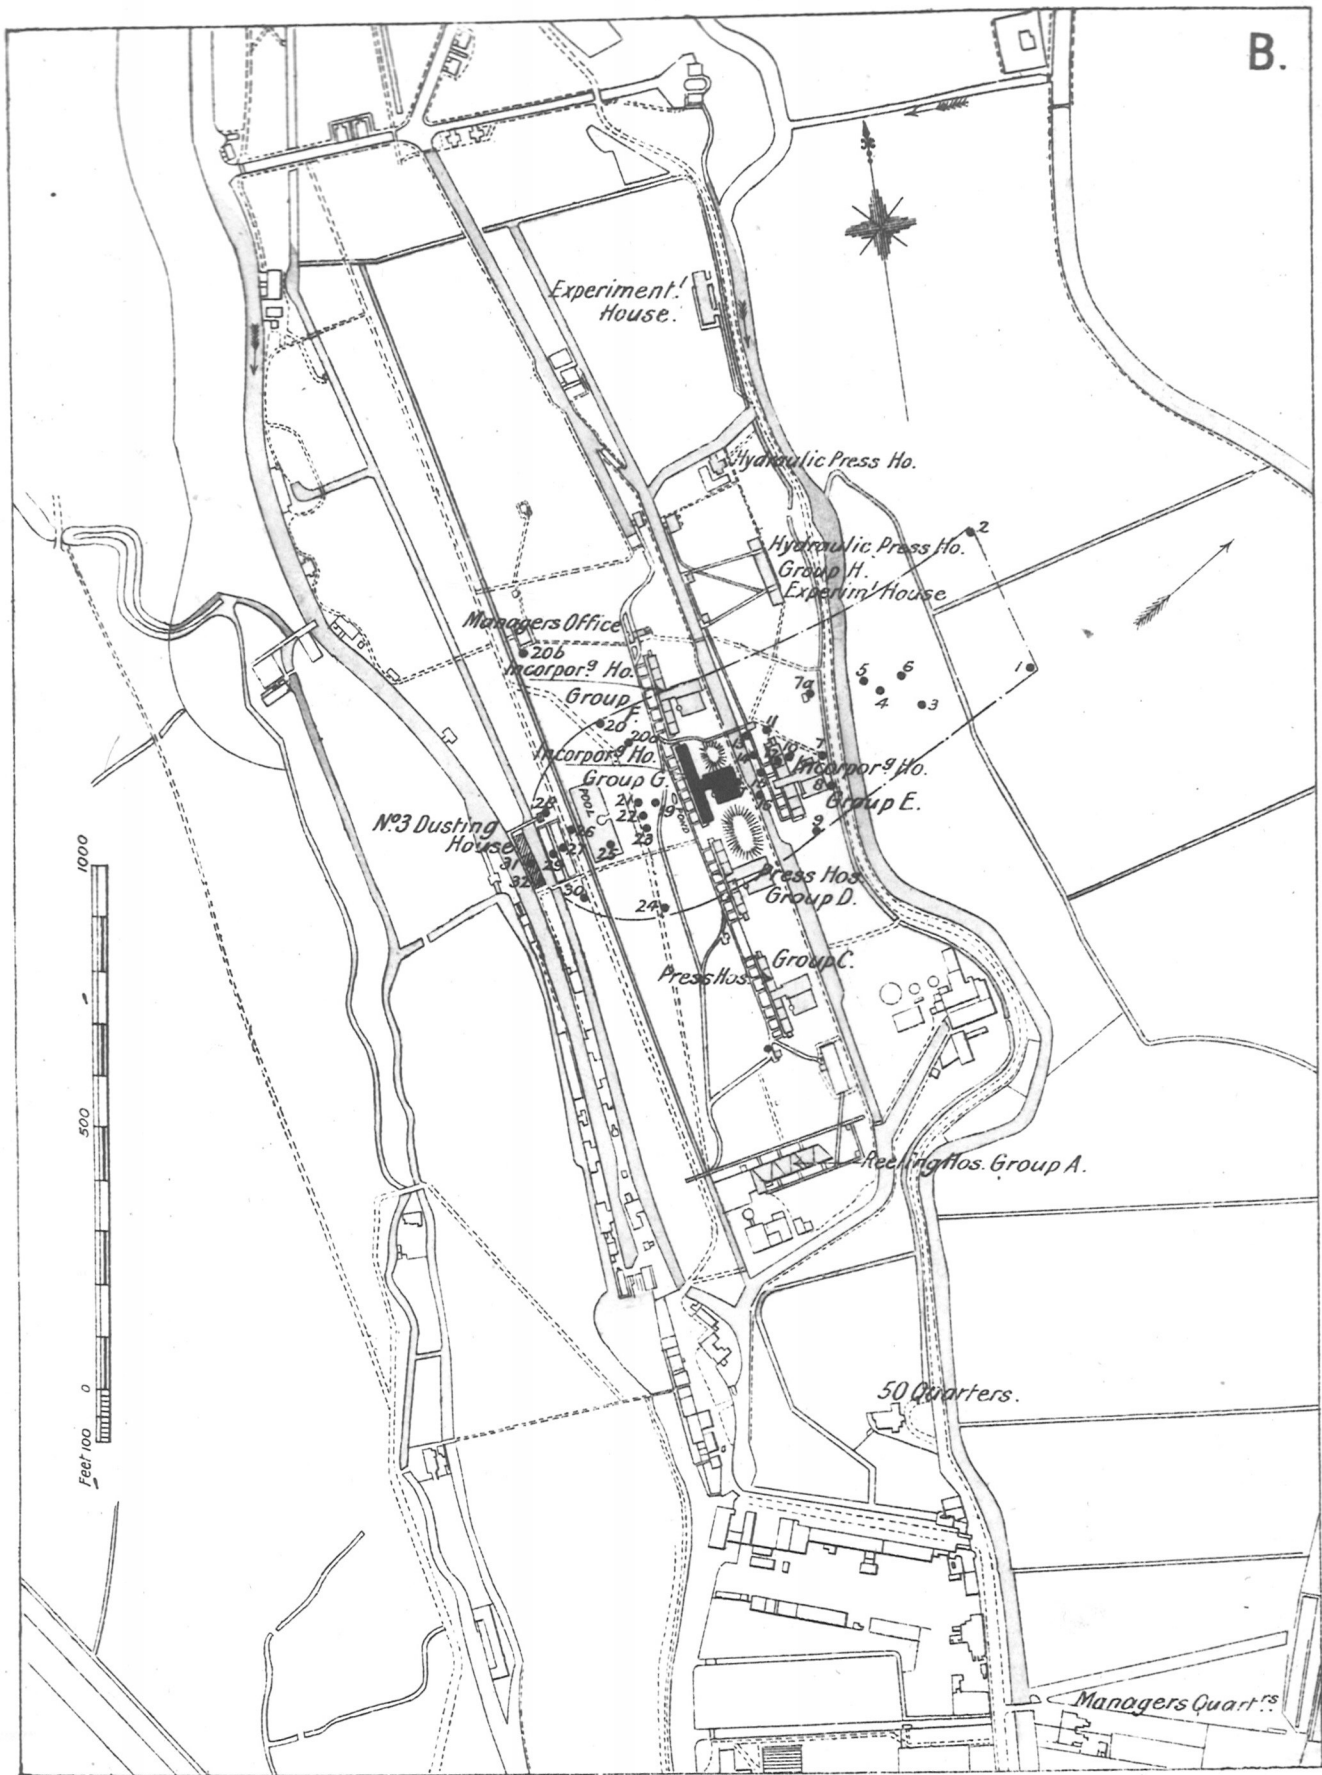
Debris Area enclosed thus

| 16 Sheet Lead 2' 6" x 8" | 32 Roof pierced, Fragment not found. |
| 17 Sheet Lead 4' 8" & two fragments of Incorporator. | |
