REPORT OF A LOCAL COMMITTEE OF INQUIRY HELD AT
THE PROPELLANTS, EXPLOSIVES AND ROCKET MOTOR ESTABLISHMENT
WALTHAM ABBEY, ESSEX
ON FEBRUARY 2nd, 1982

By Order of the Director/PERME for the purpose of enquiring
into and reporting upon the incident which occurred in
Building P720 on January 27th, 1982. Report to Director/PERME.

Photographs of the Mixer after the Accident

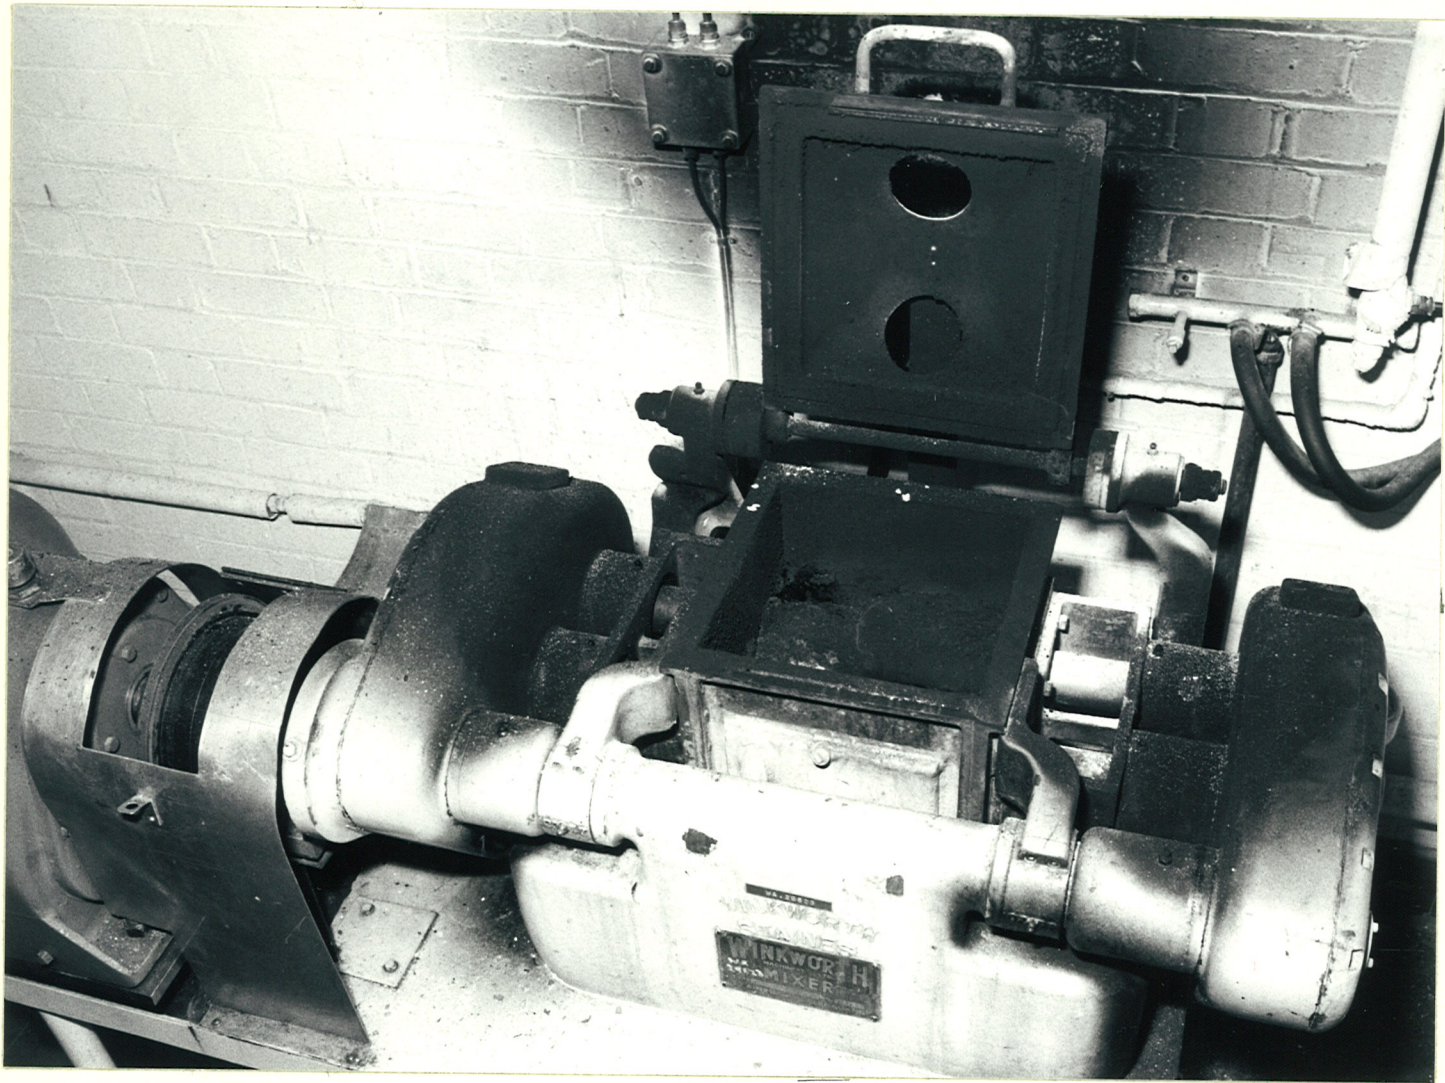
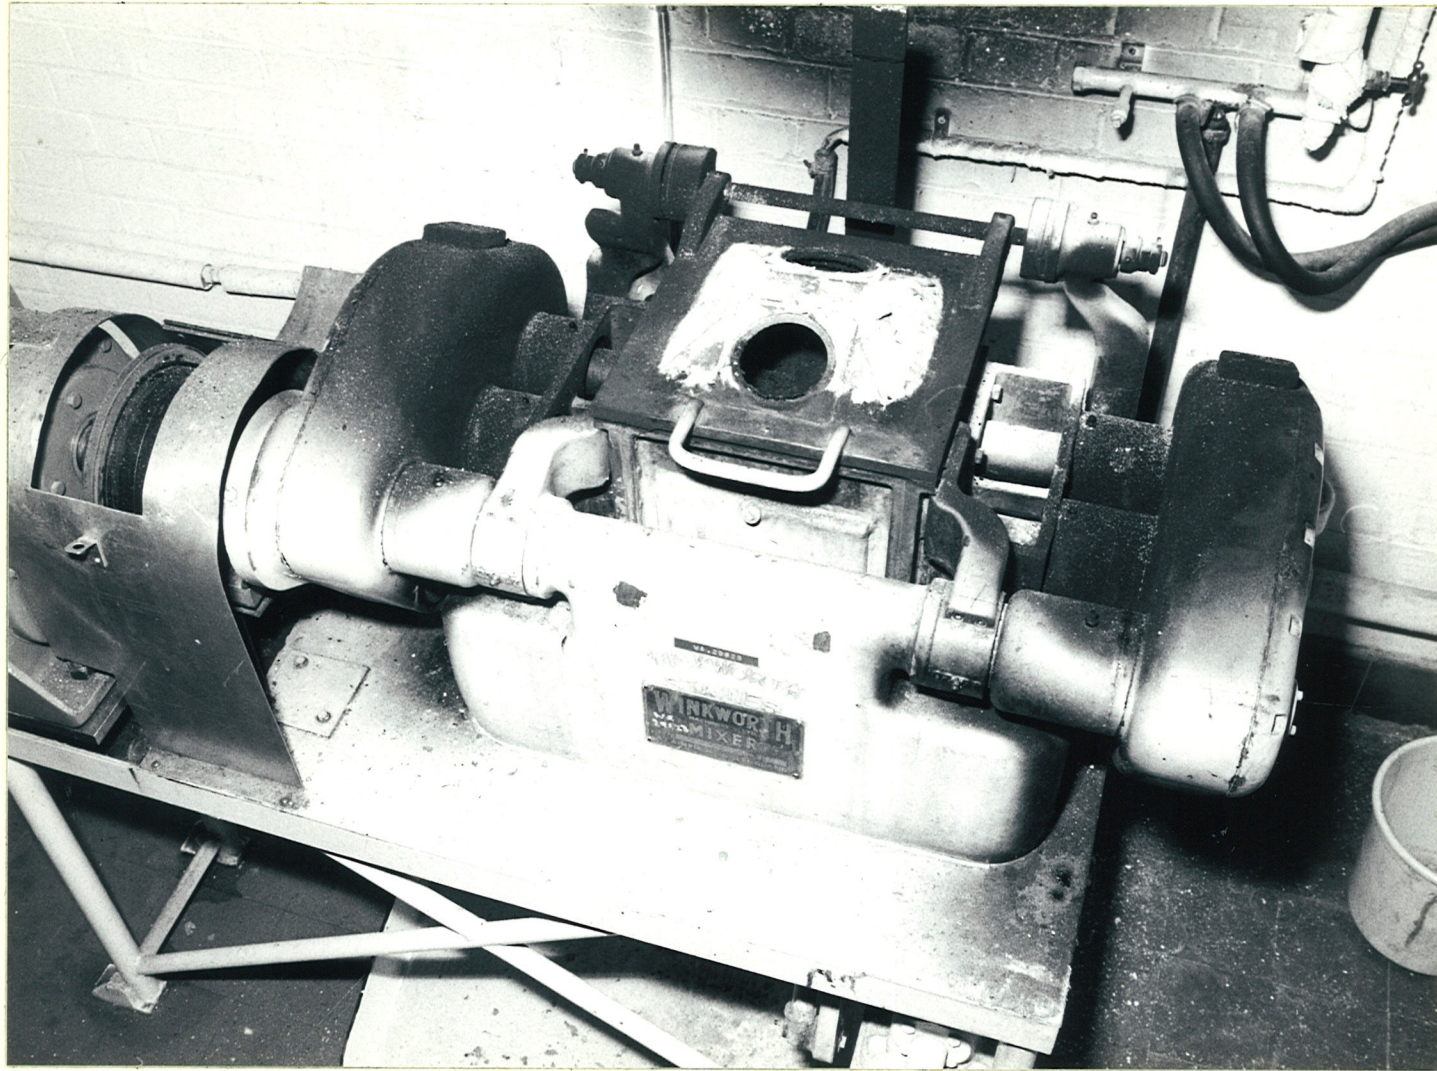
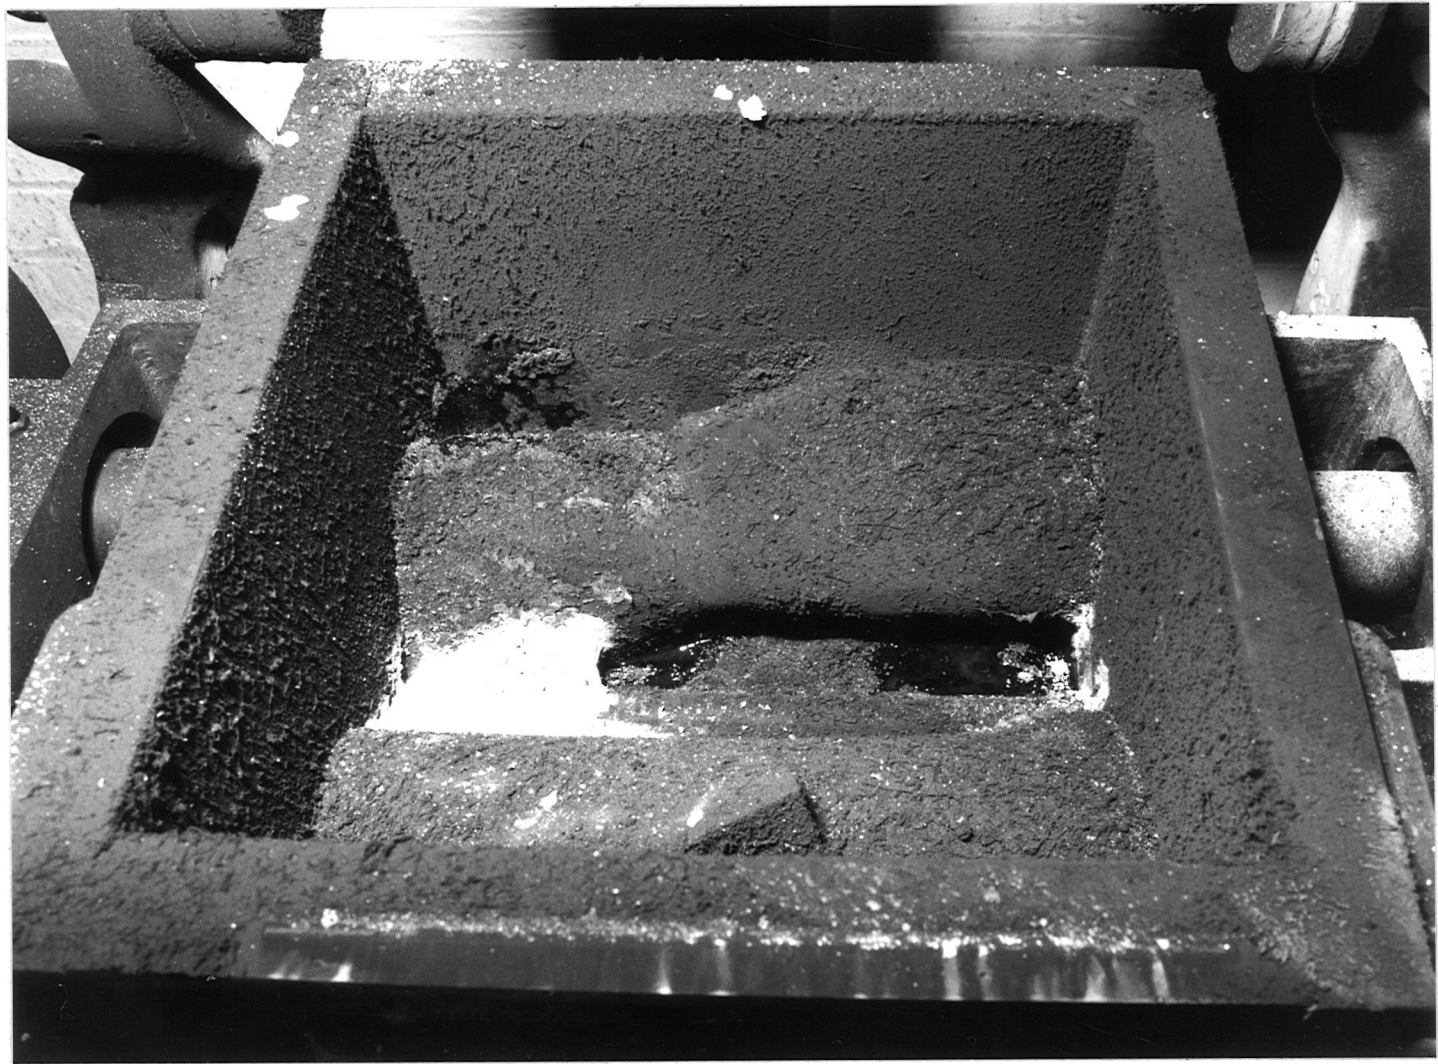
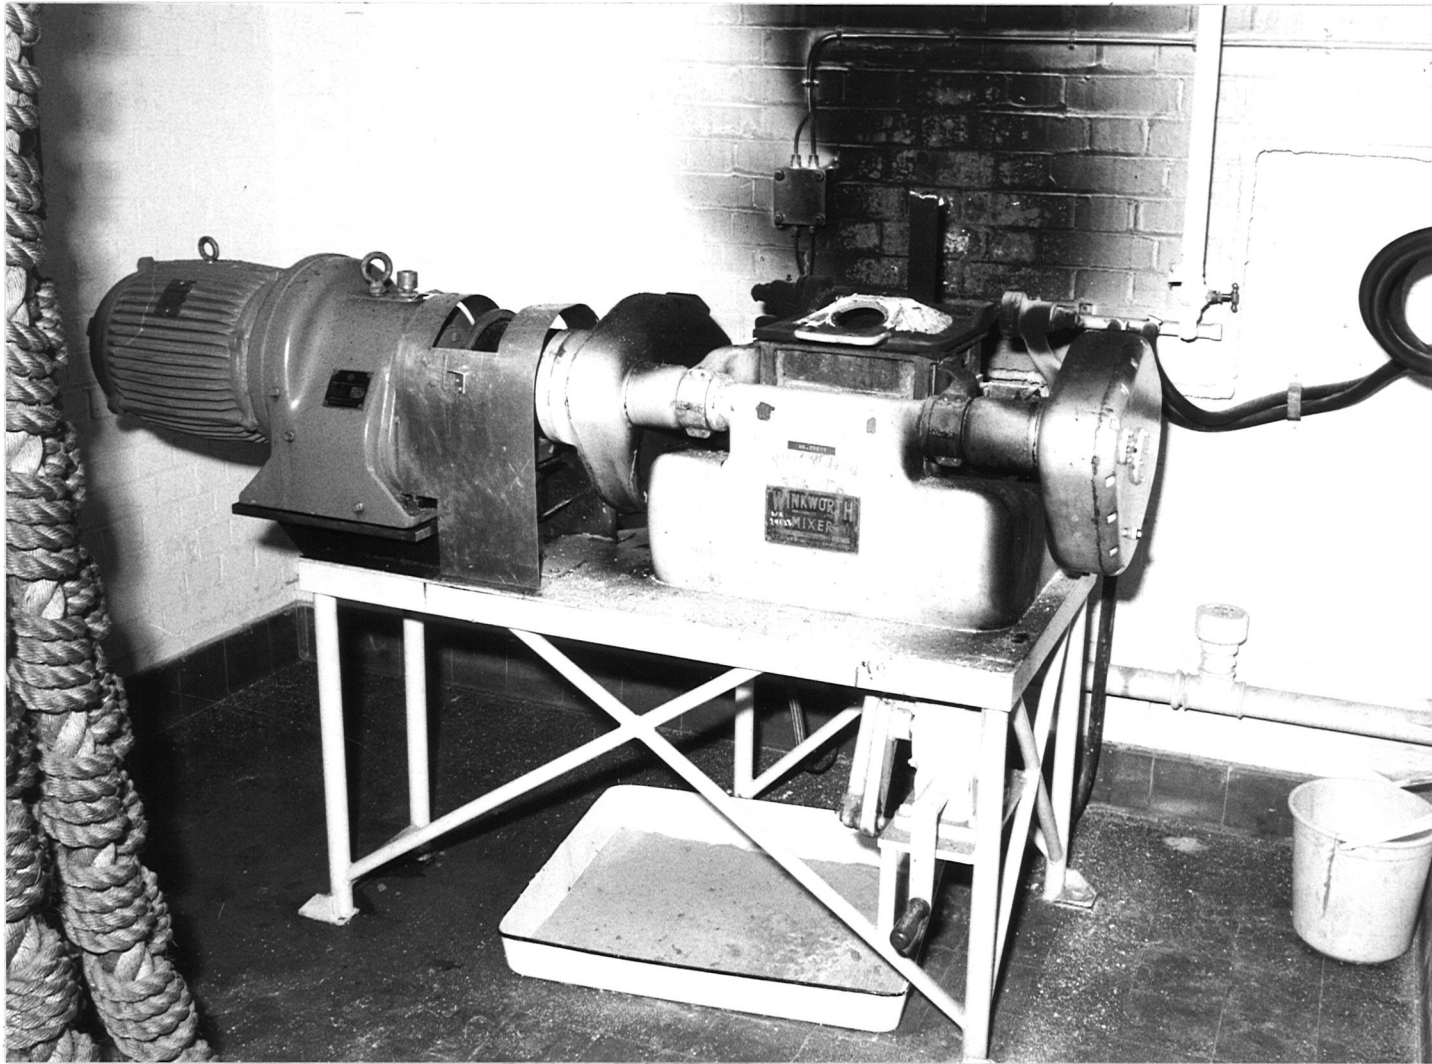
At approximately 9.30 am on Wednesday, 27th January 1982 a fire occurred while the ingredients of an experimental propellant composition were being introduced into a horizontal mixer in Bay 1, Building P720. The fire was confined to the mixer and extinguished itself within a few minutes. The Fire Brigade were called and attended the incident.

- i) Two plastic sightglasses normally located in the hinged cover of the mixer had been destroyed and the paintwork of the lid scorched.

MAPO is known to undergo rapid acid catalysed homopolymerisation and it is likely that BOBBA 8 which is based on MAPO and contains unreacted aziridine rings would behave similarly. The results obtained above strongly suggest that AP is not consumed in any significant amount in the reaction which occurs between the two materials. It is therefore suggested that BOBBA 8 will rapidly homopolymerise in the presence of ammonium perchlorate at 100°C with liberation of heat.

In his opinion the cause of the accident was due to a violent reaction between Bobba 8 and ammonium perchlorate made worse by steam heating. He thought that the problem could be overcome by using a different order of mixing, for example by diluting the Bobba 8 with binder before addition to the other ingredients, making sure that the temperature was not above 80°C.
