Title:- Report on an Explosion in a Cordite Incorporating House at R.O.F. Bishopton on 20th April, 1945.

Report on an Explosion  
In a Cordite Incorporating House  
at R.O.F. Bishopton  
on 20th April, 1945.

Reported by: D. Cross.

Date: October, 1945

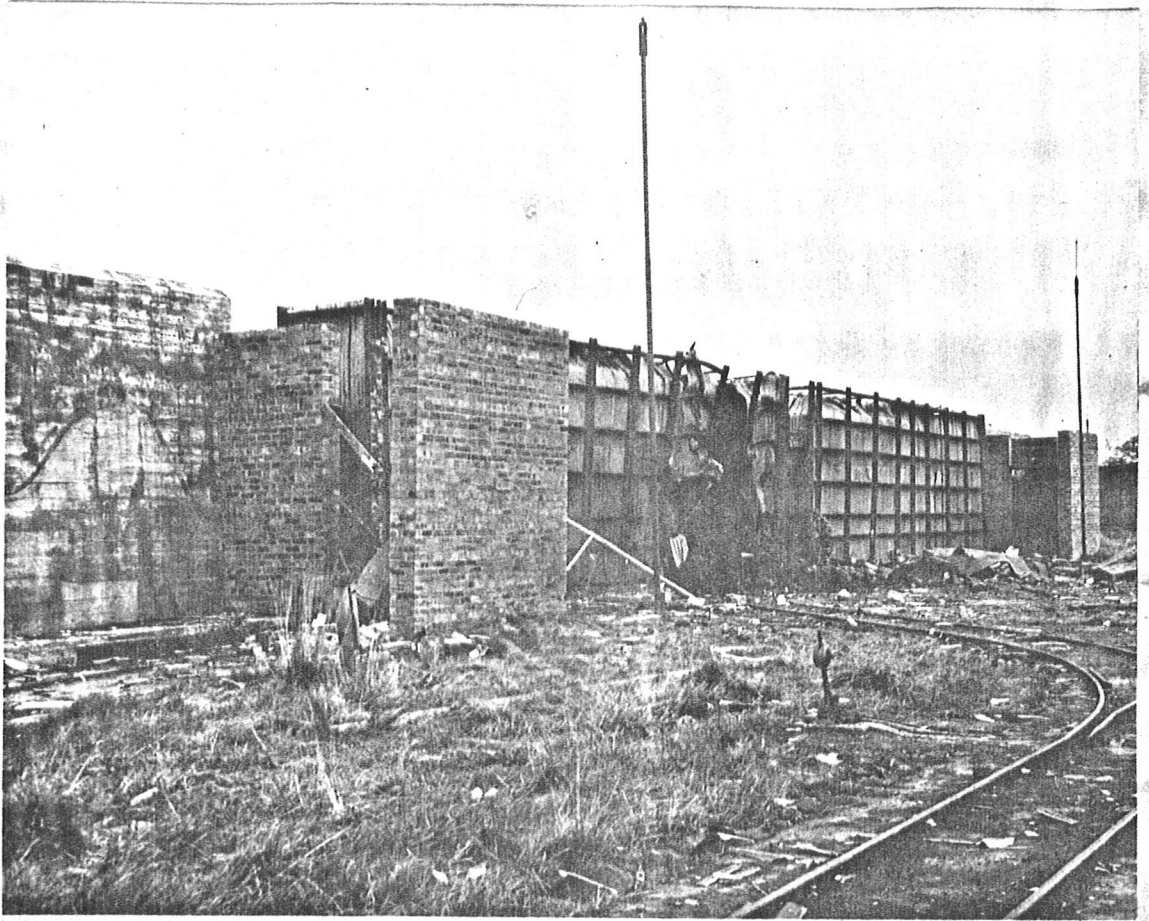
Traverses outside front of house showing  
damage due to explosion of trucks of paste.

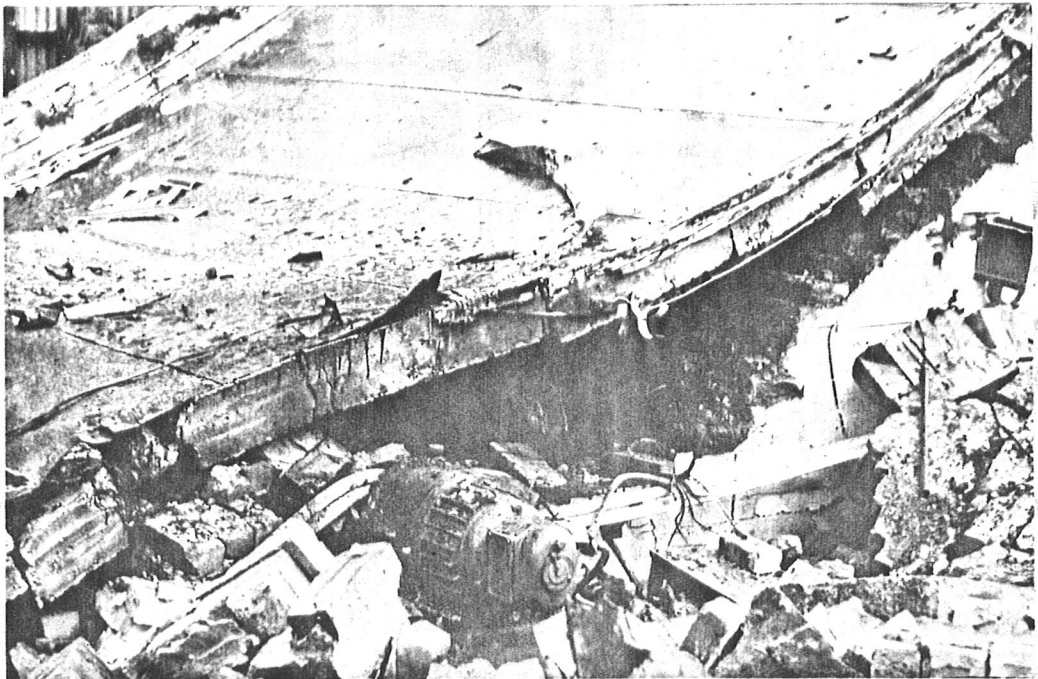
All walls demolished. Roof resting on floor. One machine demolished; other machine badly damaged but parts may be recoverable.

View showing roof collapsed on floor of  
bay 3.

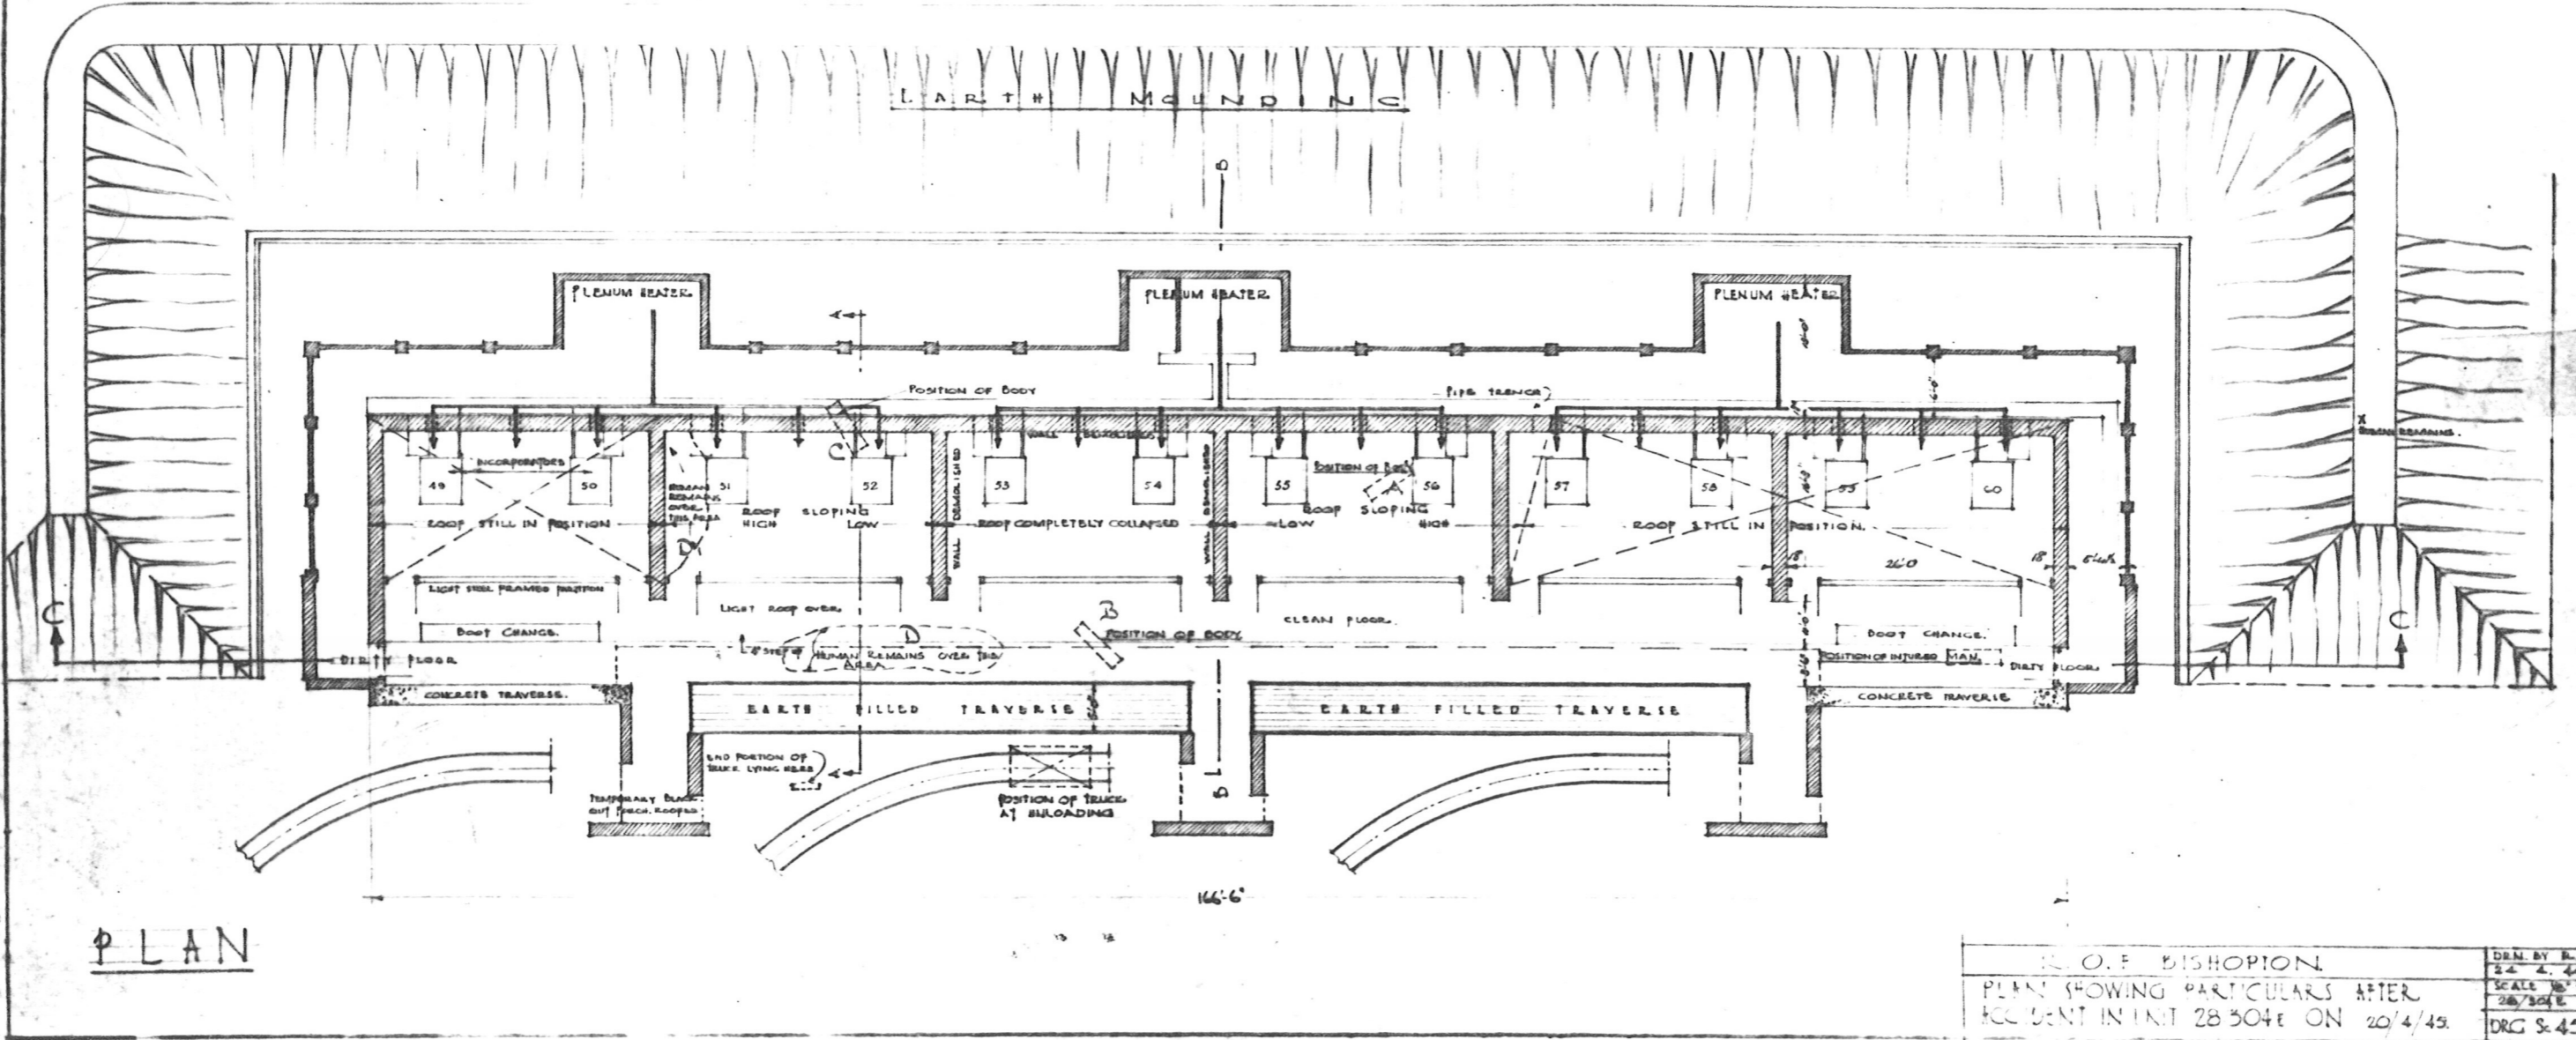
H.O.F. BISHOPTON		DRN BY B.S.
PLAN SHOWING PARTICULARS AFTER		24-4-45
ACCIDENT IN UNIT 28 304E ON 20/4/45.		SCALE 1/8" = 1'-0"
		28/304E
		DRG S-452

The medical evidence enables the bodies marked A and B on Plan No. 2 to be identified definitely as those of Mitchell and Mullen, respectively. No identifying characteristics are available in the case of the body C and the remains DD, but, by considering the medical evidence in the light of normal operating procedure, it is possible to say which represents Hill and which Fulton with reasonable certainty. The demolition of the body of machine 53 shows that dry paste detonated inside it and confirms that the operation of loading was in progress at the time. In carrying out that operation the loading table would be placed at the side of machine 53 nearest to machine 54 and one of the workers would stand alongside it and feed the paste into the machine; the other worker would stand at the opposite side of the machine - that is, between machine 53 and the side wall of the bay - and manipulate the solvent spray can. In normal routine the two workers do not do both jobs indifferently but each has his own job and sticks to it fairly rigidly. In the case of Fulton and Hill, the former normally fed in the paste and the latter handed the solvent can and it may reasonably be accepted that that was the case on this occasion. In the same way paste is normally taken from the paste trucker by the worker feeding the paste - that is to say by Fulton in this case. If Hill were in his normal position between the machine and the wall when/

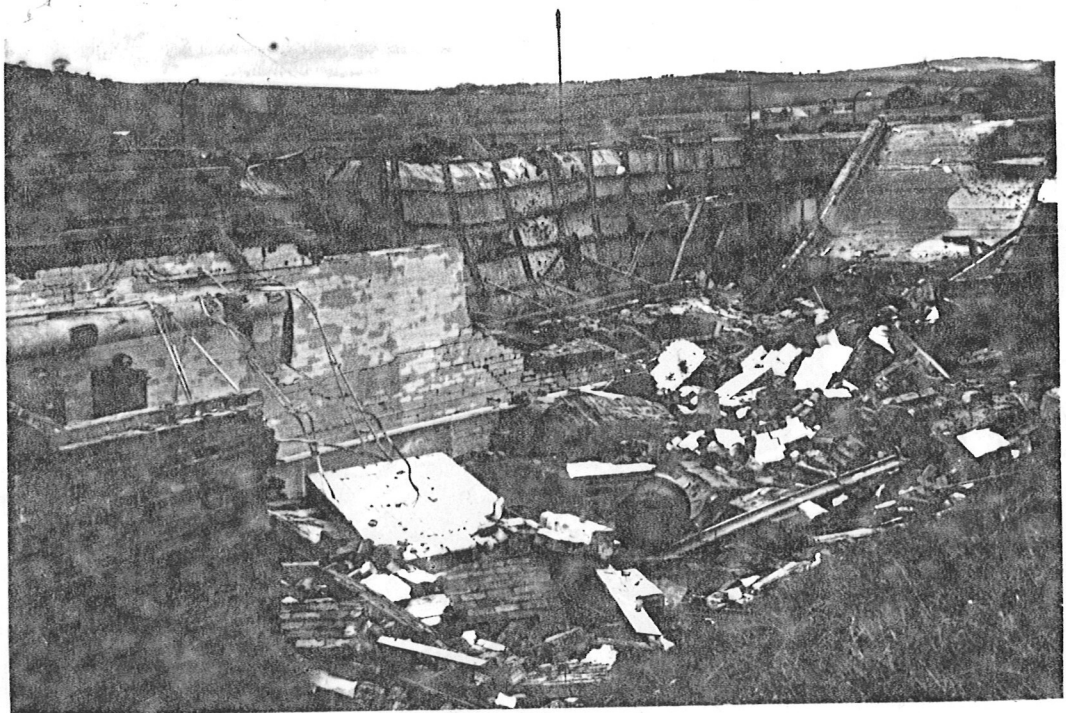
View showing roof collapsed on floor of  
bay 3.  
VIEW FROM BACK OF HOUSE LOOKING S.
