Video and Notes  
on Dismantling of  
Round Houses  
S. Site  
Mar 1998

Hertfordshire Arch Trust  
Royal Ordnance Factory  
(Waltham Abbey)  
Ref P779  
Video Footage  
Dismantling Buildings 486 & 544

NITRO-GLYCERINE WASH  
HOUSE DISMANTLING

NITRO-GLYCERINE MIXING  
HOUSE. DISMANTLING

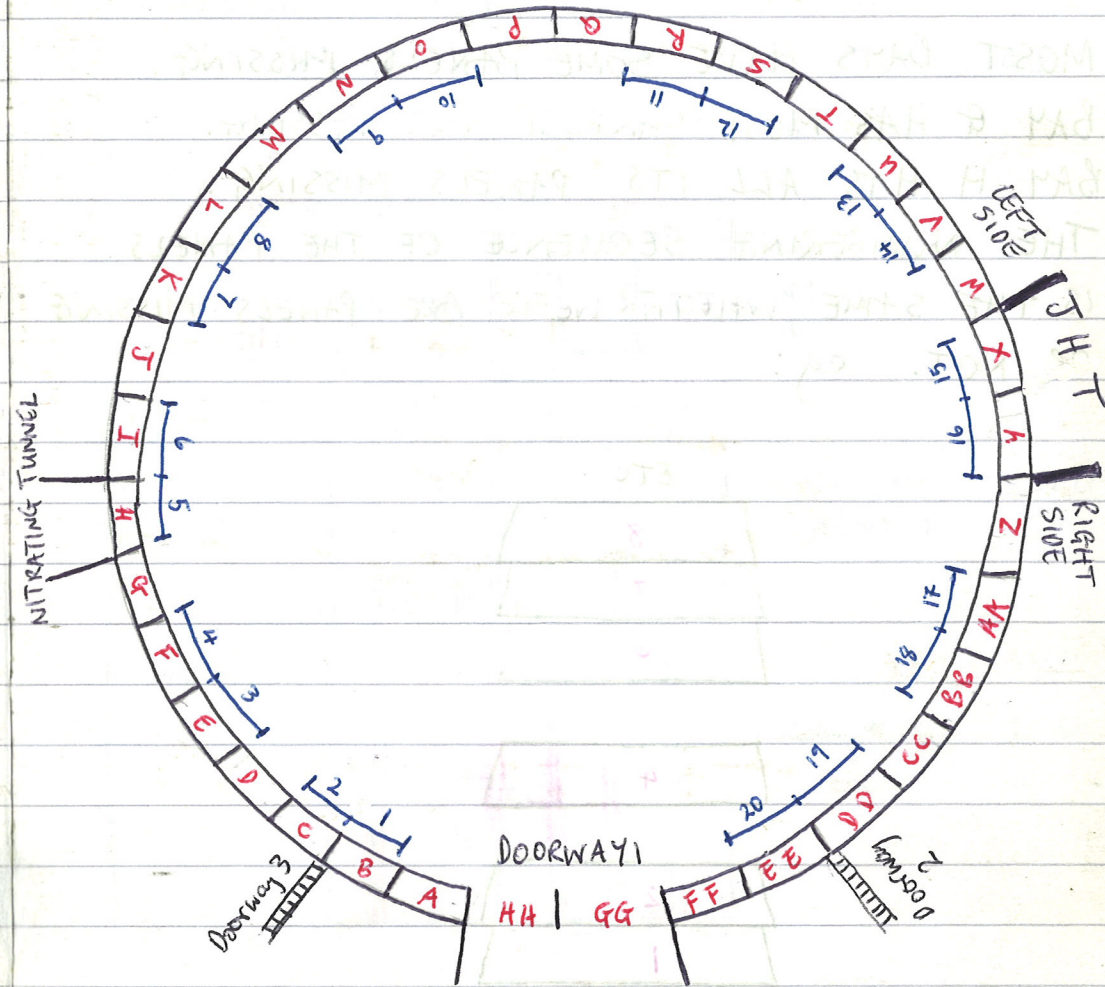
PLAN SHOWING LOCATION OF EXTERNAL WALL PANEL BAYS, WINDOWS, 2 SMALL TUNNELS  
EACH BAY HAS A LETTER. EACH EWP WITHIN THAT BAY HAS A NUMBER RISING FROM 1 AT THE BOTTOM TO 13 BELOW A WINDOW OR 17 BELOW THE ROOF.

MOST BAYS HAVE SOME PANELS MISSING.  
 BAY G HAS MOST OF ITS PANELS MISSING.  
 BAY H HAS ALL ITS PANELS MISSING.  
 THE NUMBERING SEQUENCE OF THE PANELS  
 IS THE SAME WHETHER THERE ARE PANELS MISSING  
 OR NOT. eg:

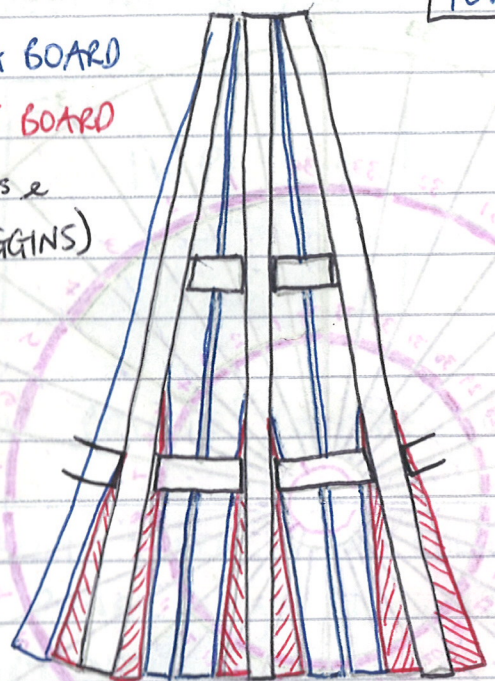
ROOF PLAN FROM INSIDE

ALL ROOF BOARDS ARE IN VERY GOOD CONDITION.

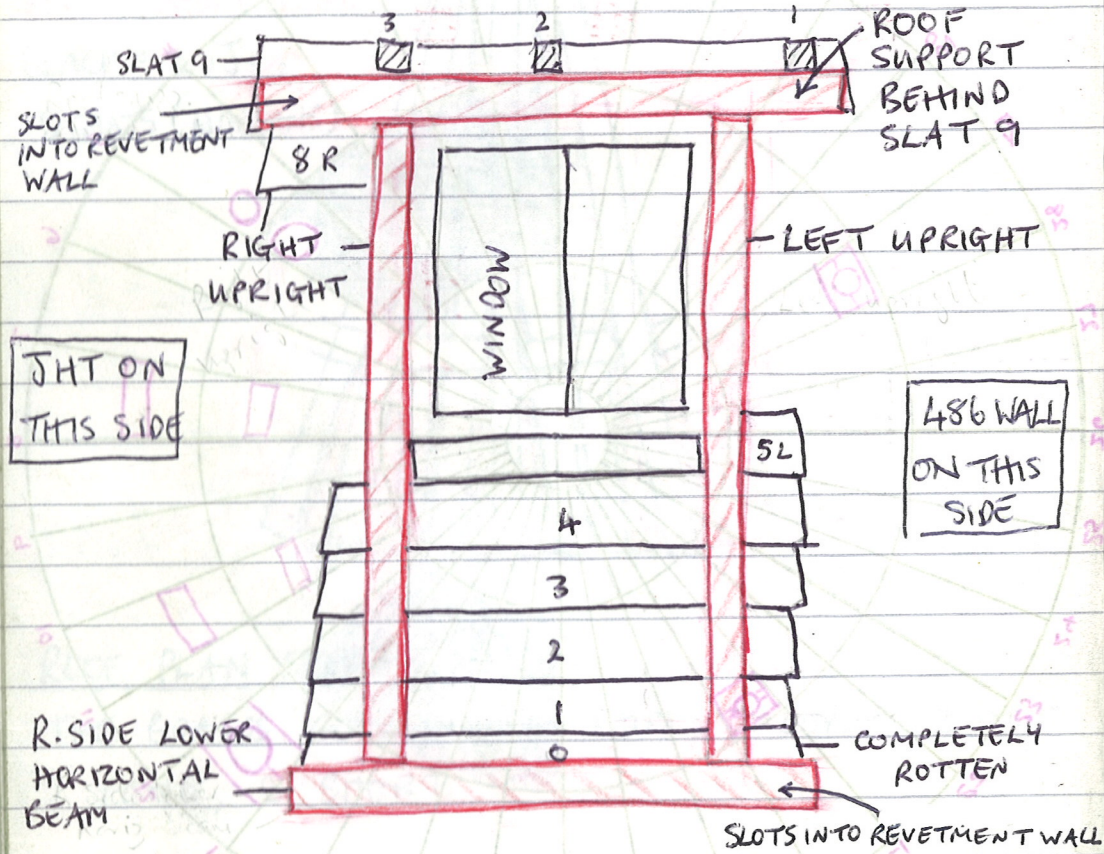
JUNCTION HOUSE TUNNEL (JHT). ELEVATION OF RIGHT SIDE INTERIOR

JHT LEFT SIDE INTERIOR & EXTERIOR WOULD HAVE BEEN THE SAME AS THE RIGHT SIDE. ALL SLATS HAVE FALLEN OFF THE EXTERIOR.

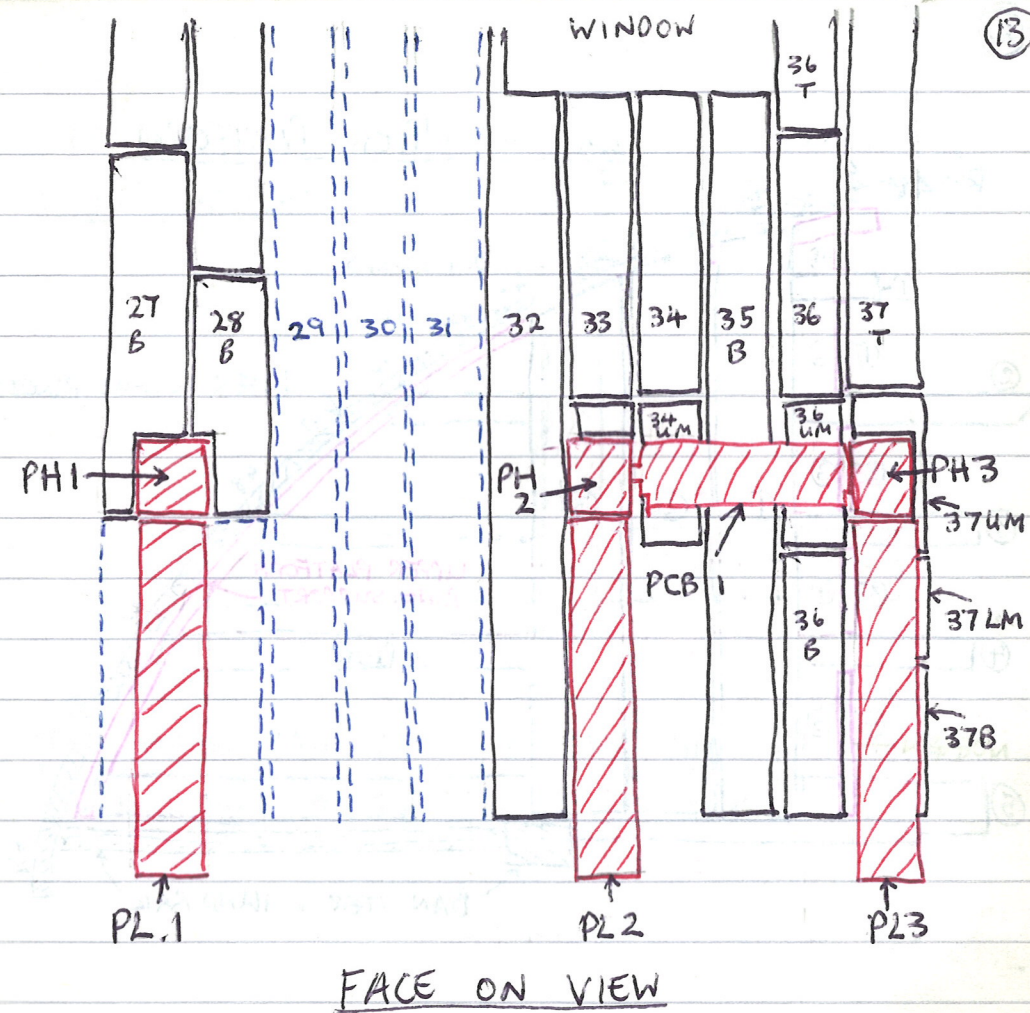
SECTION THROUGH THE GROUP OF POSTS FORMING THE LOWER PLATFORM. THERE ARE 2 PLATFORM CROSS BEAMS, ONE DIRECTLY BEHIND THE OTHER, BETWEEN PLATFORM HORIZONTALS 2 & 3.

IWP'S 29, 30, 31 ARE ALL MISSING & WILL NEED REPLACING.

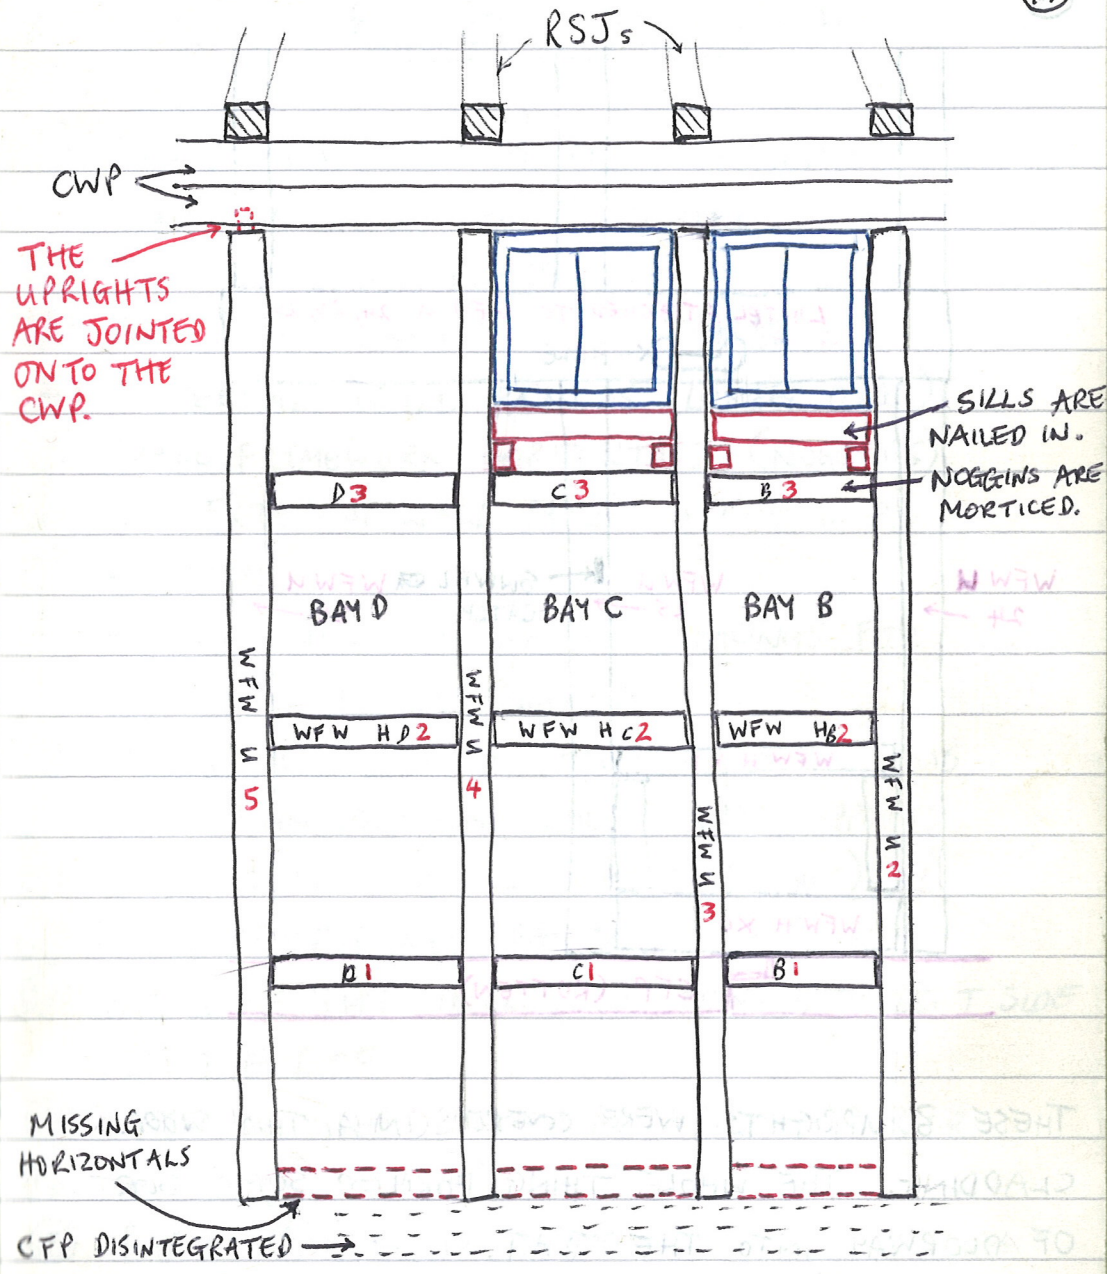
ELEVATION OF FRAMEWORK IN S44.

THERE WOULD HAVE BEEN A HORIZONTAL AT THE VERY BOTTOM BUT THEY HAVE ALL ROTTED AWAY. THE CIRCULAR FLOOR PLATE HAS ALSO ROTTED AWAY. SOME/MOST OF THE UPRIGHTS WERE NOT RESTING ON ANYTHING & WERE HELD UP BY THE HORIZONTALS. ALL THE UPRIGHTS ARE ROTTEN AT THE BOTTOM & WILL NEED REPLACING.

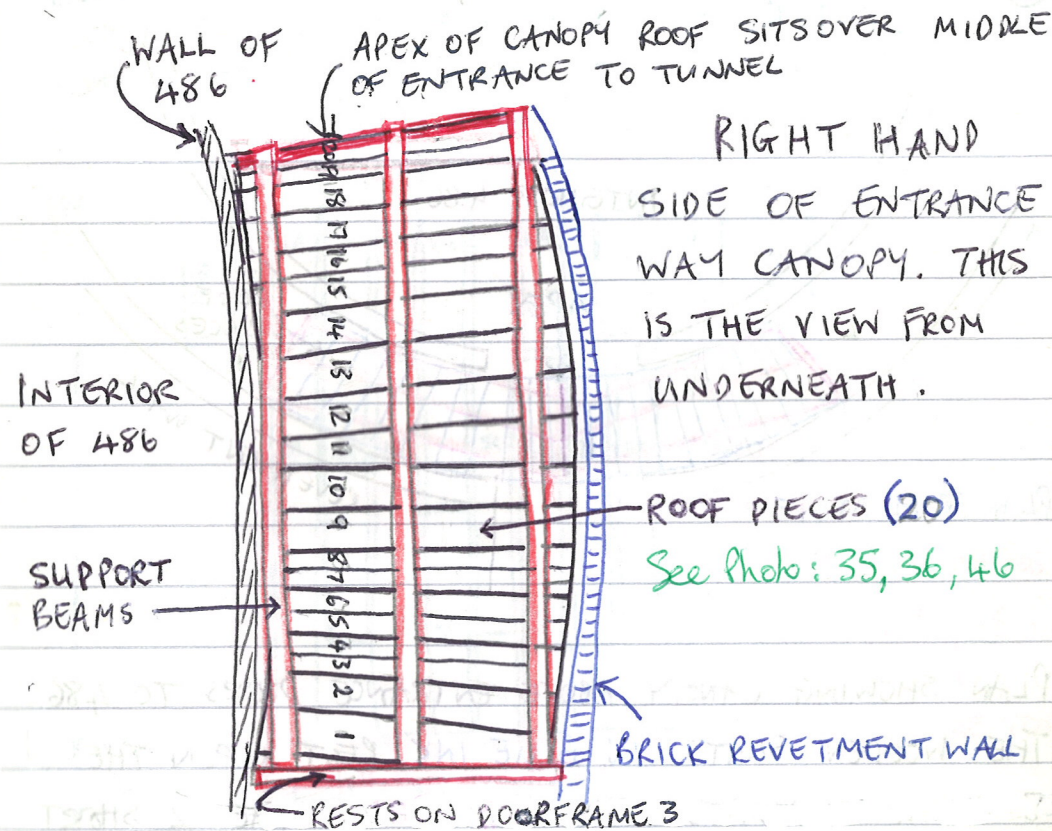
THE LEFT HAND CANOPY JOINED THIS IN THE MIDDLE BUT COLLAPSED ON REMOVAL OF THE FRAME TO DOOR 4. THE SLATS ARE VERY ROTTEN. LEFT HAND ROOF PIECES ARE NOT INDIVIDUALLY NUMBERED.

RIGHT HAND BOARDS WERE NUMBERED UP BUT MOST OF THEM DISINTEGRATED ON REMOVAL. THE BEST ONES ARE STILL ATTACHED TO THE BEAMS.

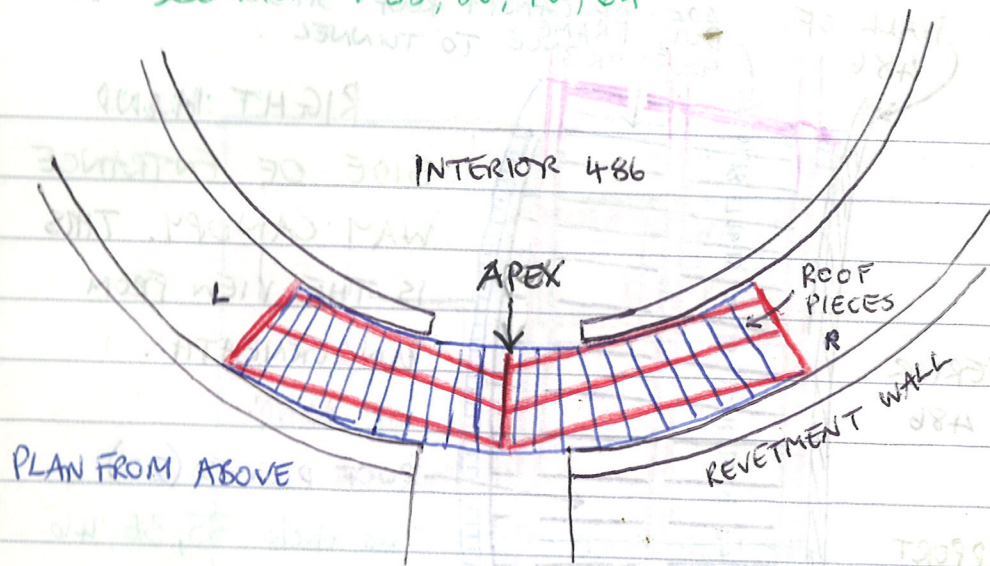
PLAN SHOWING CANOPY ABOVE ENTRANCE DOORS TO 486. THE WOODEN SLATS IN BLUE INK REST UPON THE 3 LONG SUPPORTS SHOWN IN RED. THE 2 SHORT SUPPORTS SHOWN IN RED REST ON THE DOOR LINTELS OF DOORS 4 & 3. THE SLATS ARE VERY ROTTEN & WILL NEED REPLACING. THE SHORT RED SUPPORT FORMS THE JOIN FOR THE 2 HALVES & IS THE APEX OF THE CANOPY.

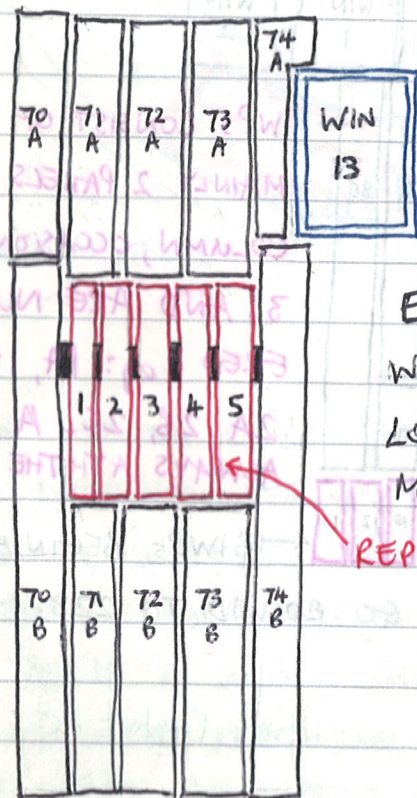
ELEVATION SHOWING REPAIR WORK DONE TO THE IWPs. LOCATED DIRECTLY OPPOSITE MAIN DOOR.

THIS SECTION OF IWPs COVERS THE SMALL TUNNEL ACCESS. THERE COULD HAVE BEEN A PIPE COMING THROUGH THE WALL FROM THE STA AT THIS POINT.

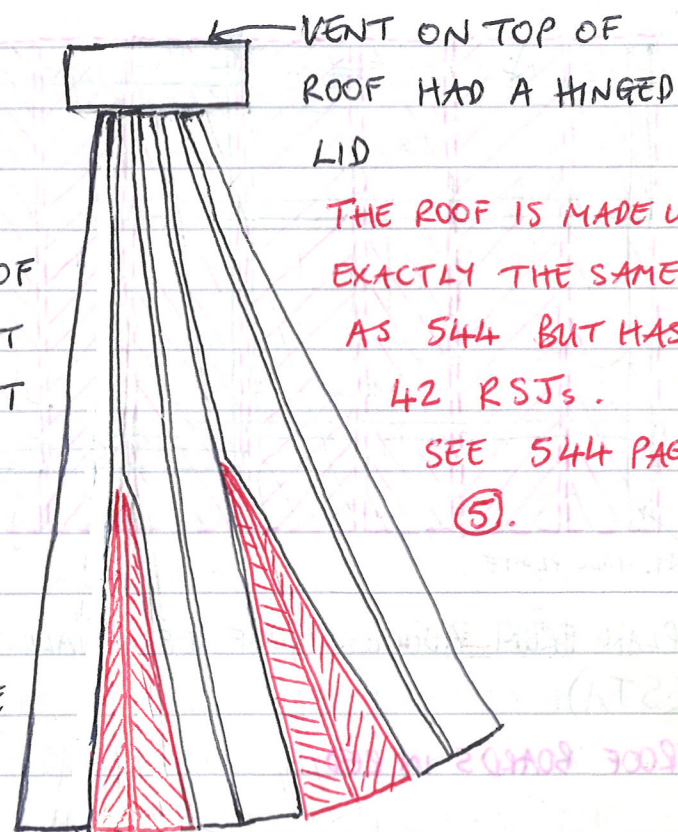
EXAMPLE OF ROOFING BOARDS.

90% OF THE BOARDS ARE RE-USABLE. ONLY THE ONES OVER BAYS MM-PP HAVE WATER DAMAGE.

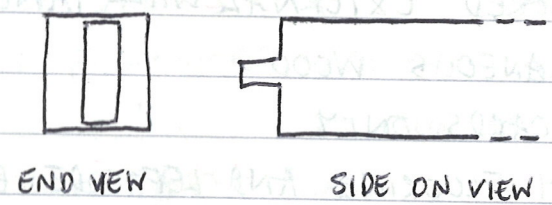
MOST NOGGINS WILL NEED REPLACING.

MOST OF THE UPRIGHTS HAVE REPAIRS BUT ARE STILL VERY ROTTEN ESPECIALLY AT THE TOP & BOTTOM.

UPRIGHTS B ARE VERY ROTTEN.

NOGGINS 1 ARE VERY ROTTEN, AND ONLY SEEM TO HAVE BEEN ADDED IN ORDER TO SUPPORT THE BIWPs WHICH ARE IN THEMSELVES REPAIRS. (SEE PAGE 13 FOR BIWPs)
