THE ROYAL GUNPOWDER FACTORY

WALTHAM ABBEY, ESSEX

BUILDING RECORDING

C.A.T JOB: 0476
C.A.T REPORT: 95272

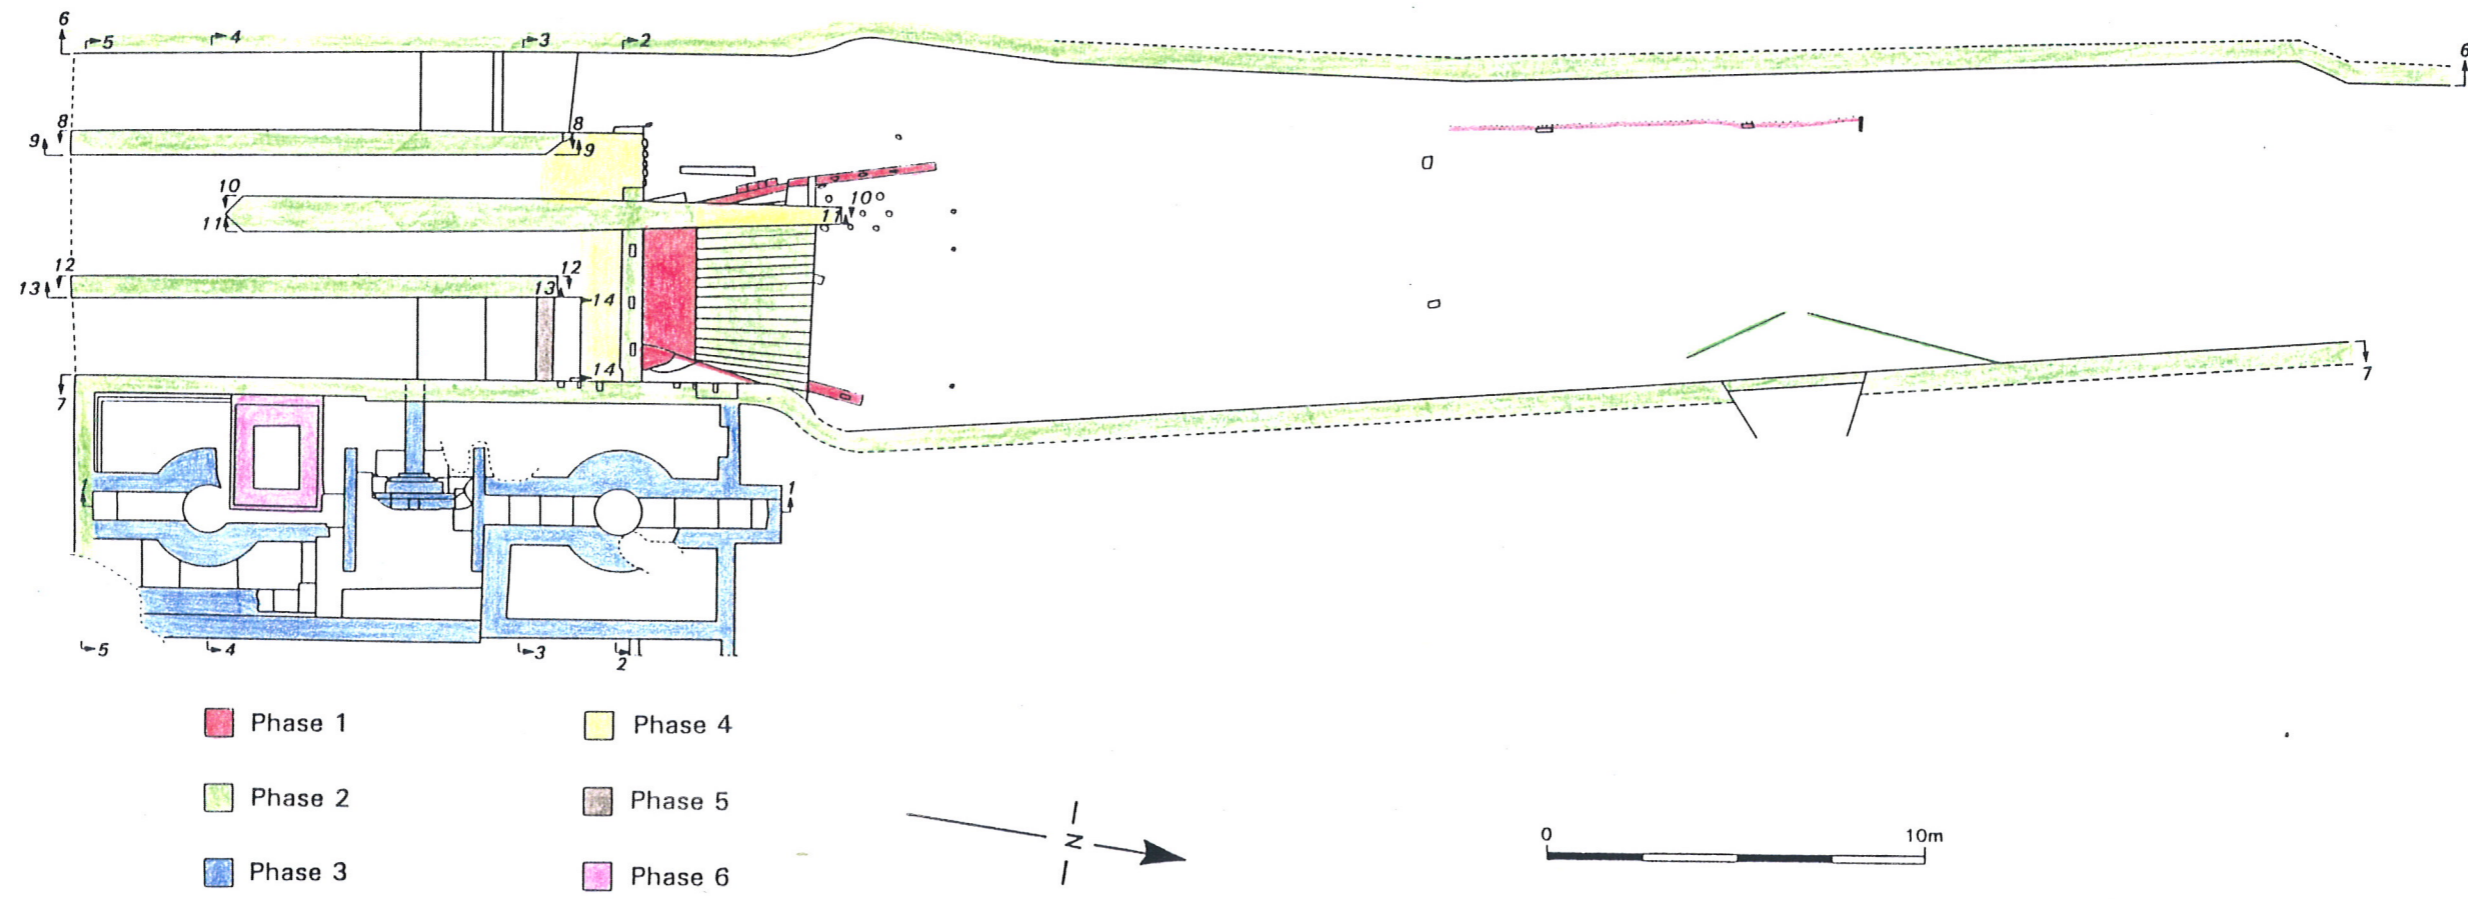
Figure 3: Phase plan of site

7.1 The study area can be divided into at least six phases (Fig 3).

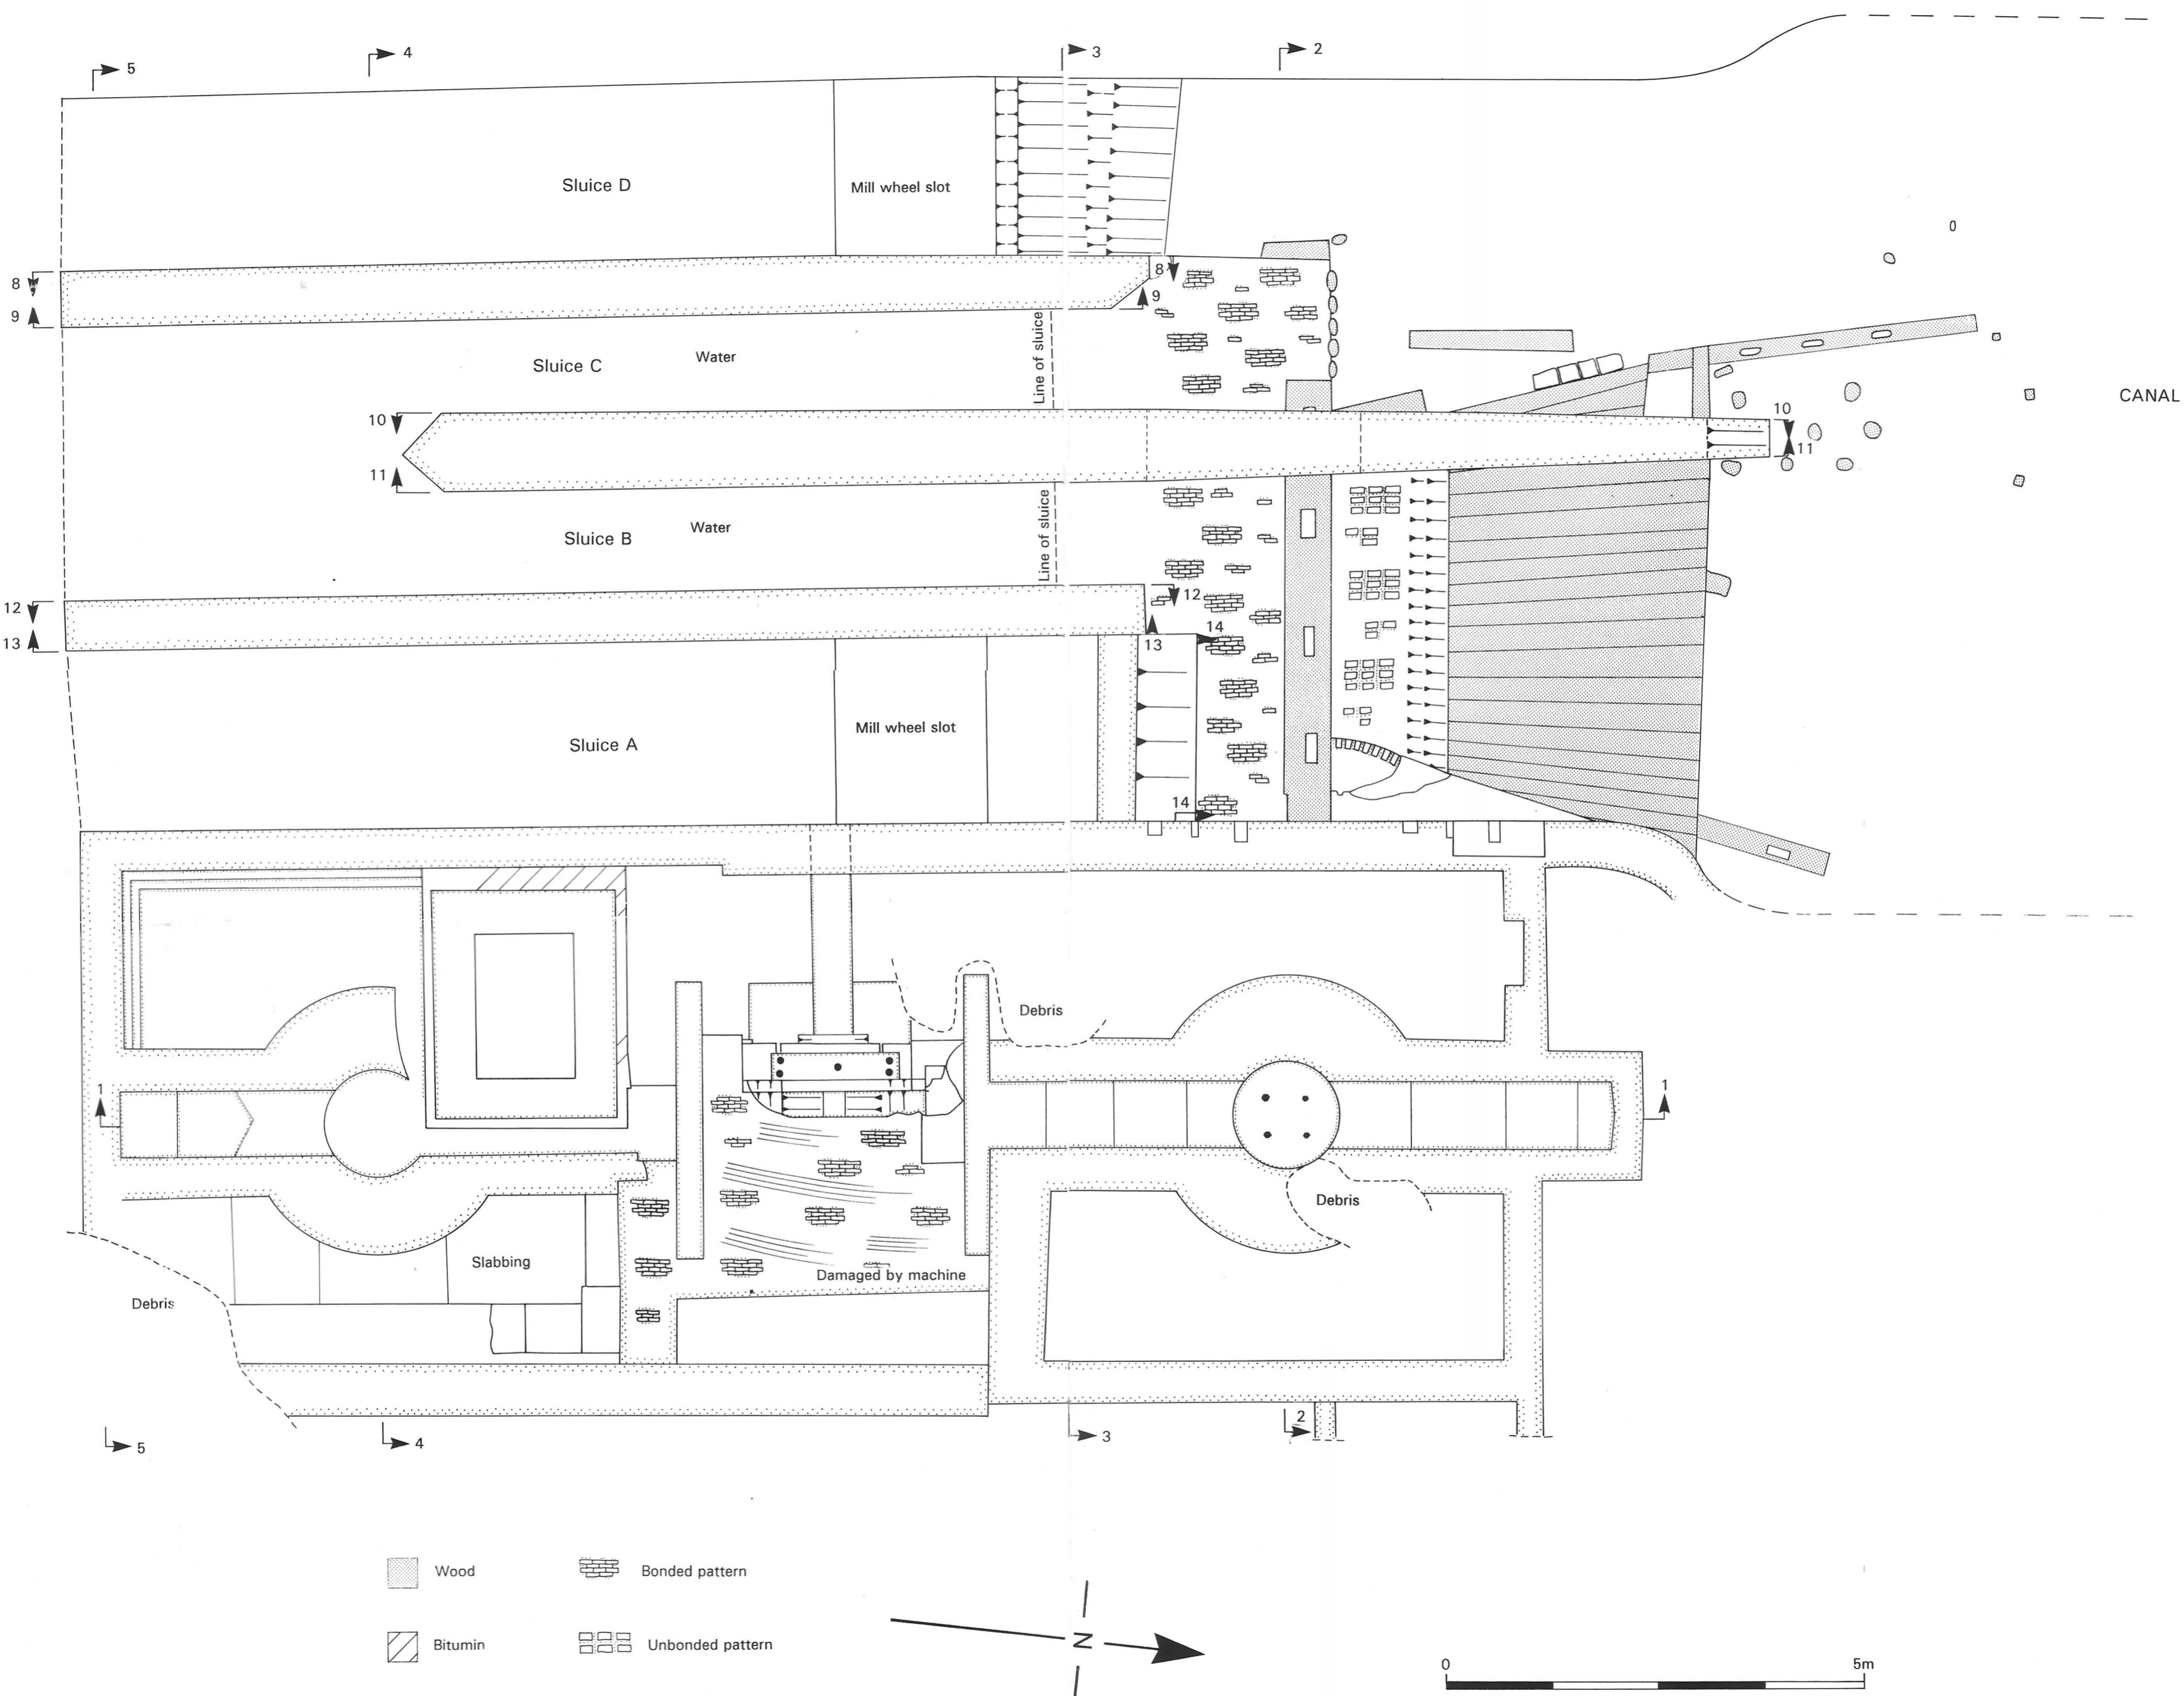
Figure 4: Plan of incorporating mill and sluice system

7.2 Phase 1: The earliest phase consists of the timber baulk and vestigial limestone wall on the western side of the extended pier of sluices B and C (Fig 4). The alignment of the timberwork appears to indicate that the canal has been widened to allow for the construction of a four sluice outlet. The timberwork and wall can also be aligned with the chalk rubble observed on the north-western side of the canal (Fig 3). The chalk is presumed to be part of the original foundations of the canal wall. A small semi-circle of broken brickwork on the eastern edge of the canal conforms with the timber base but not the canal wall (Fig 4). This may indicate that the original eastern canal wall was further to the west.

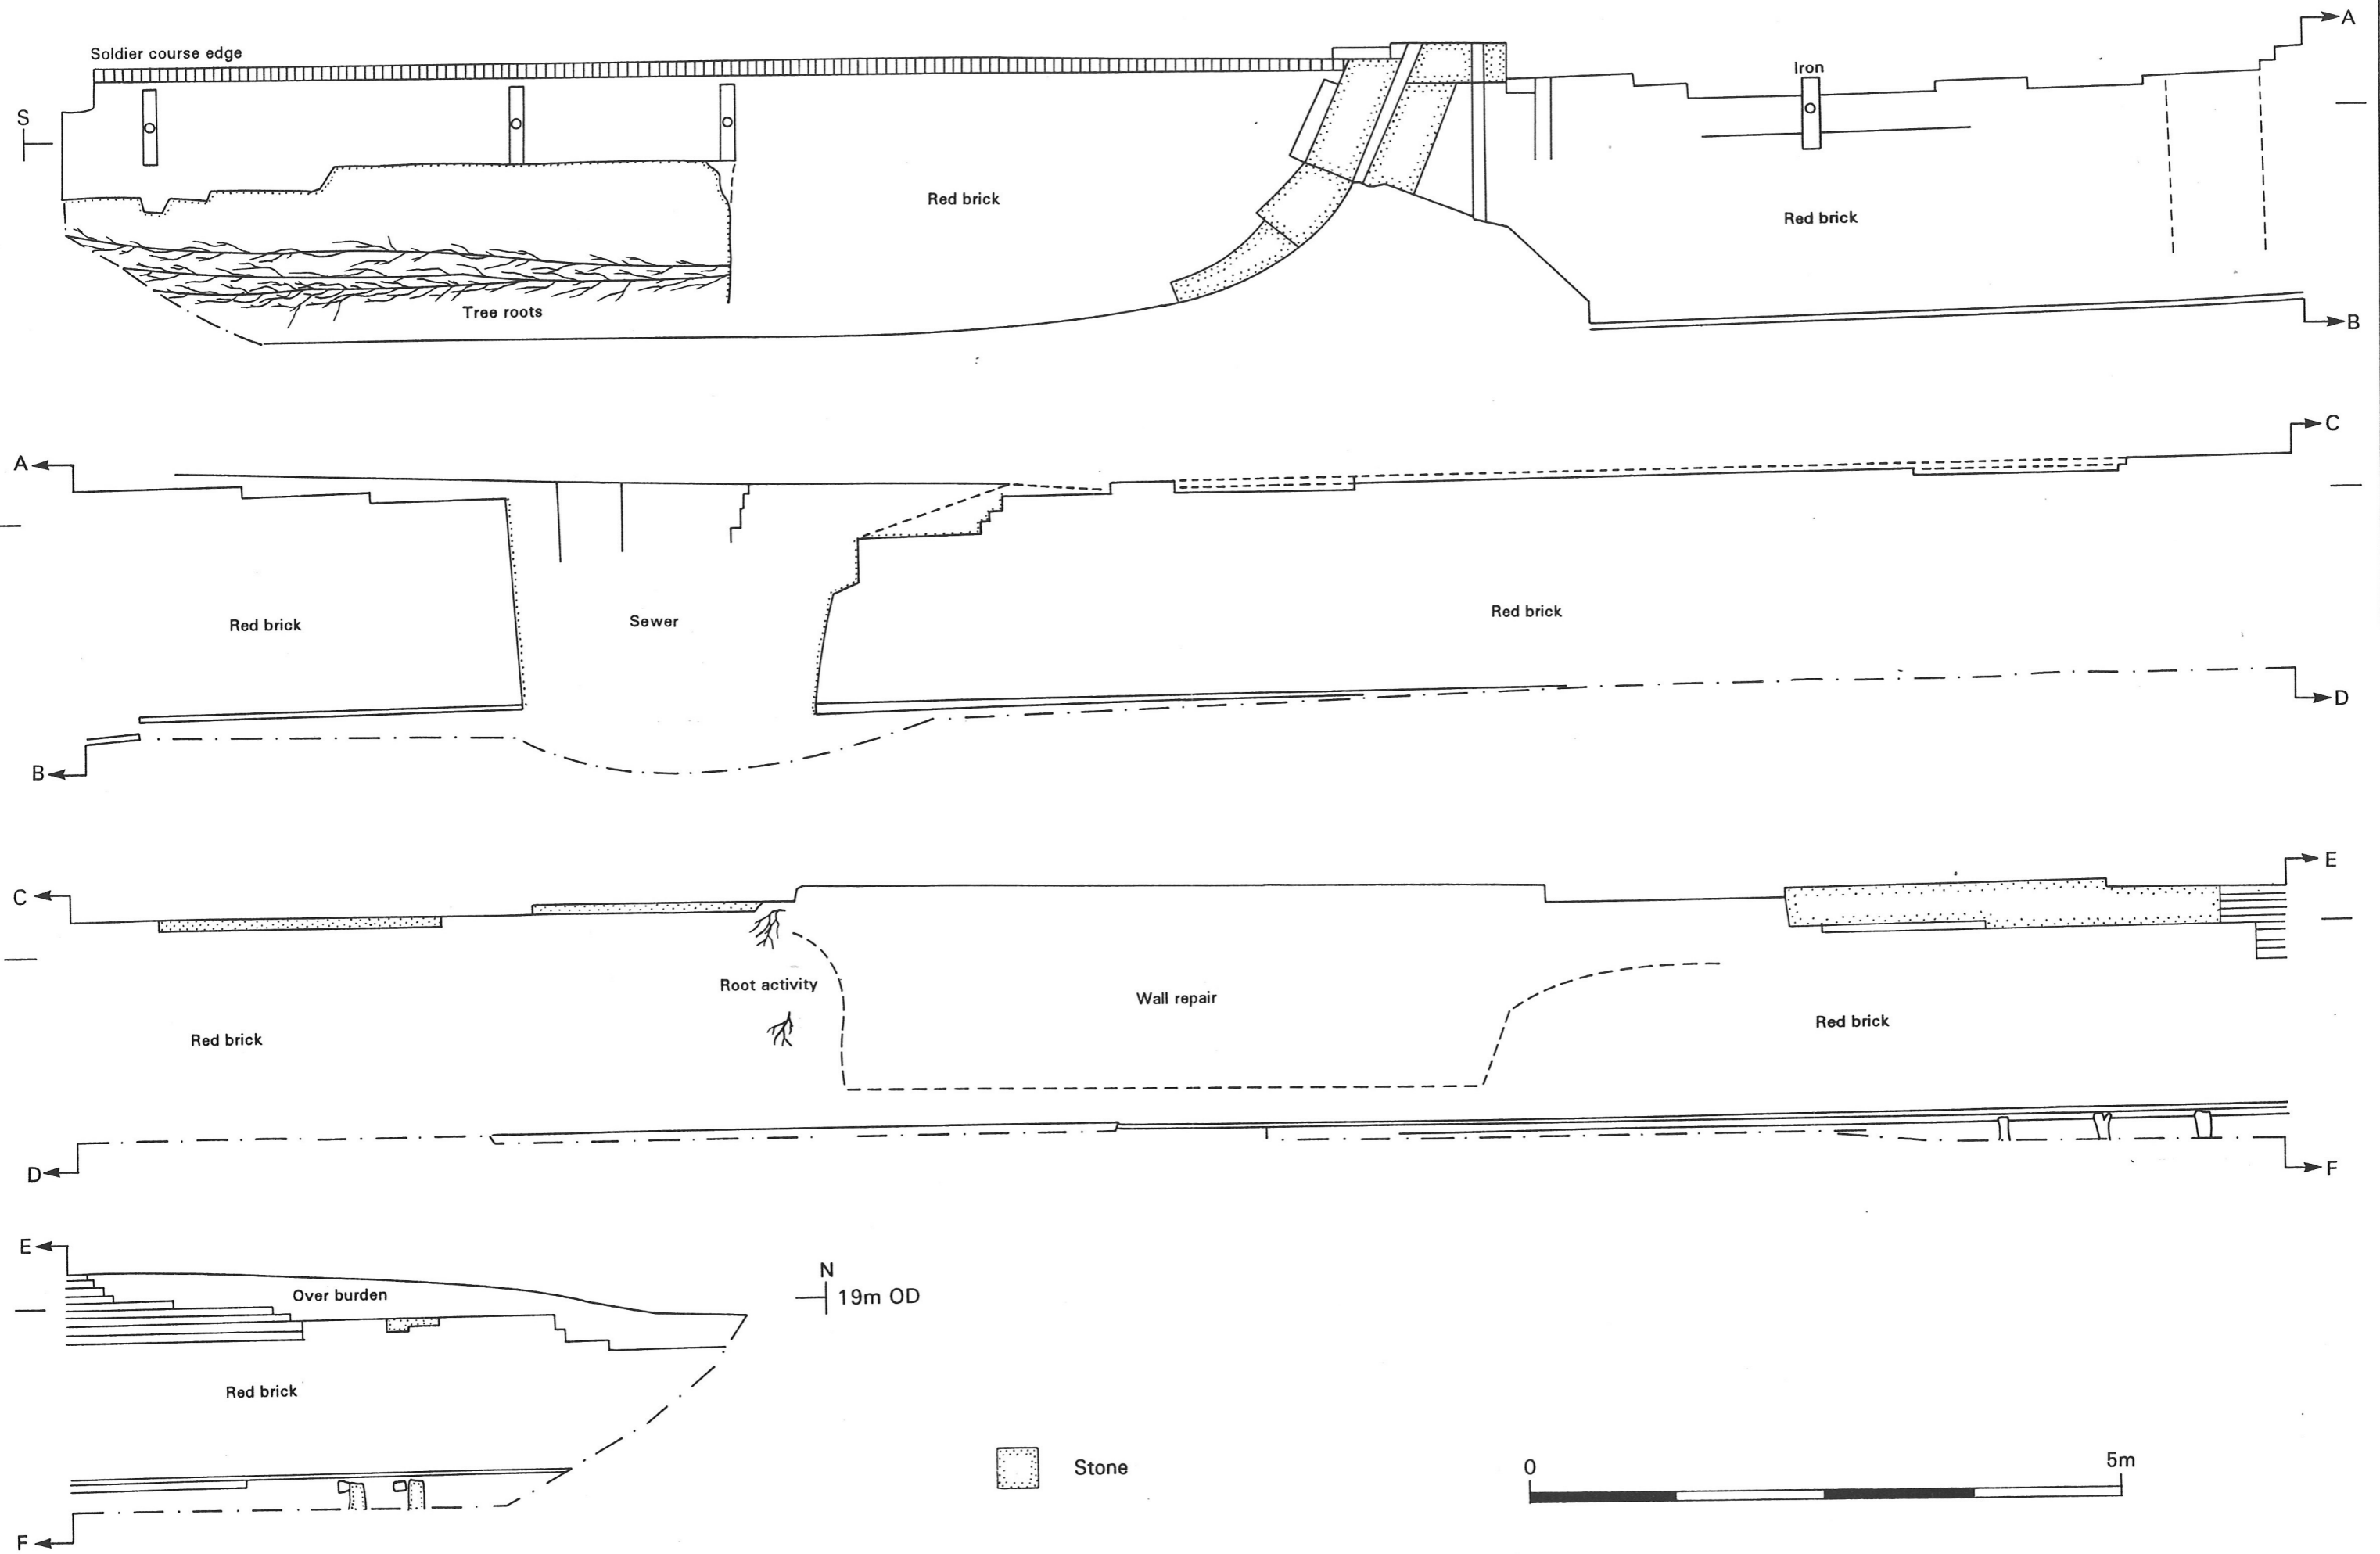
Figure 7: Canal elevation 6

6.1.6 The western side of the canal also displayed an obvious patch of repair work, to the south of the corbled brick (Fig 7).
