Interim Report 1946/14

Propellants Plastic

Use with Light Alloy Motor

P.D.E. Aberporth

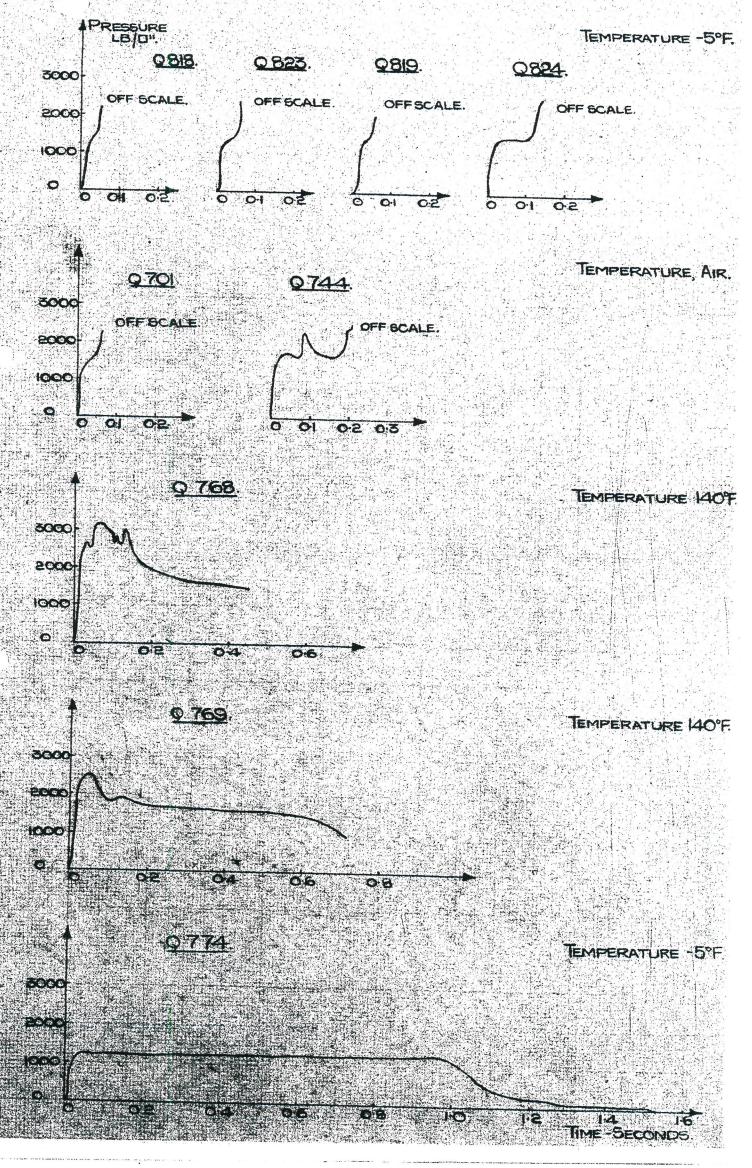
Fig.1. PRESSURE TIME CURVES FOR LAP/RP BURST ROUNDS.

It will be noticed that in general bursts have occurred very early, i.e. at not more than 0.2 sec. after the commencement of burning or late, i.e. after 0.6 sec. burning. Examination of fragments of tubes and propellant from the former type has generally indicated that they were due to detachment of the propellant from the walls of the motors leading to excessive burning surfaces, the high pressures then developed were clearly established by the pressure recording. This type of burst is portrayed in Fig. 1 rounds Q.818, 823, 819, 824, 701, 744 and Fig. 2 round Q.788.

The late bursts, or merely tube perforations as they are in some cases, occur without any marked rise in pressure and in a mild case as shown in Fig. 1 round Q.774 and Fig. 2 round Q.784, there is nothing in the pressure-time curve to suggest any fault. Measurement of the performance indices shows that this figure is slightly below normal in these two cases, indicating that the perforation occurred almost at the end of burning. The majority of the remaining failures of this type were clearly due to the same phenomenon i.e. overheating of the exposed wall at the venturi end because of detachment of the propellant at this point. The only doubtful late bursts appear to be rounds Q.768 Fig. 16 in which the tube burst only at the head end and 5.P.351 Fig. 18 which was fired without recording the pressure-time curve and again failure appears to have started at the head end. The pressure at which the latter burst occurred is unfortunately not known.

A description of the type and probable cause of each burst appears in Table II which should be studied in conjunction with the photographs (Figs. 15 to 23) and miniature pressure or thrust time curves (Figs. 1 and 2).

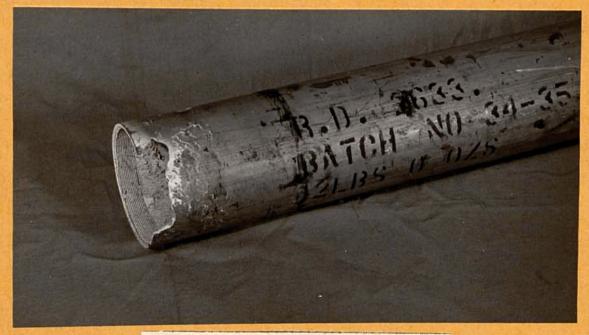
Fig. 17. 5.P.349 Q. 769

It seemed clear at this stage that late bursts were in general caused by tube failures at a point immediately to the rear of the venturi plate indicating that the walls had become exposed to the hot gases by detachment of the propellant at this point. (See Figs. 17, 19 and 20). In order to overcome this defect a

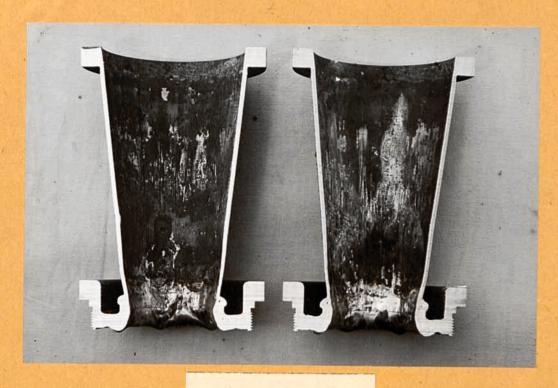
Fig. 24.

It was noticed that a number of venturi were swollen at a point just outside the throat after firing with propellant R.D.2633 (See Fig. 24 showing sectioned venturi). In the case of rounds 5.P.344 and 5.P.282 the venturi were completely split open just before all-burnt as illustrated in Figs. 26 and 27. These components were examined by C.E.A.D. and stated to be below the specified wall thickness.

The high energy binder propellant causes considerable erosion of the venturi entry. This is shown in Fig. 24 while Fig. 25 shows the appearance of the venturi, fitted with modified venturi plate, before and after firing. In general the throat diameter using R.D.2633 does not alter appreciably, being sometimes slightly reduced and sometimes slightly enlarged on firing. On the other hand the low energy binder propellant R.D.2049 causes appreciable reduction in throat diameter. This may be due to the fact that there is a greater area of metal exposed to the gas stream in the latter case due to the use of a smaller venturi throat.
