ERDE NORTH SITE - TWO  
CIRCULAR BRICK STRUCTURES  
UNCOVERED DURING  
DEMOLITION OF A203?  
HORSE MILLS. 3 b/w PHOTOS  
PLAN + DESCRIPTION

December 1963. Two circular brick structures uncovered during demolition of A 203 etc. Stores buildings. Three photographs and attached plan showing approx. dimensions and locations.

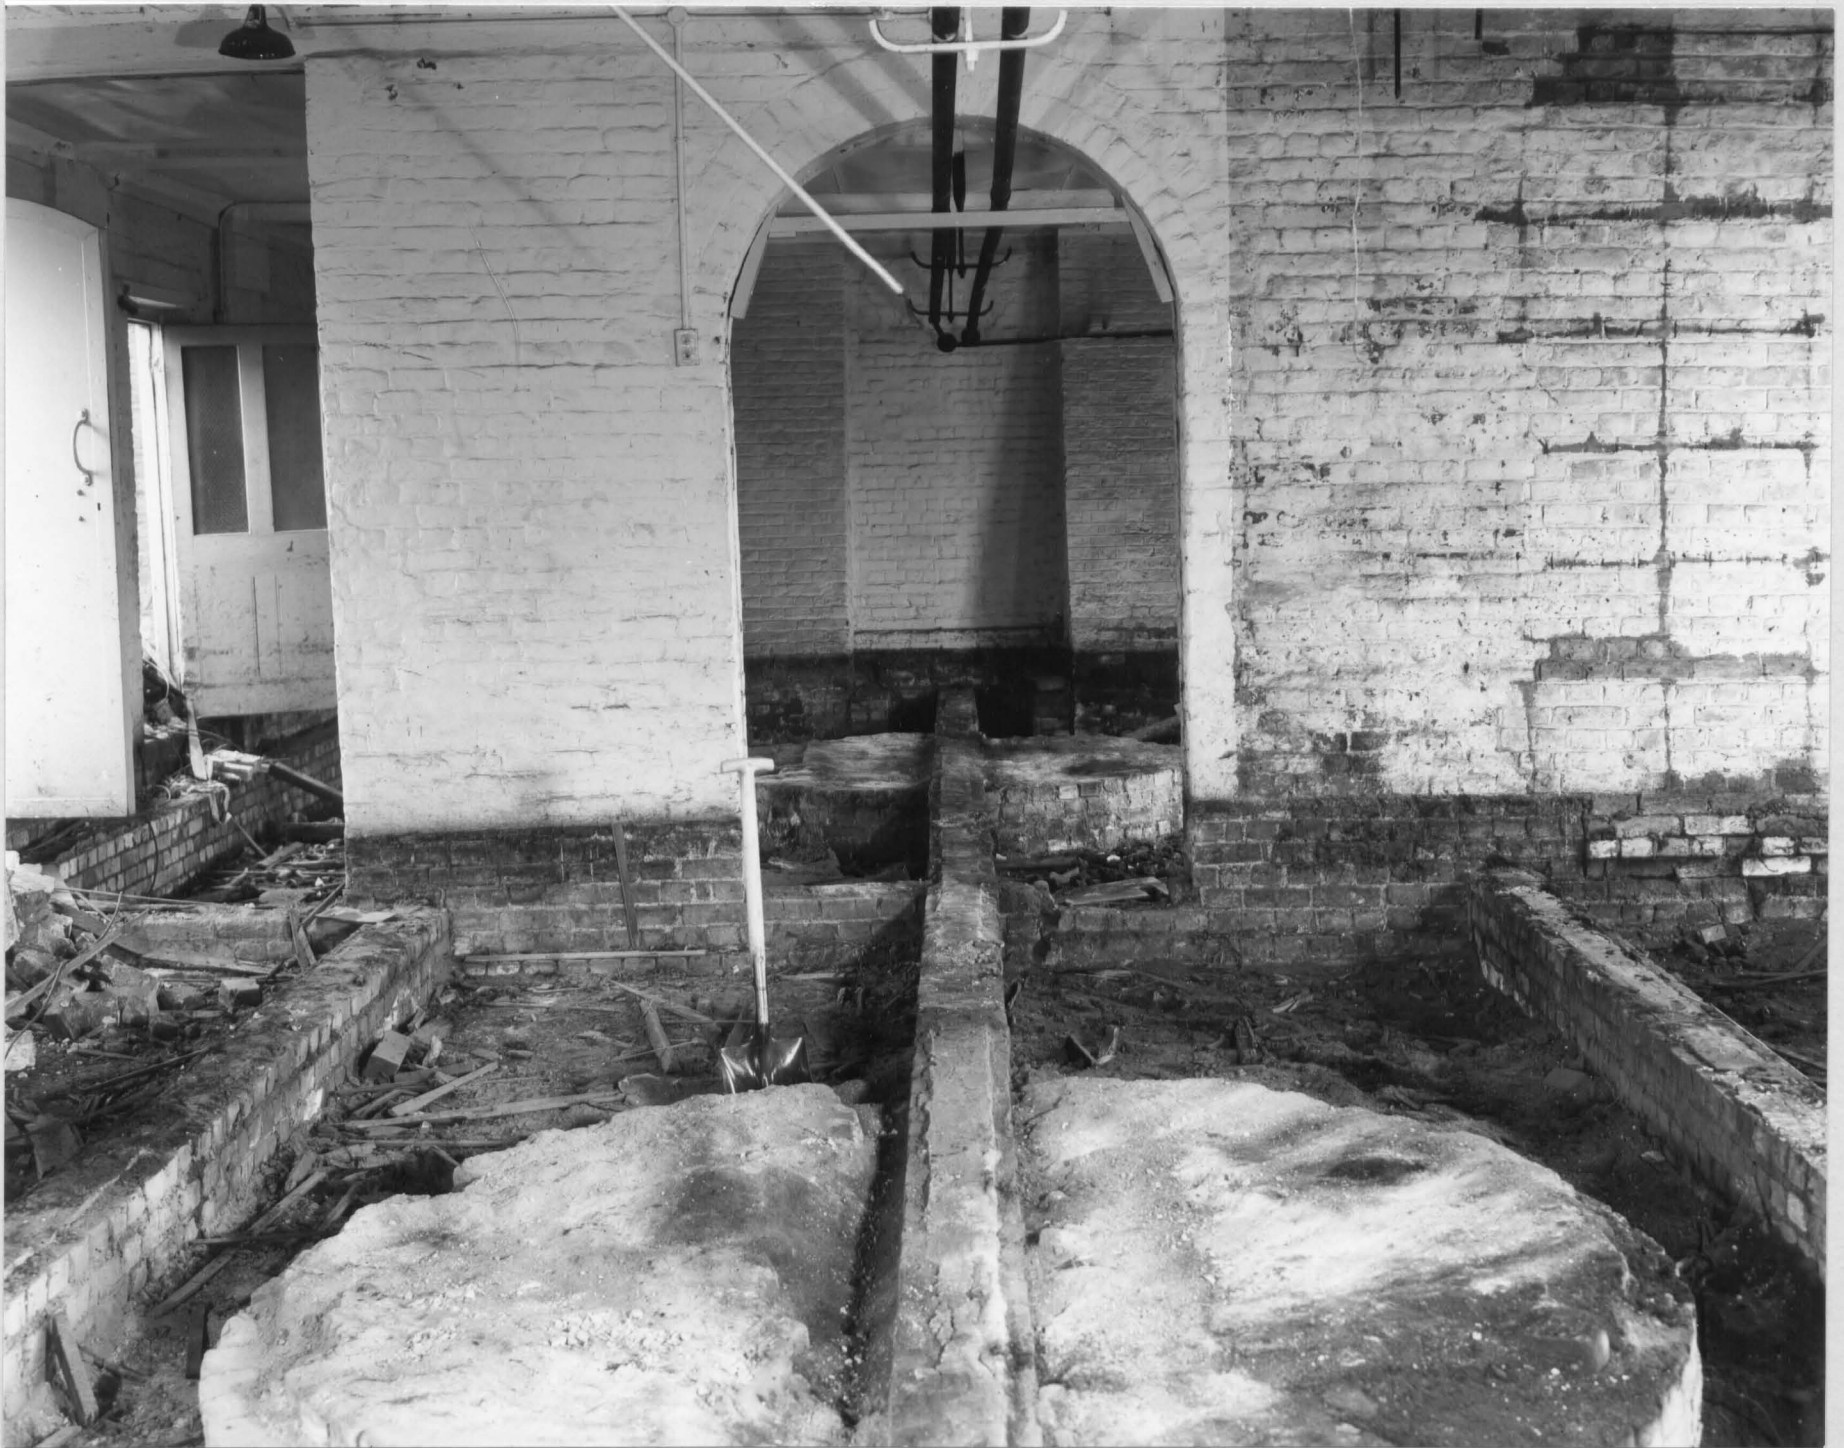
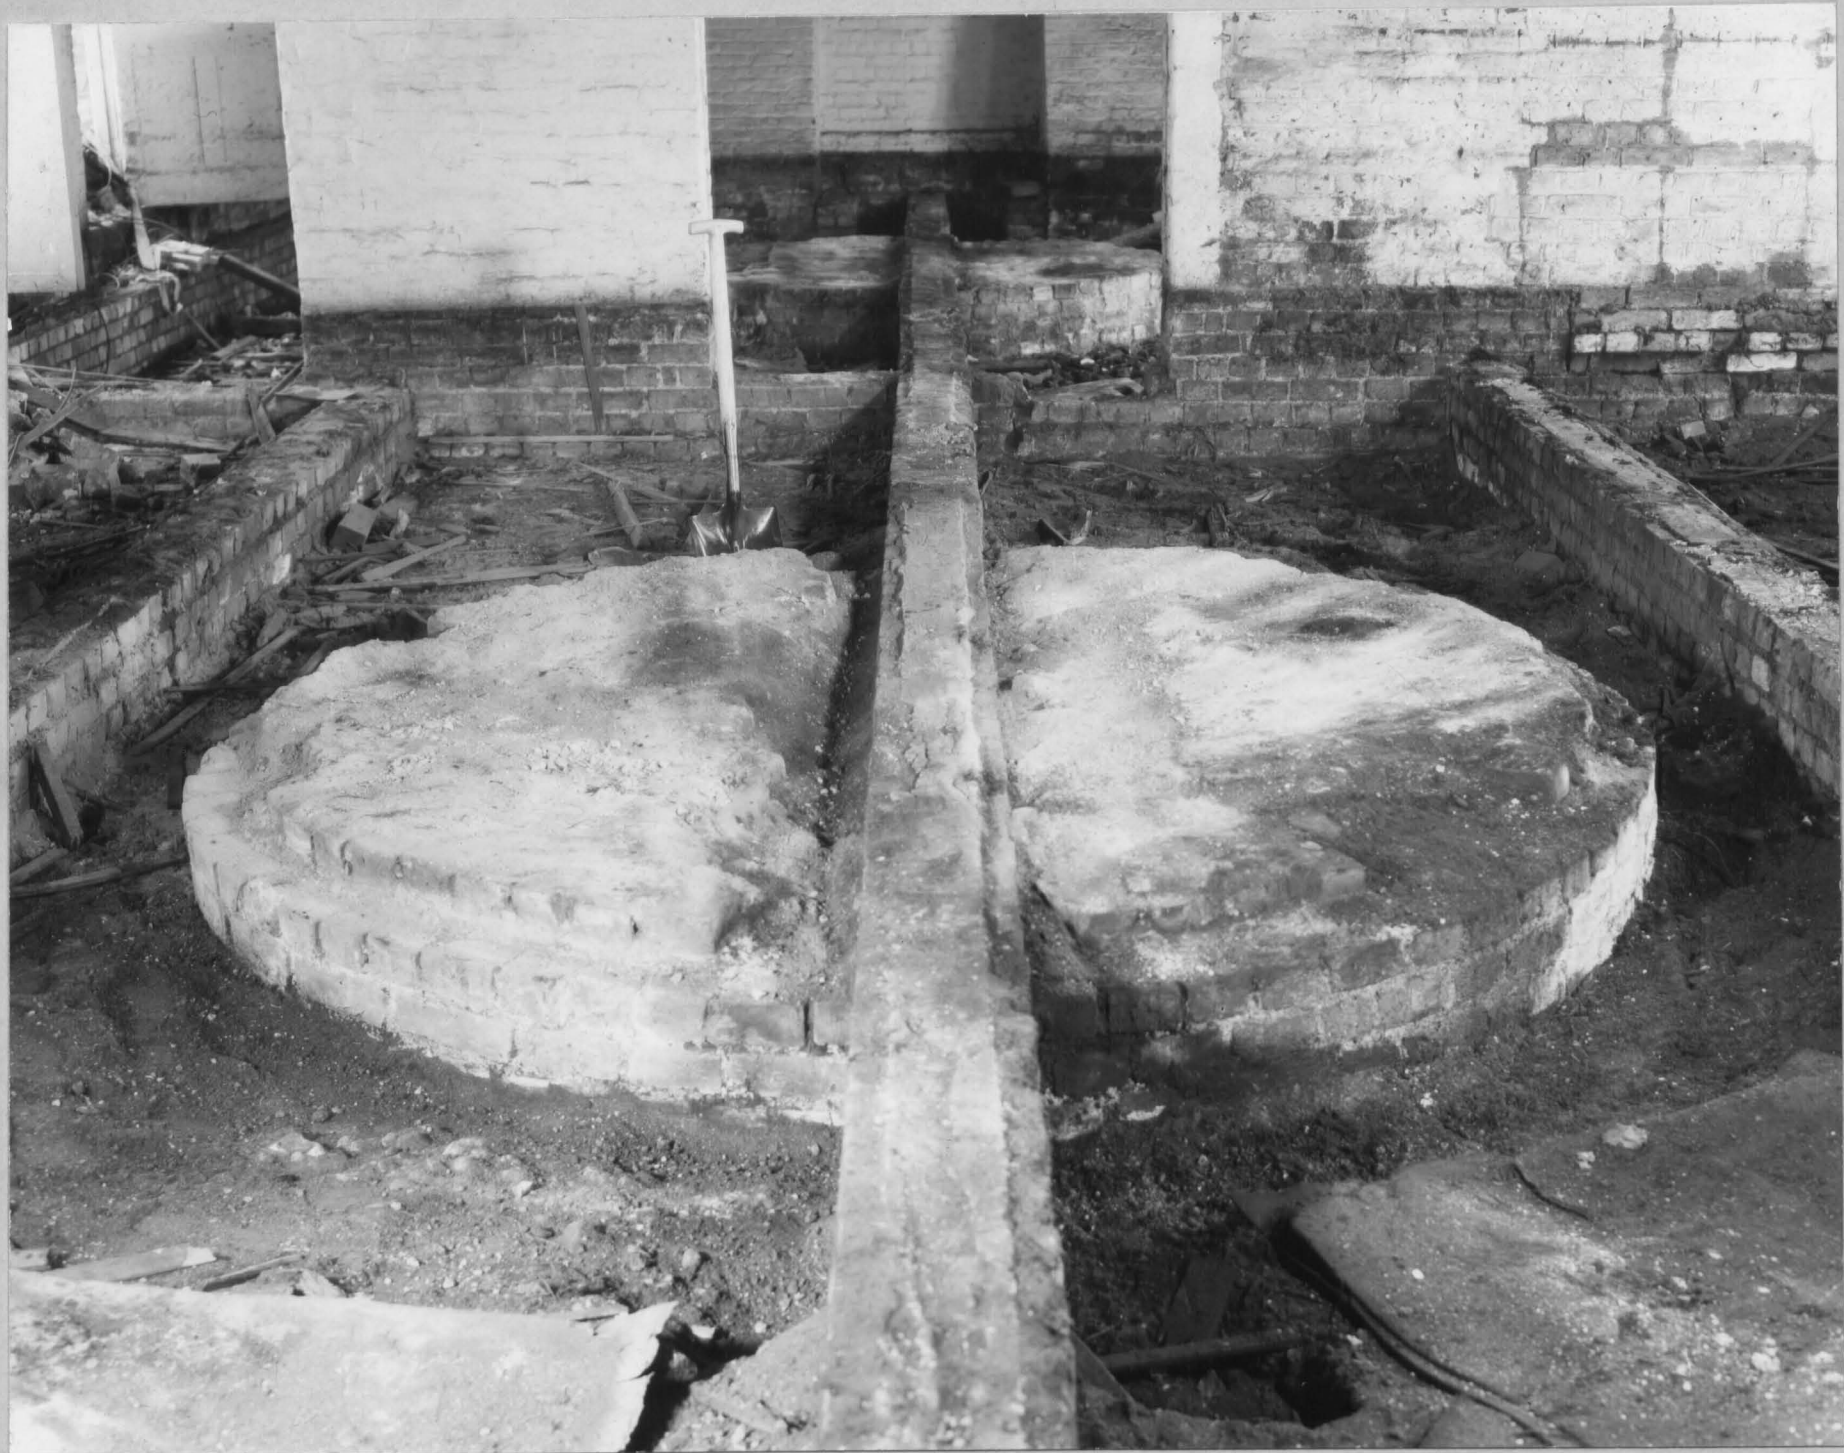
On being uncovered they were examined by Engineer and Library staff but this did not reveal any evidence of their origin or purpose. The central portion of each had been partly cut away and the later foundations shown in the photograph as passing through them had been built on to them.

Their positions seem to coincide with that of the "three horse mills" depicted in the 1735 drawing by R. West in Farmer's History and it is supposed that these are the foundations of two of them. The third was supposed to be under the concrete floor of the A203 building and no attempt was made to locate it.

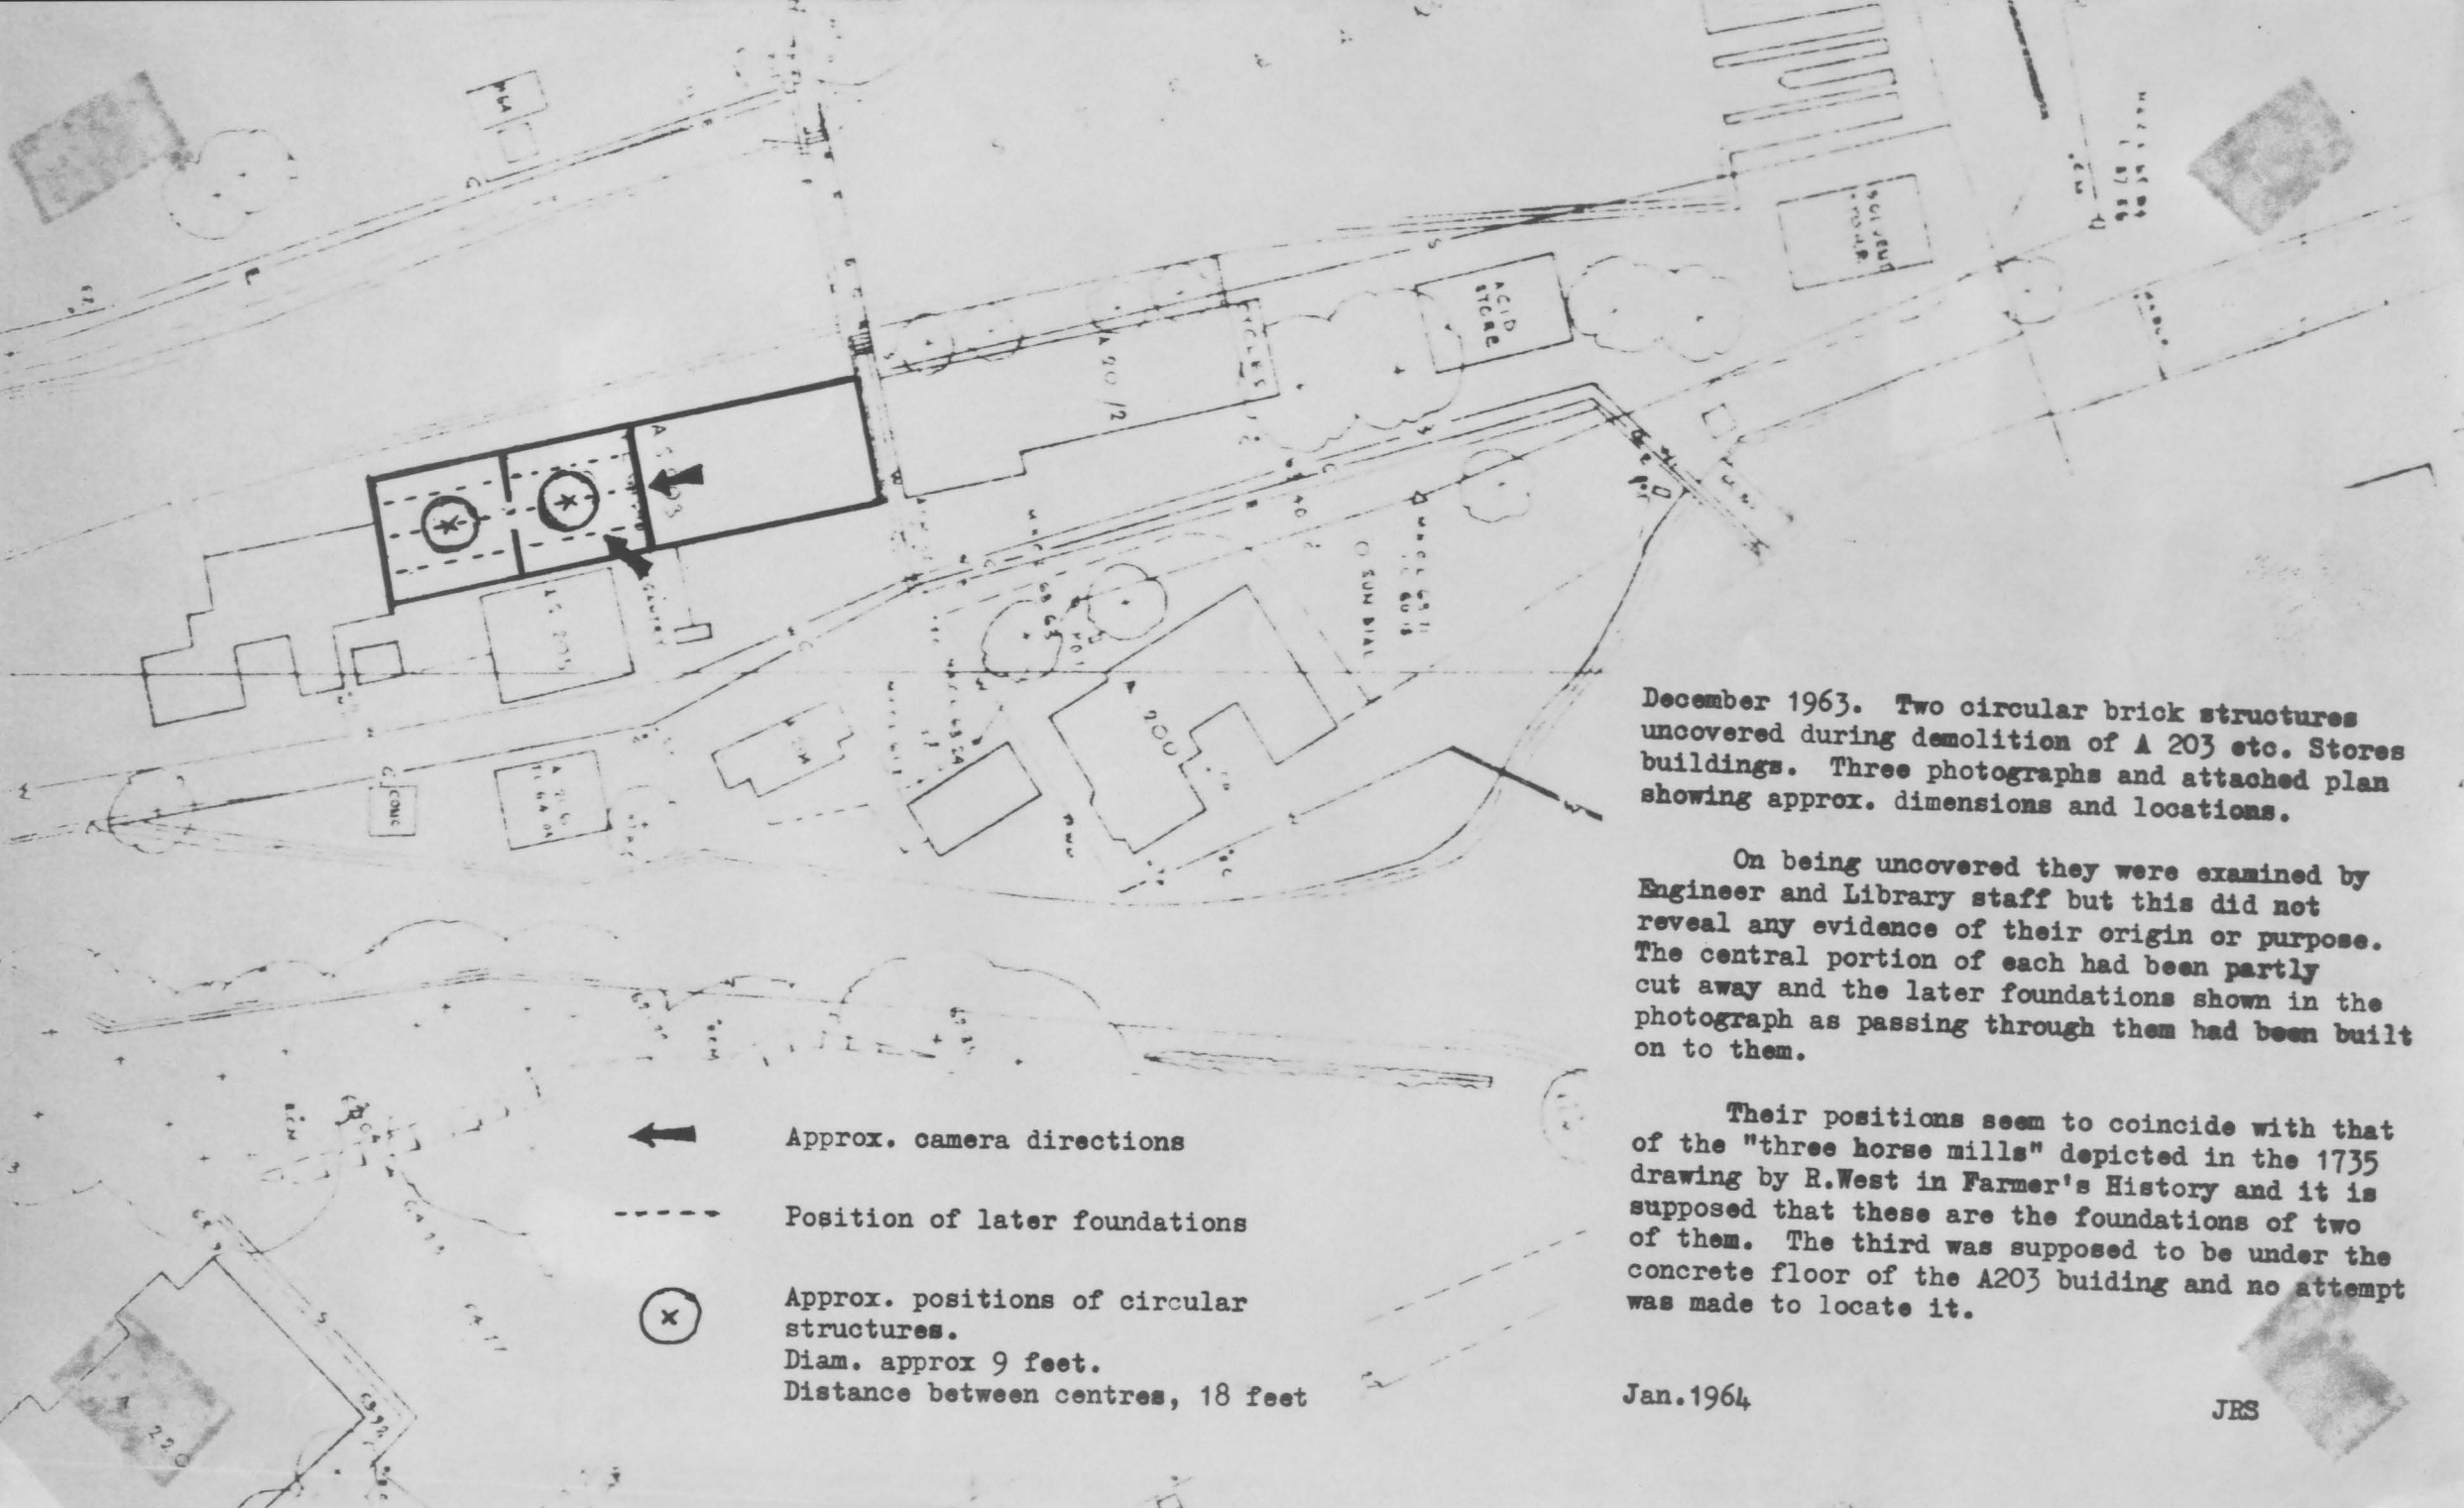
- ← Approx. camera directions
- - - Position of later foundations
- ⊗ Approx. positions of circular structures.  
Diam. approx 9 feet.  
Distance between centres, 18 feet
