WASC 2018
WAI 506

Nitro-glycerine washing house, South Site, Waltham Abbey Royal Gunpowder Factory, Essex

STUART FOREMAN

This article presents the results of an archaeological survey of the late 19th-century Quinton Hill nitro-glycerine washing house at Waltham Abbey Royal Gunpowder Factory, carried out in 1996 in advance of the redevelopment of RGPF South Site. The building is remarkably well-preserved, retaining many internal fixtures and fittings from the turn of the century. As part of the first government cordite factory, and as the only standing example of its type in the country, the washing house is a monument of national importance.

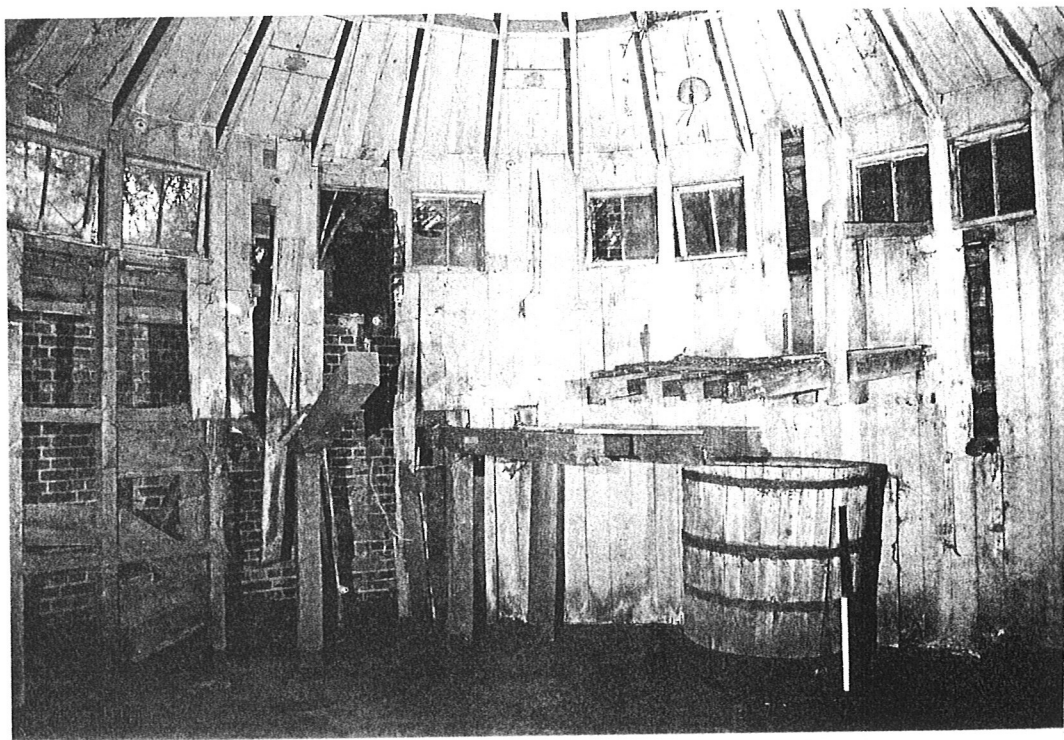
Figure 12.
RGPF South Site.
Interior of the Quinton Hill nitro-glycerine washing house in 1996 (looking north) (photograph by N. Macbeth for Essex CC).

The internal diameter of the washing house is 6.7m. At the north end of the building are the remains of a raised wooden platform with two levels, the lower of which formerly supported the washing tanks. Because of the weight of the tanks, the horizontal supports of the lower platform pass through the roundhouse wall and are set into the brick-work revetment.

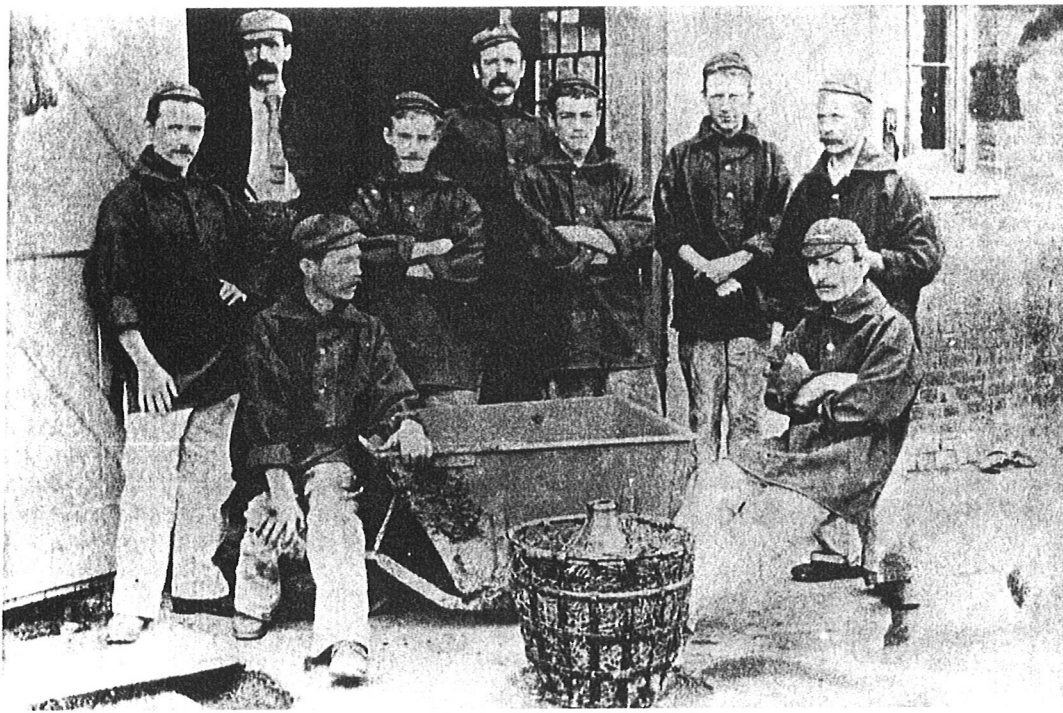
Figure 13.
Waltham Abbey
RGPF. Late 19th
century cordite
workers, posing with
an acid bogie and
carbonyl (MOD
photograph).
