THE ROYAL GUNPOWDER FACTORY

WALTHAM ABBEY

Guncotton Drying Stoves

74-98

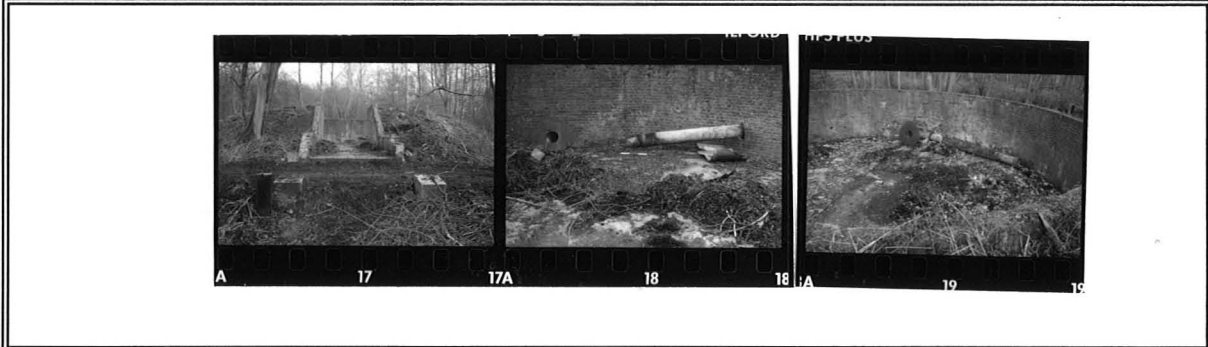
5) The guncotton stove survives as a circular brick wall 2.05m in height and 10.7m in diameter with an earthen mound packed around it almost to wall height. The Stove was entered from the northwest through a covered porch 7.4 m length and 2.4m wide. The porch consists of a low brick wall into which bolts were set to secure the timber superstructure. Two concrete blocks on the opposite side of the modern track mark the positions of upright timbers. These formerly supported a cover over narrow gauge railway that served the stove. Opposite to the entrance is a 'telegraph' pole that formerly carried an overhead line, the poles and insulators dated from the 1890s.

The stove was situated within a circular round house set on a platform separated from the enclosing wall by a narrow gully. The inner edge of this gully is lined with grey engineering bricks into which are set vertical bolts that formerly carried the timber frame of the building.

The heating was supplied to the stove by a single pipe which entered from the south west from motor and switch house 92b. The pipe is constructed from joined sheet metal segments forming two flanged straights 1.92m and 2.43m in length with a bore of 30.3cm connected to a flanged curve. The pipe is lagged with fibrous abestos secured by chicken wire with an outer sheet metal coat. The pipe formerly connected to the apex of the conical roof of the stove and was secured by a circular metal plate.

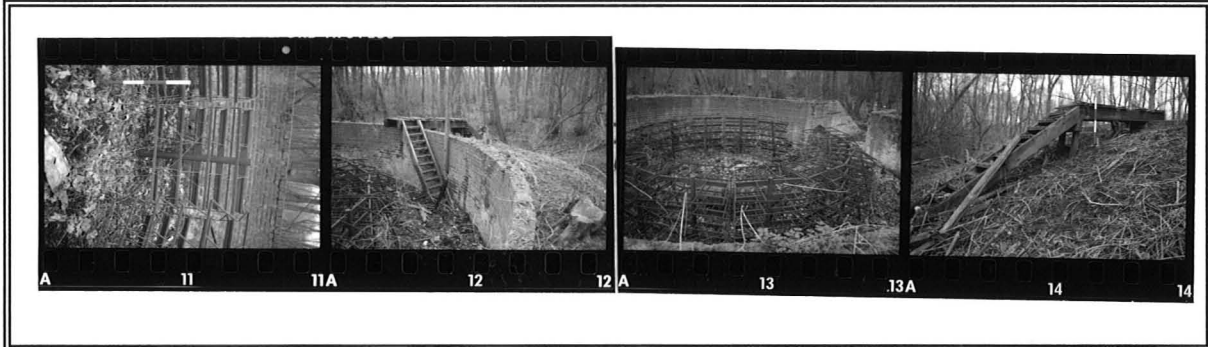
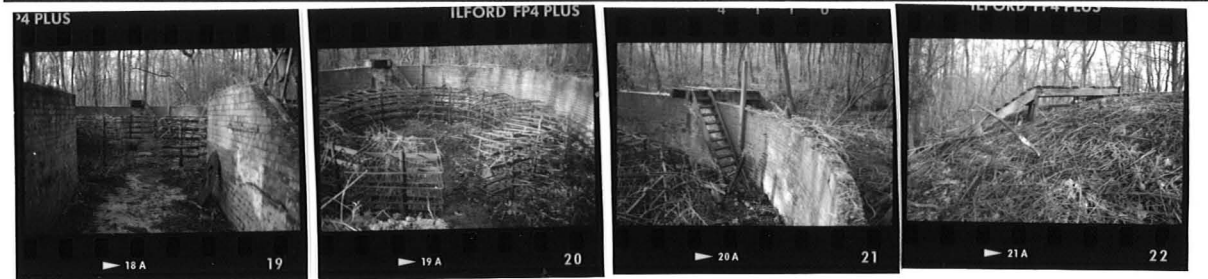
NUMBER	OLD SERIES 98a	RCHME NUMBER	N.G.R. TL 37815 01760
--------	-------------------	--------------	--------------------------

NAME/FUNCTION Guncotton Stove No.2	START DATE 1908-14	END DATE 1945
---------------------------------------	-----------------------	------------------

<p>PHOTOGRAPHY HISTORIC</p>	<p>PHOTOGRAPHY RCHME <i>206 D 19-21</i></p> <p>1) 206/M/11 4 Mar 1993 Detail of Drying Rack 206/M/12 4 Mar 1993 Detail of steps on West side 206/M/13 4 Mar 1993 Drying Racks 206/M/14 4 Mar 1993 Detail of steps on West side 2) BB92/26161 98a Detail of interior of Guncotton Stove</p>
---------------------------------	--

<p>CONDITION: Good</p>
------------------------

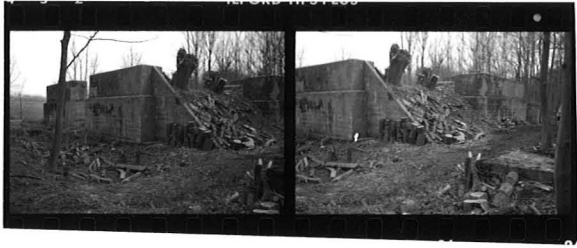
- 1) **CONSTRUCTIONAL MATERIAL**  
Breeze block and earthwork
- 3) **POWER SOURCE**  
Steam heating and electricity
- 4) **DIMENSIONS** i) L 22.5m ii) W 19.65m iii) HT 3.95m
- 5) The weighing house has been demolished however its protective traverse remains. The weighing house replaced an earlier structure that was badly damaged in 1940 in the accidental explosions in Mixing House [46 and 63]. A low brick wall incorporated into the southern edge of S27 appears to be the only surface remain of the earlier structure.
