**THE ROYAL GUNPOWDER FACTORY,
WALTHAM ABBEY, ESSEX**

Buildings 001-040

ROYAL
COMMISSION
ON THE HISTORICAL
MONUMENTS
OF ENGLAND

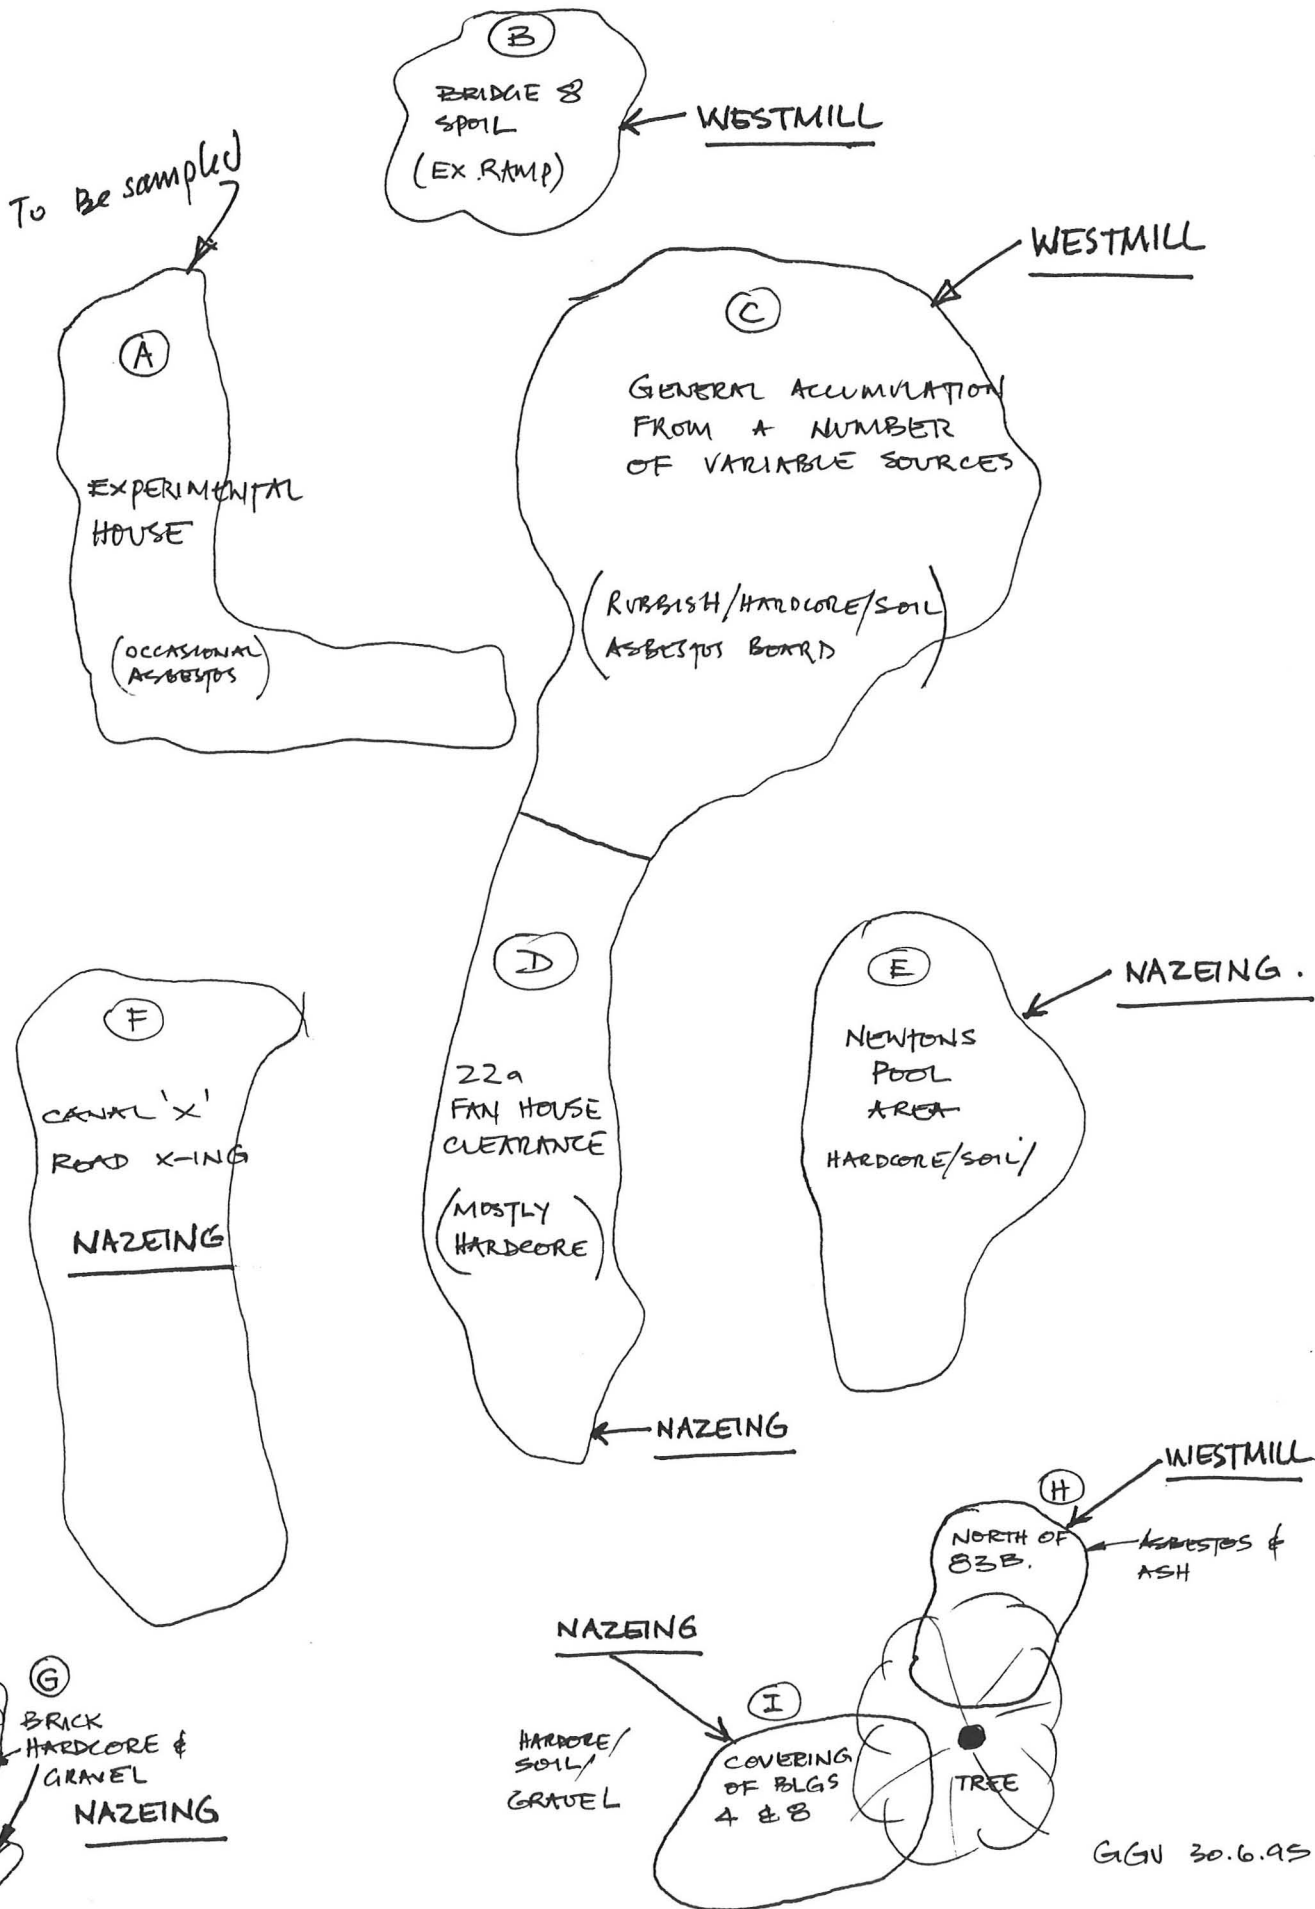
MUCK STOCKPILES @ BRIDGE 8

Dredged material
containing blue+white
asbestos/cerite
+ mixed with
foul odour ex. H26

sp. waste ex fan pit
Cerite/Asb. Wks.

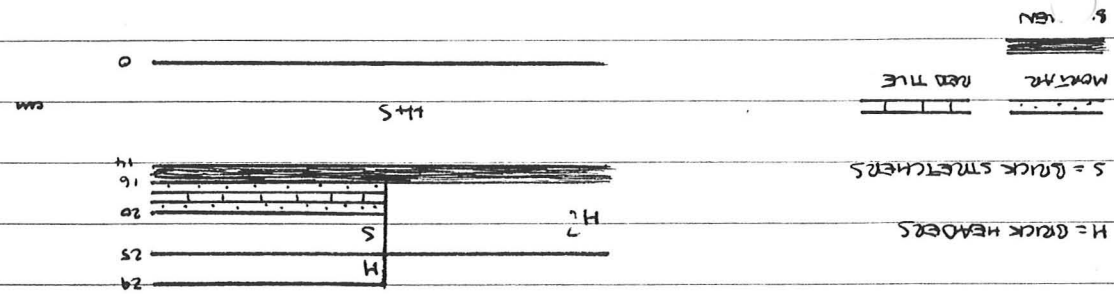
Section through large lateral wall in Bldg 27.

(Looking north of eastern end of central portion)

3 Bldg 27 - The intervals wall to the N. of the large lateral wall is constructed of headers \square in its existing position (i.e. one course); the interval wall to the S. is constructed of headers \square (as before).

4 Bldg 27 - There is a layer of red tile underlying the brick of the interval walls where they go over the street and into the external walls.
