Waltham Abbey Royal Gunpowder Factory  
( Former RARDE North Site )

Bridge Report

February 1994

Adam Ford  
Consultant Archaeologist

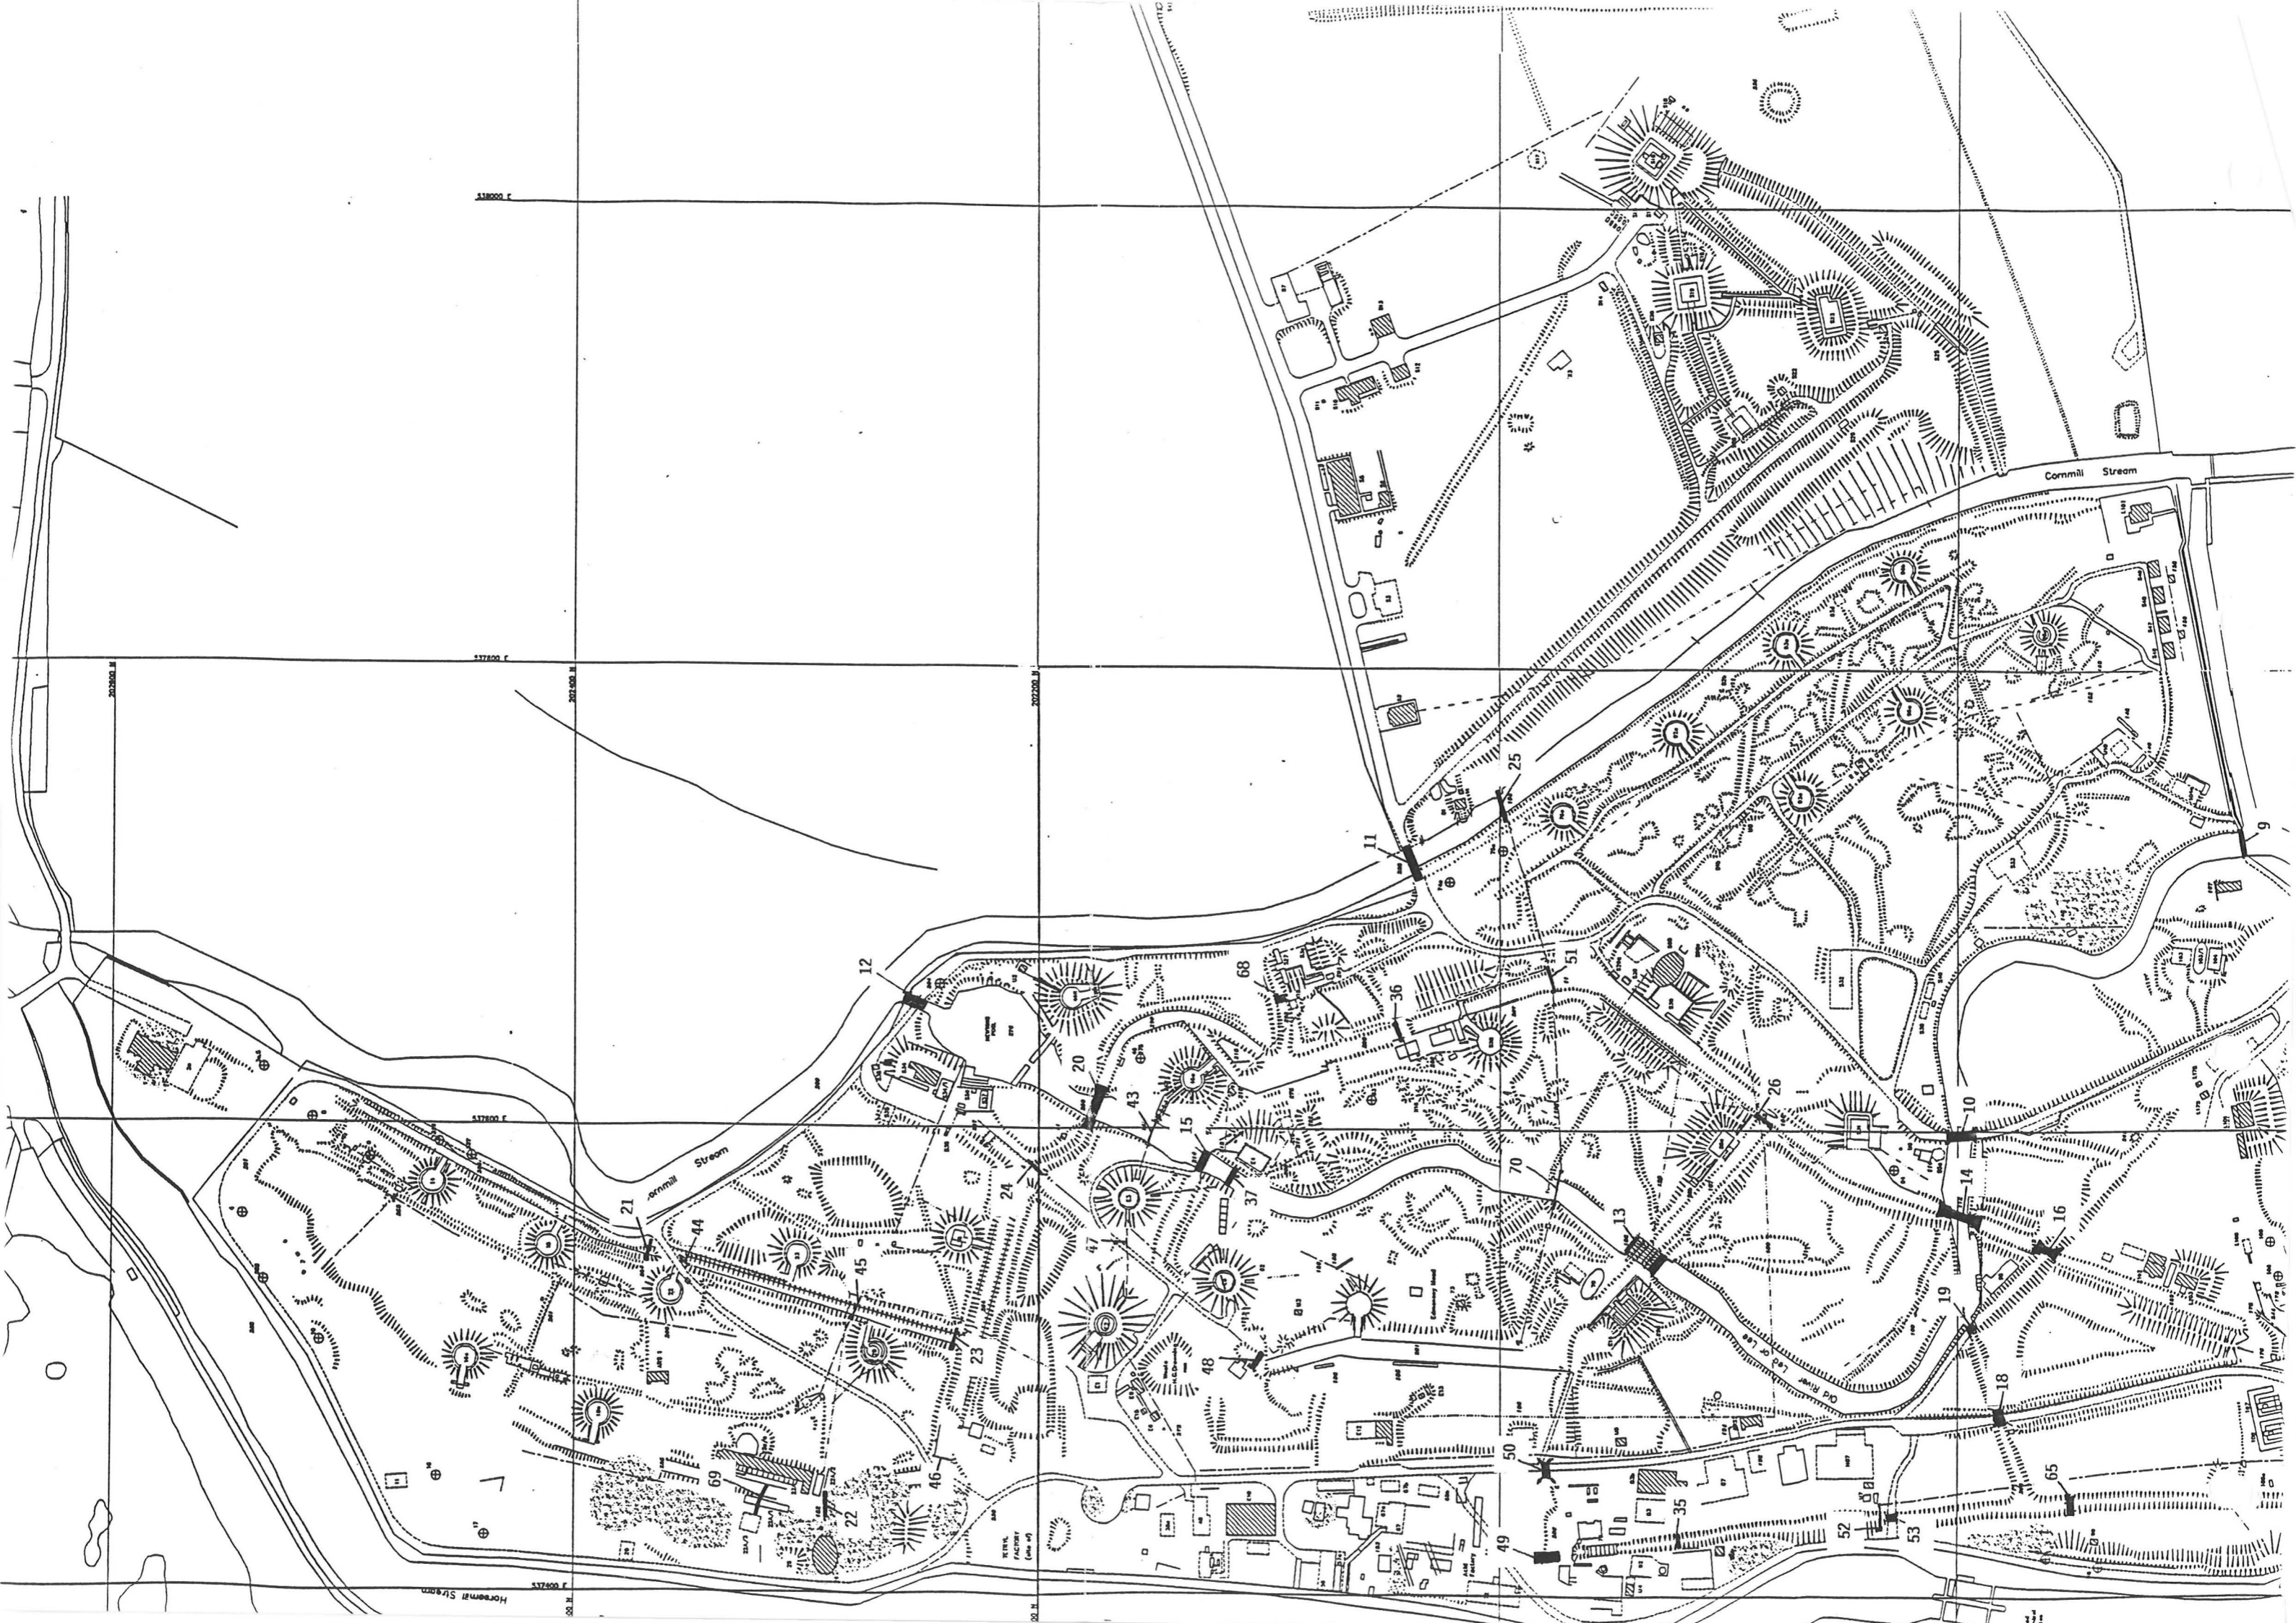
WALTHAM ABBEY RARDE SITE BRIDGE REPORT		
SITE NO.	RCHME NO.	BRIDGE TYPE
BR 01	132	Flagstaff Road Bridge
CONSTRUCTION DATE	GRID REF.	INITIAL CONDITION
1832	TL 37725 00877	Fair/Good
DESCRIPTION and CONDITION		
<p>Cast Iron ribbed bridge with 6 arched ribs set on brick abutments. The deck is concrete with hand rails on either side.</p> <p>Original weight limit 2.5 tonne axle load reduced to 1.9 ton.</p> <p>Refer to Roughton survey report for detail of condition and drawings.</p> <p>The bridge also carries service pipes which are slung along eastern side.</p>		
PHOTO NO.	DIMENSIONS	
(RCHME) WAP94 CP025 206/E/22 BB92/26065	L.- 7.00m W.- 3.90m	
DOCUMENTARY SOURCES		
<p>1993 Roughton <u>Bridge Assessment</u> p13-20 Drg. No 1 May 1993</p> <p>1993 RCHME <u>Royal Gunpowder Factory Waltham Abbey Report</u> (unpublished)</p>

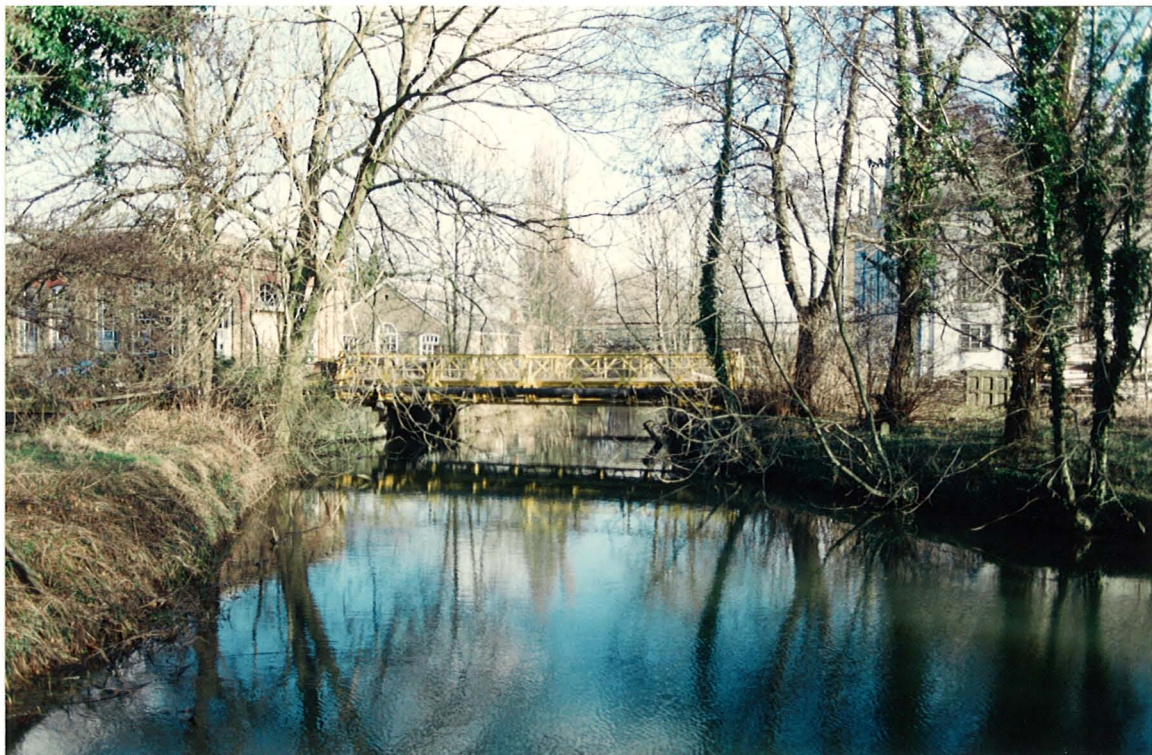
WALTHAM ABBEY RARDE SITE BRIDGE REPORT		
SITE NO.	RCHME NO.	BRIDGE TYPE
BR 02	130	Road Bridge - Bailey Type
CONSTRUCTION DATE	GRID REF.	INITIAL CONDITION
Late 1960s    Early 1970s	TL 37735 01000	Good
DESCRIPTION and CONDITION		
<p>Bailey type road bridge with 5 Tonne axle load limit. Steel structure with a timber deck with a footbridge on the eastern side, both set on concrete abutments. Refer to Roughtons survey for details of condition and drawings.</p>		
PHOTO NO.	DIMENSIONS	
WAP94 CP039	L.- 12.37m W.- 4.11m Ht.- 1.55m	
DOCUMENTARY SOURCES		
1993 Roughtons <u>Bridge Assessment</u> p.21 - 29 Drg. No 02 May 1993 1993 RCHME <u>Royal Gunpowder Factory Waltham Abbey</u> Report (unpublished)

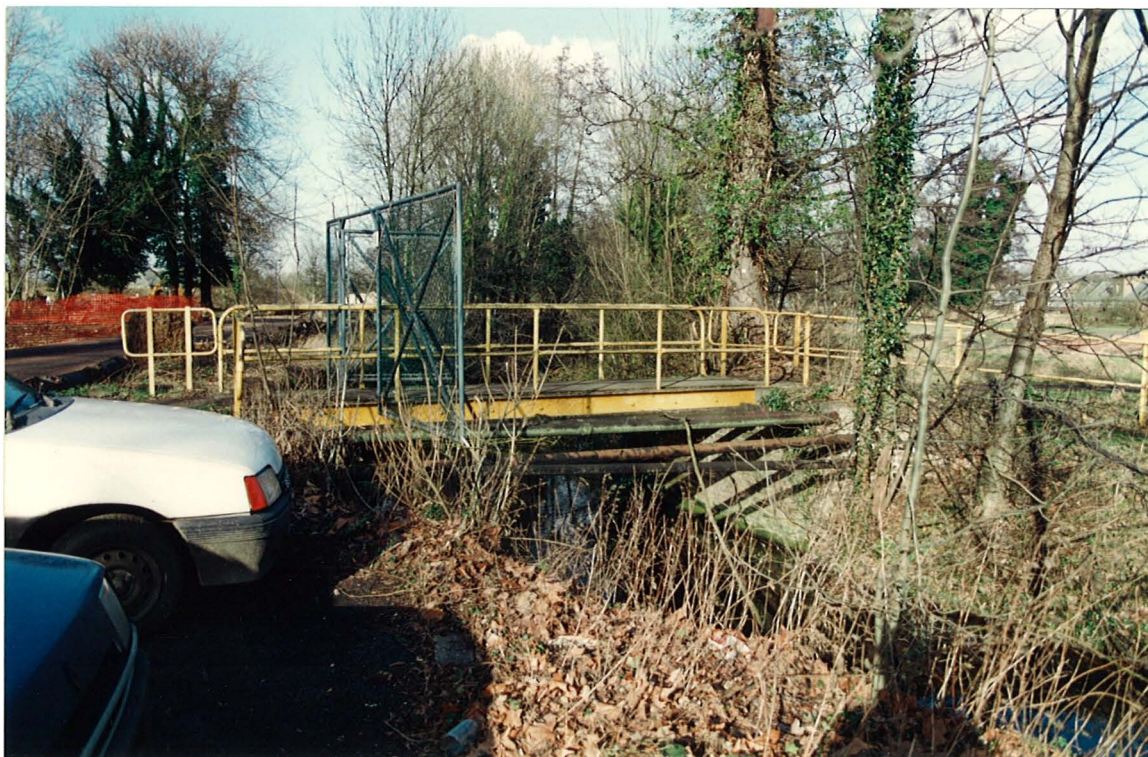
WALTHAM ABBEY RARDE SITE BRIDGE REPORT		
SITE NO.	RCHME NO.	BRIDGE TYPE
BR 03	133	Footbridge
CONSTRUCTION DATE	GRID REF.	INITIAL CONDITION
Late 1960s Early 1970s	TL 37690 00992	Good
DESCRIPTION and CONDITION		
<p>Modern footbridge constructed of two steel RSJs supporting a timber and asphalt deck and two tubular steel handrails.</p> <p>The bridge is set upon brick and concrete abutments. The bridge is flanked on either side by a number of service pipes</p> <p>Refer to Roughtons survey report for details of condition and drawings.</p>		
PHOTO NO.	DIMENSIONS	
(RCHME) WAP94 CP040 206/E/24	L.- 6.85m W.- 1.64m	
DOCUMENTARY SOURCES		
<p>1993 Roughtons <u>Bridge Assessment</u> p.30-36 Drg. No.03 May 1993</p> <p>1993 RCHME <u>Royal Gunpowder Factory Waltham Abbey</u> Report (unpublished)</p>

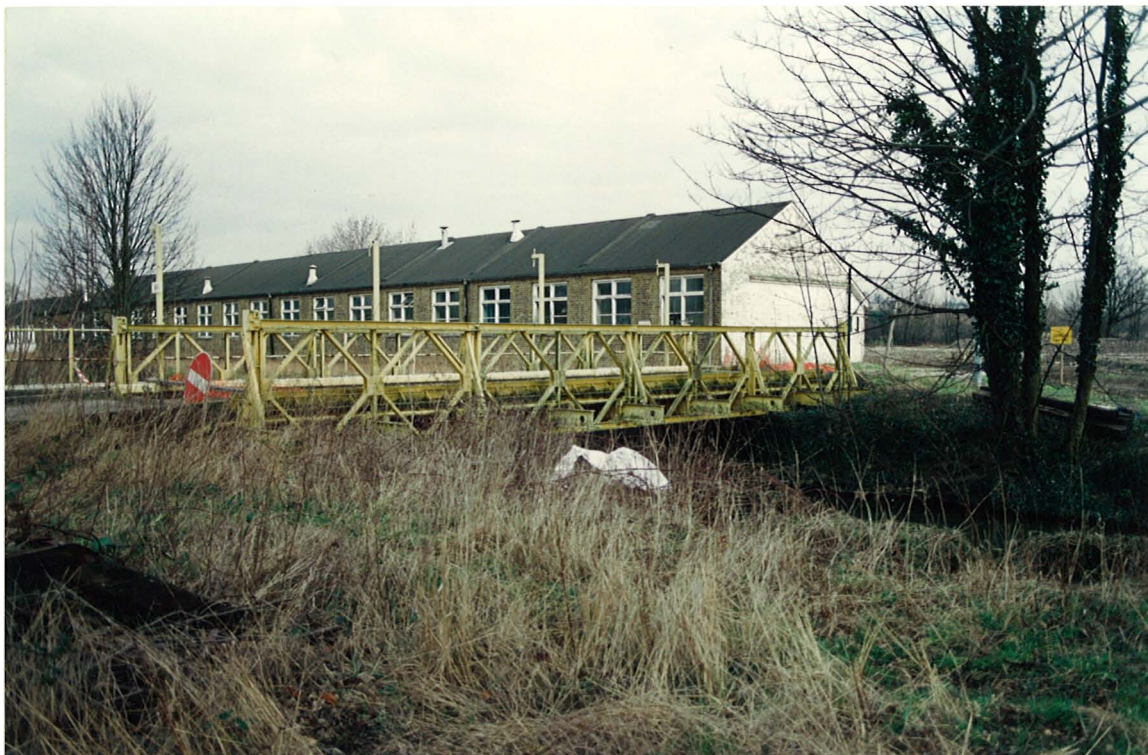
WALTHAM ABBEY RARDE SITE BRIDGE REPORT		
SITE NO.	RCHME NO.	BRIDGE TYPE
BR 04	271	Road Bridge - Bailey Type
CONSTRUCTION DATE	GRID REF.	INITIAL CONDITION
Mid 1950s Early 1960s	TL 37793 01115	Good
DESCRIPTION and CONDITION		
<p>Bailey type road bridge with 5 tonne axle load limit. Similar to bridge 02. Steel structure with a timber deck and a footbridge on the north side. The abutments seem to be concrete with timber piles.</p> <p>Refer to Roughtons survey report for details of condition and drawings.</p> <p>The bridge also carries a number of service pipes. The letters MKII are welded to either end of the bridge.</p>		
PHOTO NO.		DIMENSIONS
(RCHME) WAP94 CP023 206/Q/25		L.- 12.37m W.- 5.43m
DOCUMENTARY SOURCES		
<p>1993 Roughtons <u>Bridge Assessment</u> p.37-44 Drg. No. 04 May 1993</p> <p>1993 RCHME <u>Royal Gunpowder Factory Waltham Abbey</u> Report (unpublished)</p> <p>1965 Drg. No. L-B.17 Plans and elevations of footbridge 10/9/1965</p>

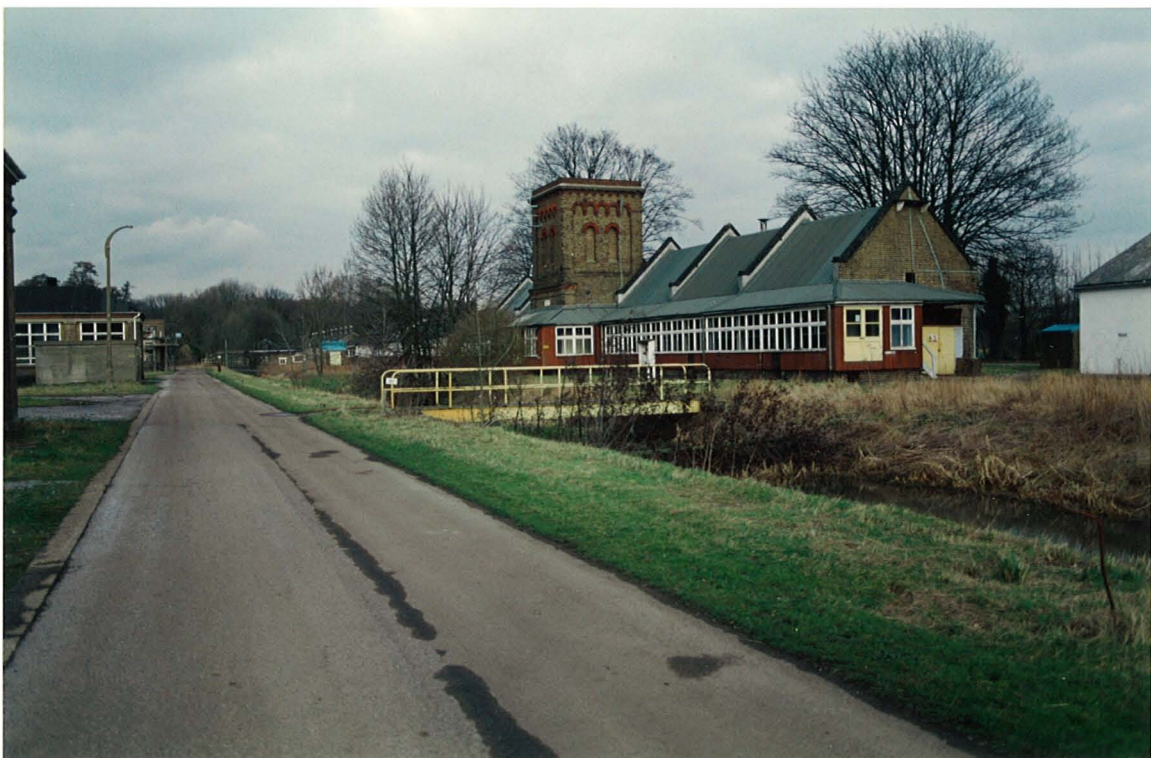
WALTHAM ABBEY RARDE SITE BRIDGE REPORT		
SITE NO.	RCHME NO.	BRIDGE TYPE
BR 05	279	Footbridge
CONSTRUCTION DATE	GRID REF.	INITIAL CONDITION
1957	TL 37735 02156	Good
DESCRIPTION and CONDITION		
<p>The footbridge is constructed of a steel frame supporting a timber deck. All set on concrete abutments and has tubular steel handrails on either side. Refer to Roughtons survey report for details of condition and drawings.</p>		
PHOTO NO.	DIMENSIONS	
WAP94 CP022	L.- 9.85m W.- 1.95m	
DOCUMENTARY SOURCES		
1993 Roughtons <u>Bridge Assessment</u> Drg. No. 05 May 1993 1993 RCHME <u>Royal Gunpowder Factory Waltham Abbey</u> Report (unpublished) 1957 Drg. No. L-B.10 Plans and Elevations 22/7/1957

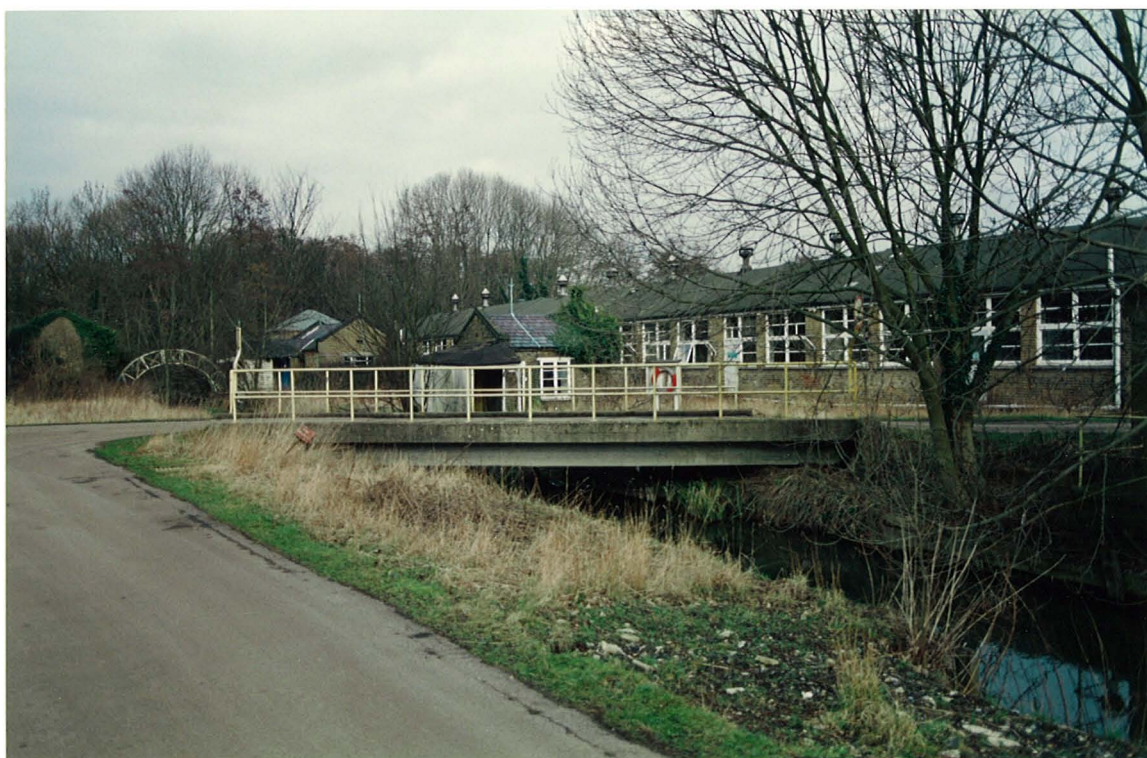
WALTHAM ABBEY RARDE SITE BRIDGE REPORT		
SITE NO.	RCHME NO.	BRIDGE TYPE
BR 06	269	Road Bridge
CONSTRUCTION DATE	GRID REF.	INITIAL CONDITION
1955	TL 37675 01395	Good
DESCRIPTION and CONDITION		
<p>Reinforced concrete bridge with a concrete and asphalt deck. Bridge set on concrete abutments with rocker bearings between has tubular steel handrails on either side.</p> <p>Refer to Roughtons survey report for details of condition and drawings.</p>		
PHOTO NO.	DIMENSIONS	
(RCHME) WAP94 CP021 206/Q/20	L.- 12.53m W.- 4.26m	
DOCUMENTARY SOURCES		
<p>1993 Roughtons <u>Bridge Assessment</u> p.50-57 Drg. No. 06 June 1993</p> <p>1993 RCHME <u>Royal Gunpowder Factory Waltham Abbey</u> Report (unpublished)</p> <p>1954 Drg No. L- B.05 (XD1/2)</p>

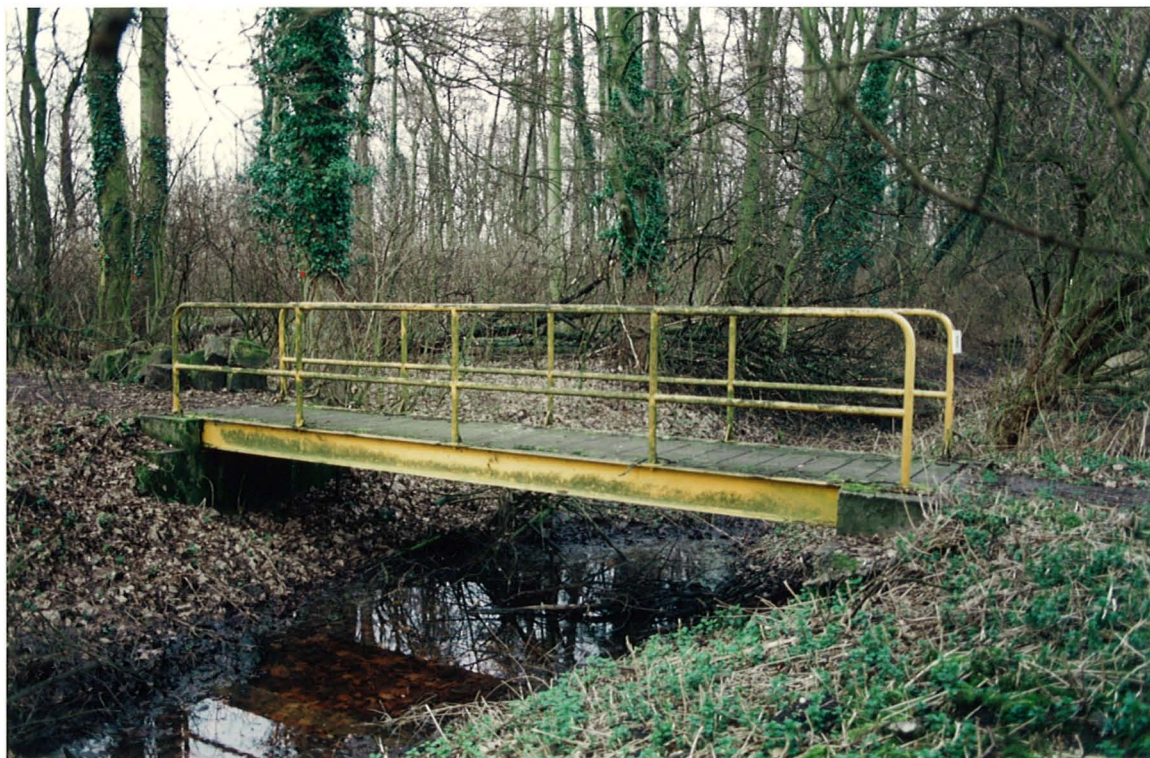
WALTHAM ABBEY RARDE SITE BRIDGE REPORT		
SITE NO.	RCHME NO.	BRIDGE TYPE
BR 07	507	Footbridge
CONSTRUCTION DATE	GRID REF.	INITIAL CONDITION
1960s	TL 37545 01345	Good
DESCRIPTION and CONDITION		
<p>The bridge is constructed with a thick timber plank deck supported by two RSJ which in turn rest upon concrete abutments.  Refer to Roughtons survey report for details of condition and drawings.  Tubular steel handrails fitted are on either side.</p>		
PHOTO NO.	DIMENSIONS	
WAP94 CP020	L.- 6.80m W.- 1.30m	
DOCUMENTARY SOURCES		
1993 Roughtons <u>Bridge Assessment</u> p.58-64 Drg No. 07 June 1993

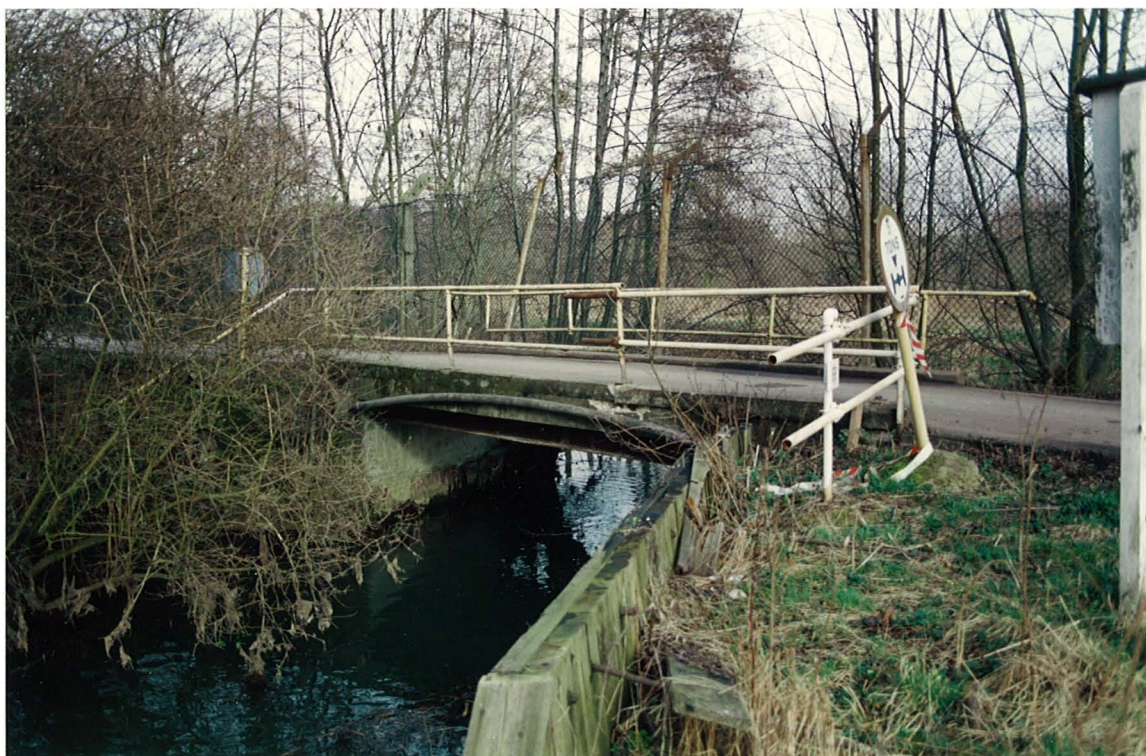
WALTHAM ABBEY RARDE SITE BRIDGE REPORT		
SITE NO.	RCHME NO.	BRIDGE TYPE
BR 08	228	Road Bridge
CONSTRUCTION DATE	GRID REF.	INITIAL CONDITION
Late 1960s early 1970s	TL 37680 02106	Good
DESCRIPTION and CONDITION		
<p>The bridge is constructed of concrete and steel. The deck, made up of concrete and asphalt is supported by RSJs which in turn lie on concrete abutments. Handrails are fitted to either side of the bridge with the outer security fence attached to the eastern side.</p> <p>Refer to Roughtons survey report for details of condition and drawings.</p>		
PHOTO NO.	DIMENSIONS	
WAP94 CP018	L.- 7.50m W.- 3.05m	
DOCUMENTARY SOURCES		
1993 Roughtons <u>Bridge Assessment</u> p.63-71 Drg. No. 08 April 1993 1993 RCHME <u>Royal Gunpowder Factory Waltham Abbey Report</u> (unpublished)

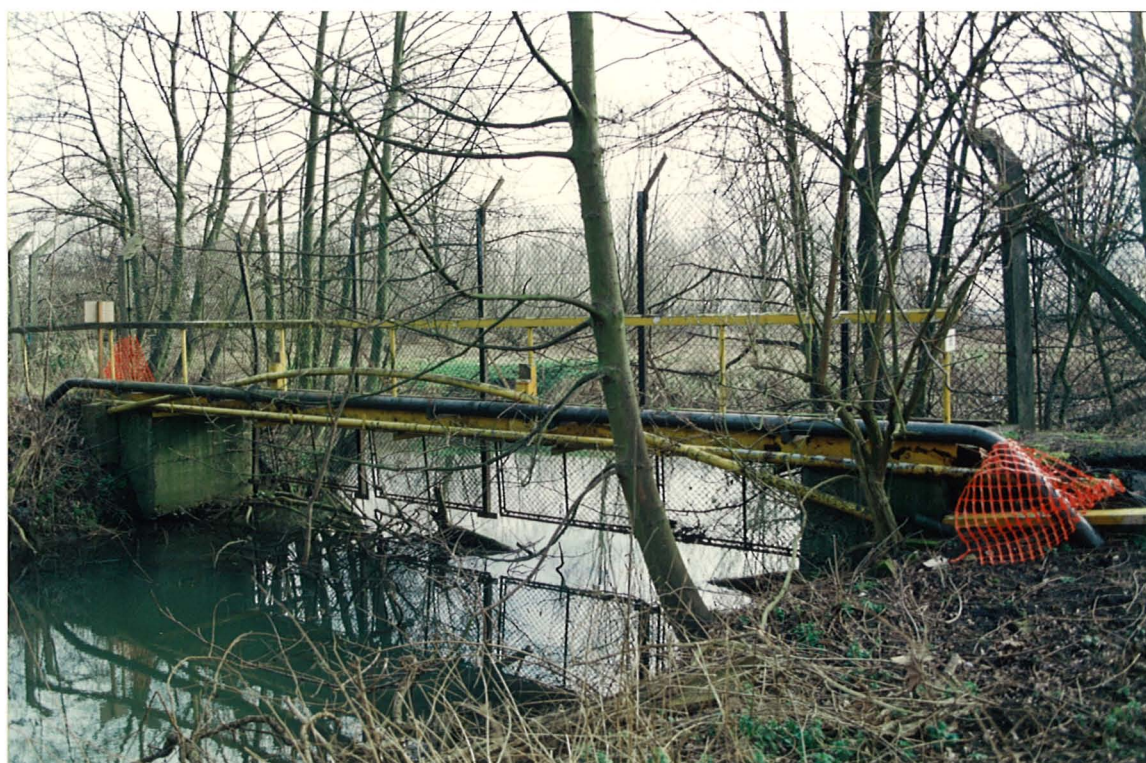
WALTHAM ABBEY RARDE SITE BRIDGE REPORT		
SITE NO.	RCHME NO.	BRIDGE TYPE
BR 09	151	Footbridge
CONSTRUCTION DATE	GRID REF.	INITIAL CONDITION
Late 1960s Early 1970s	TL 37725 01675	Fair/Poor
DESCRIPTION and CONDITION		
<p>The footbridge is made of timber and steel similar in construction to 07. The timber plank deck is supported by two RSJs which rest on concrete abutments. Handrail present on the northern side with the outer security fence attached to the southern edge.</p> <p>Refer to Roughtons survey report for details of condition and drawings.</p>		
PHOTO NO.	DIMENSIONS	
WAP94 CP017	L.- 11.60m W.- 1.60m	
DOCUMENTARY SOURCES		
1993 Roughtons <u>Bridge Assessment</u> p.72-77 Drg. No. 09 April 1993

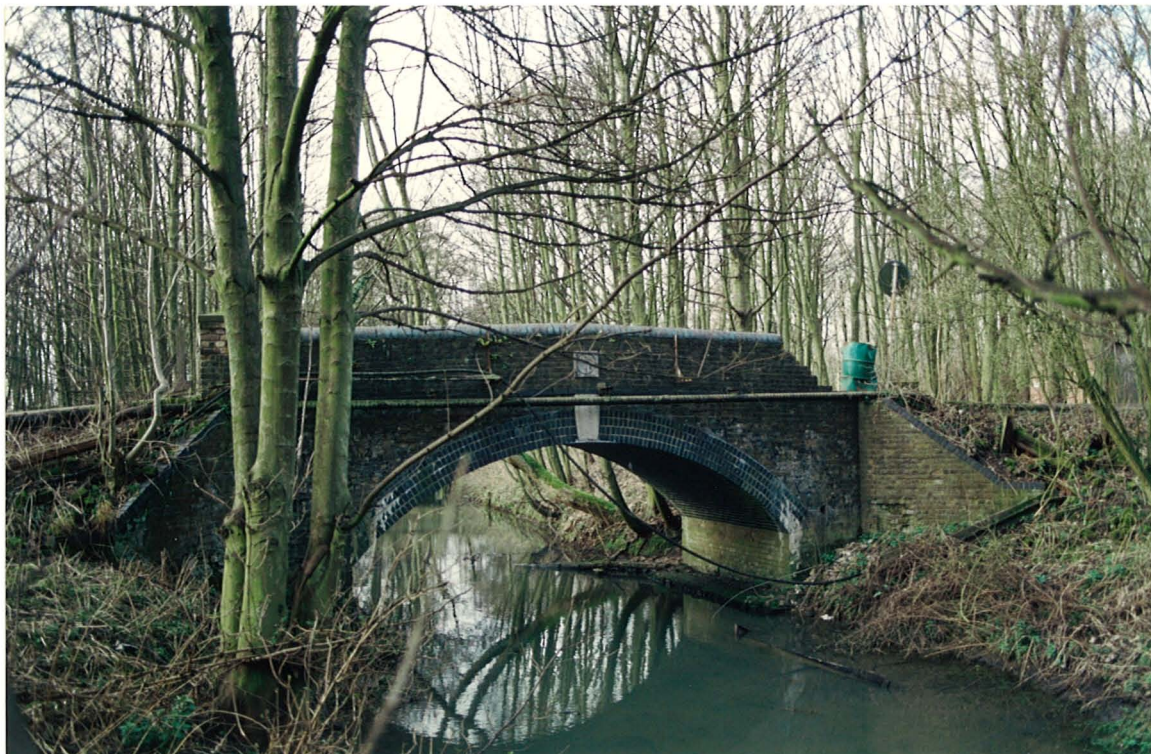
WALTHAM ABBEY RARDE SITE BRIDGE REPORT		
SITE NO.	RCHME NO.	BRIDGE TYPE
BR 10	117	Brick Arch Bridge
CONSTRUCTION DATE	GRID REF.	INITIAL CONDITION
1878/9	TL 37597 01800	Good
DESCRIPTION and CONDITION		
<p>The bridge is a brick arch supported to concrete abutments. It is constructed of blue engineers bricks and red/yellow stocks. The parapets, also of brick, have stone plaques set in either side with RGPF VR 1878 inscribed.</p> <p>Refer to Roughtons survey report for details of condition and drawings.</p> <p>5 tonne axle load limit.</p>		
PHOTO NO.	DIMENSIONS	
(RCHME) WAP94 CP016 206/J/3	L.- 10.50m W.- 3.80m Ht.- 4.40m (parapet to water)	
DOCUMENTARY SOURCES		
1993 Roughtons <u>Bridge Assessment</u> p.78-84 Drg. No. 10/1-2 April 1993 1993 RCHME <u>Royal Gunpowder Factory Waltham Abbey</u> Report (unpublished)

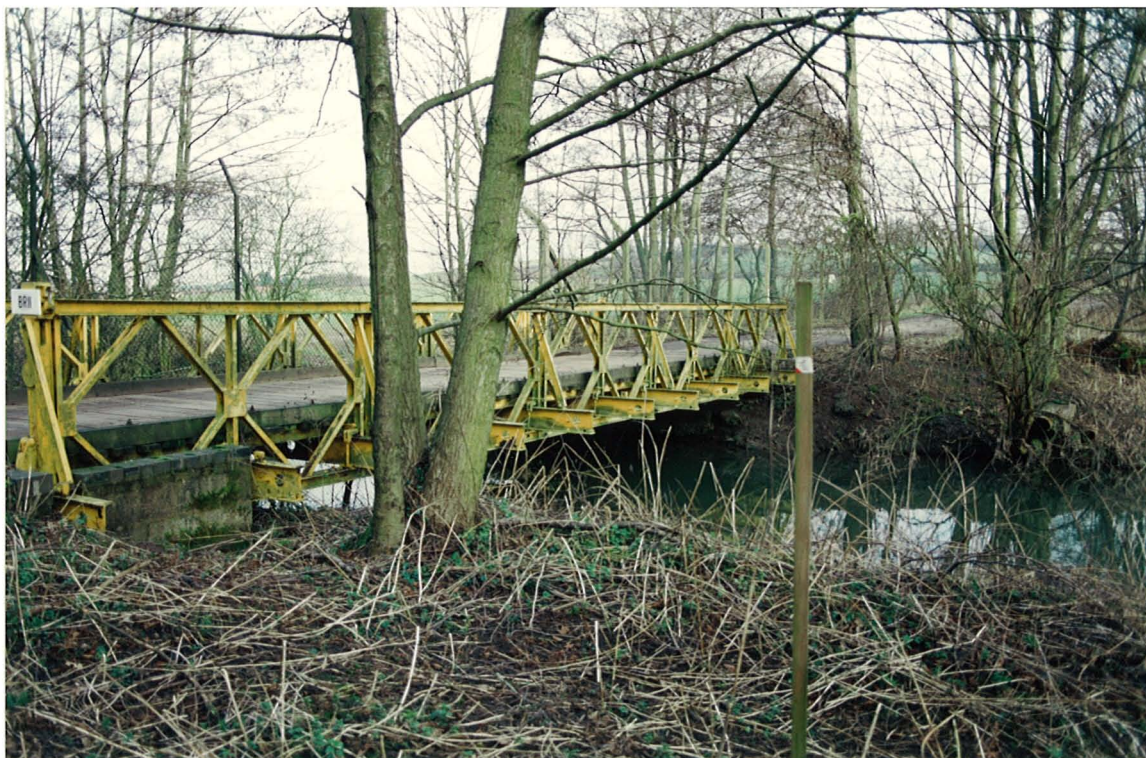
WALTHAM ABBEY RARDE SITE BRIDGE REPORT		
SITE NO.	RCHME NO.	BRIDGE TYPE
BR 11	238	Road Bridge - Bailey Type
CONSTRUCTION DATE	GRID REF.	INITIAL CONDITION
1971	TL 37715 02041	Good
<b>DESCRIPTION and CONDITION</b>		
<p>Bailey type bridge constructed of five steel panels which support a timber plank deck. The bridge is set on brick and timber abutments.  Refer to Roughtons survey report for details of condition and drawings.  "MKII" has been welded onto either end of the bridge.</p>		
PHOTO NO.	DIMENSIONS	
WAP94 CP014	L.- 15.41m W.- 4.13m	
<b>DOCUMENTARY SOURCES</b>		
1993 Roughtons <u>Bridge Assessment</u> p.85-91 Drg. No. 11 May 1993 1993 RCHME <u>Royal Gunpowder Factory Waltham Abbey Report</u> (unpublished) 1971 Drg. No. S- B.49 22/6/1971

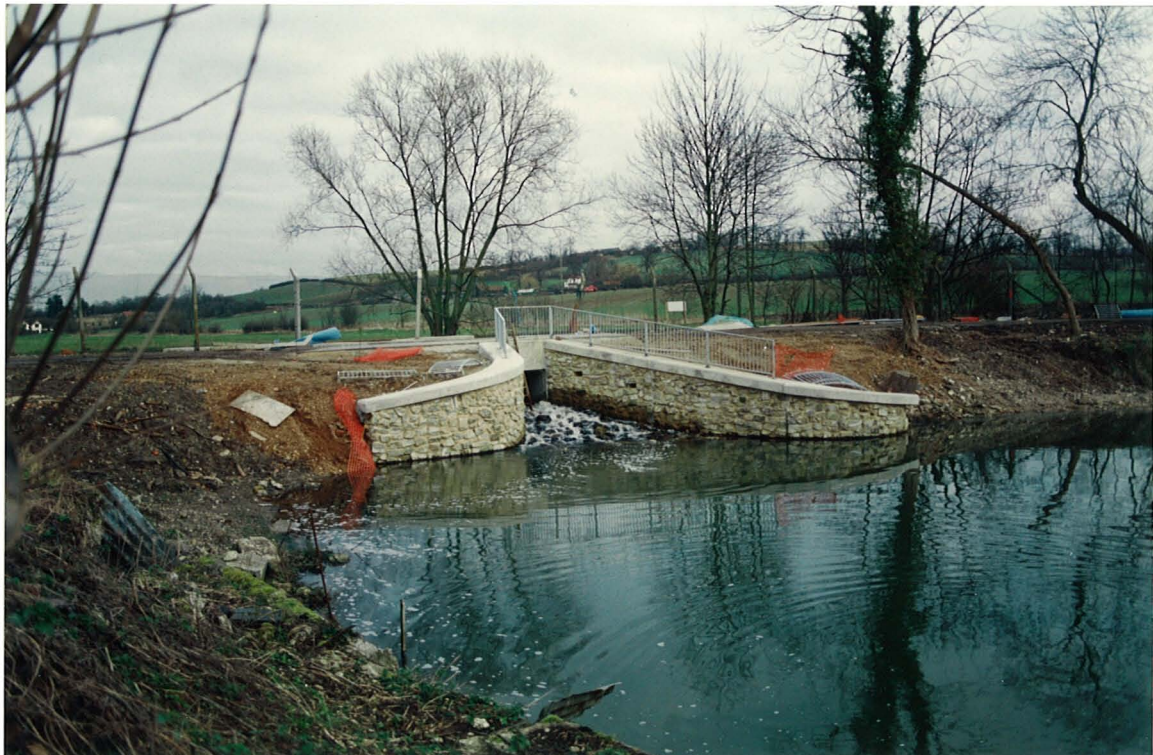
WALTHAM ABBEY RARDE SITE BRIDGE REPORT		
SITE NO.	RCHME NO.	BRIDGE TYPE
BR 12 New BR 12	506	Steel Trough Road Bridge Concrete Box Culvert
CONSTRUCTION DATE	GRID REF.	INITIAL CONDITION
1972 (demolished Oct 1993) Rebuilt Dec 1993	TL 37653 02251	Demolished
DESCRIPTION and CONDITION		
<p>For Old Bridge refer to Roughtons survey report for details of condition and drawings. The new crossing is a box section concrete culvert. See documentary sources for drawings.</p>		
PHOTO NO.	DIMENSIONS	
WAP94 CP011		
DOCUMENTARY SOURCES		
<p>1993 Roughtons <u>Bridge Assessment</u> p.91-98 Drg. No. S- B.53 1971 Drg. No. S - B. 53 Plans and Elevations 1993 Drg. No. 2247/101/102 Control Structure</p>

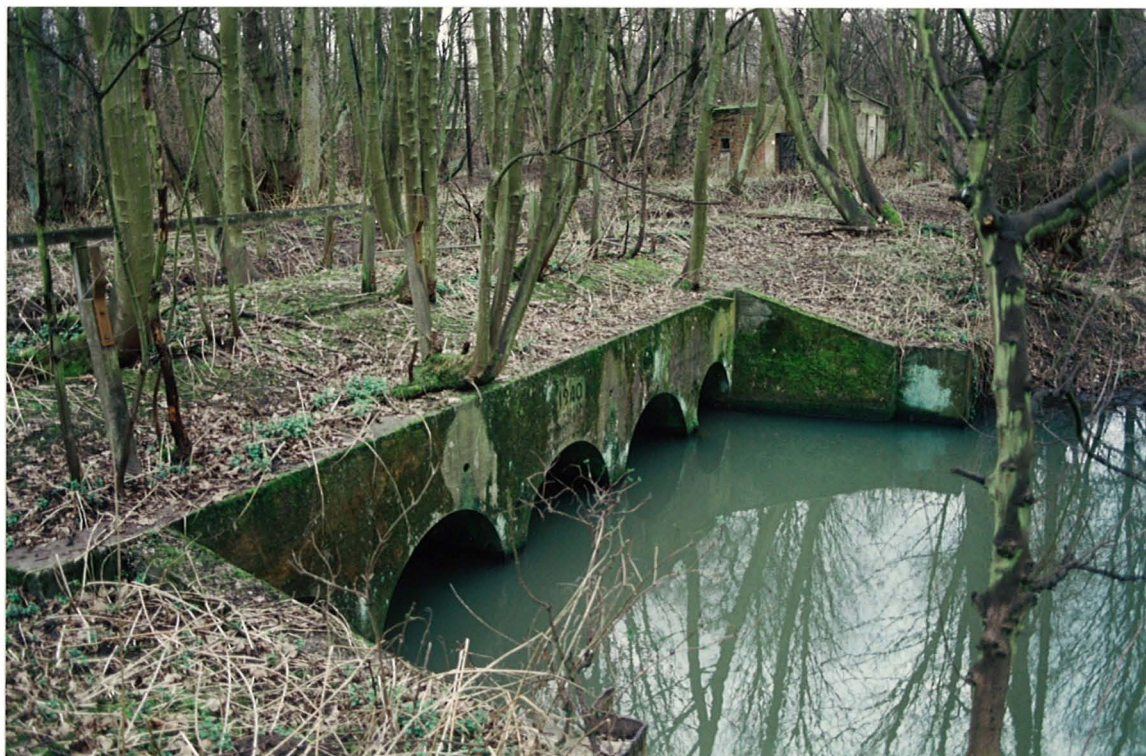
WALTHAM ABBEY RARDE SITE BRIDGE REPORT		
SITE NO.	RCHME NO.	BRIDGE TYPE
BR 13	106	Aqueduct
CONSTRUCTION DATE	GRID REF.	INITIAL CONDITION
1940	TL 37546 01935	Good/ Fair
<b>DESCRIPTION and CONDITION</b>		
<p>Concrete aqueduct constructed of 5 concrete pipes overlain with poured concrete. At present no canal runs over the structure although the embankments and tow path still exist.</p> <p>Refer to Roughtons survey report for details of condition and drawings.</p>		
PHOTO NO.		DIMENSIONS
(RCHME) WAP94 CP005 206/H/35 206/T/11		L.- 10.97m W.- 15.55m
<b>DOCUMENTARY SOURCES</b>		
<p>1993 Roughtons <u>Bridge Assessment</u> p.98-105 Drg. No. 13 1-2</p> <p>1993 RCHME <u>Royal Gunpowder Factory Waltham Abbey Report</u> (unpublished)</p>

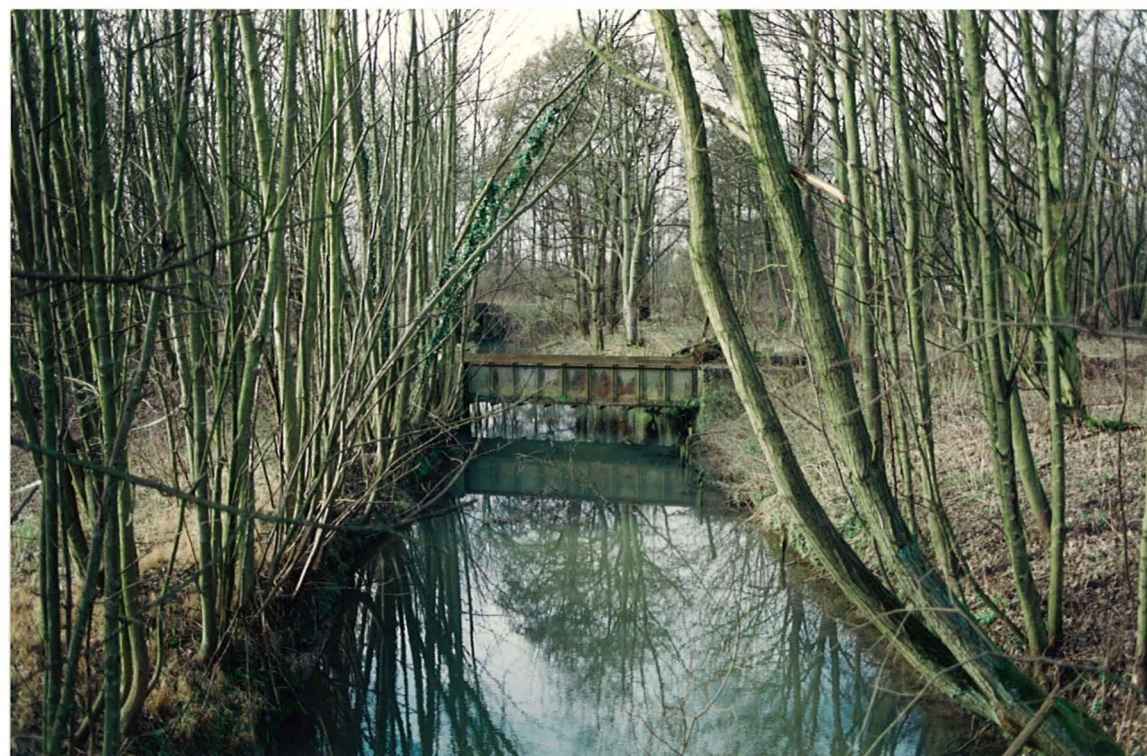
<b>SITE NO.</b>	<b>RCHME NO.</b>	<b>BRIDGE TYPE</b>
BR 14	112	Cast Iron Aqueduct

The aqueduct is constructed of cast iron panels. Each side piece is a single panel and the trough base is of iron plates bolted to the side sections. The aqueduct sits on brick abutments. the remains of a timber walkway exists on either side.  
Refer to Roughtons survey report for details of condition and drawings.

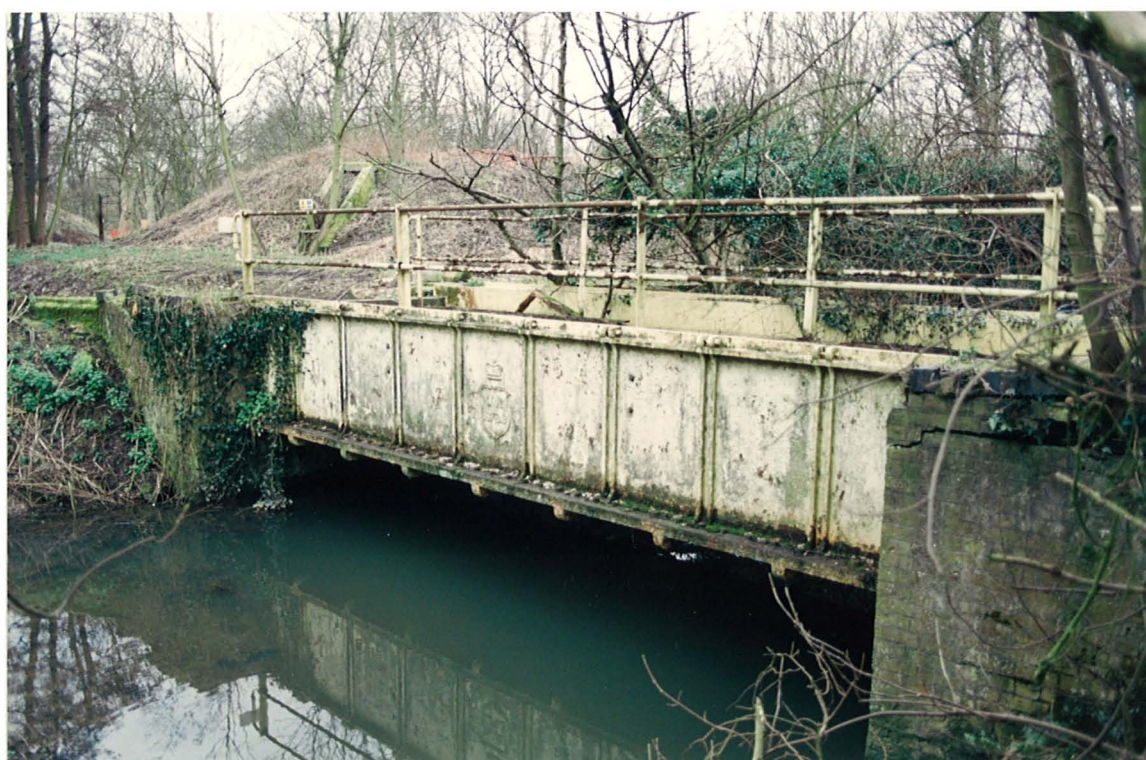
WALTHAM ABBEY RARDE SITE BRIDGE REPORT		
SITE NO.	RCHME NO.	BRIDGE TYPE
BR 15	214	Cast Iron Aqueduct/Bridge
CONSTRUCTION DATE	GRID REF.	INITIAL CONDITION
1878/9 1944?(bridge)	TL 37584 02131	Good/ Fair
DESCRIPTION and CONDITION		
Originally a cast iron aqueduct similar to 14. Later adapted to become a footbridge. The structure was also used to suspend a pipe across the Old River Lea. Refer to Roughtons survey report for details of condition and drawings.		
PHOTO NO.	DIMENSIONS	
WAP94 CP008	L.- 9.80m W.- 3.10m Dp.- 1.45m	
DOCUMENTARY SOURCES		
1903 WASC 901/198 27/5/03 Aqueduct No.5 (corrected to No.2) 1903 WASC 901/199 3/6/03 Aqueduct No.5 1993 Roughtons <u>Bridge Assessment</u> p.111-118 Drg. No. 15 April 1993 1993 RCHME <u>Royal Gunpowder Factory Waltham Abbey Report</u> (unpublished)

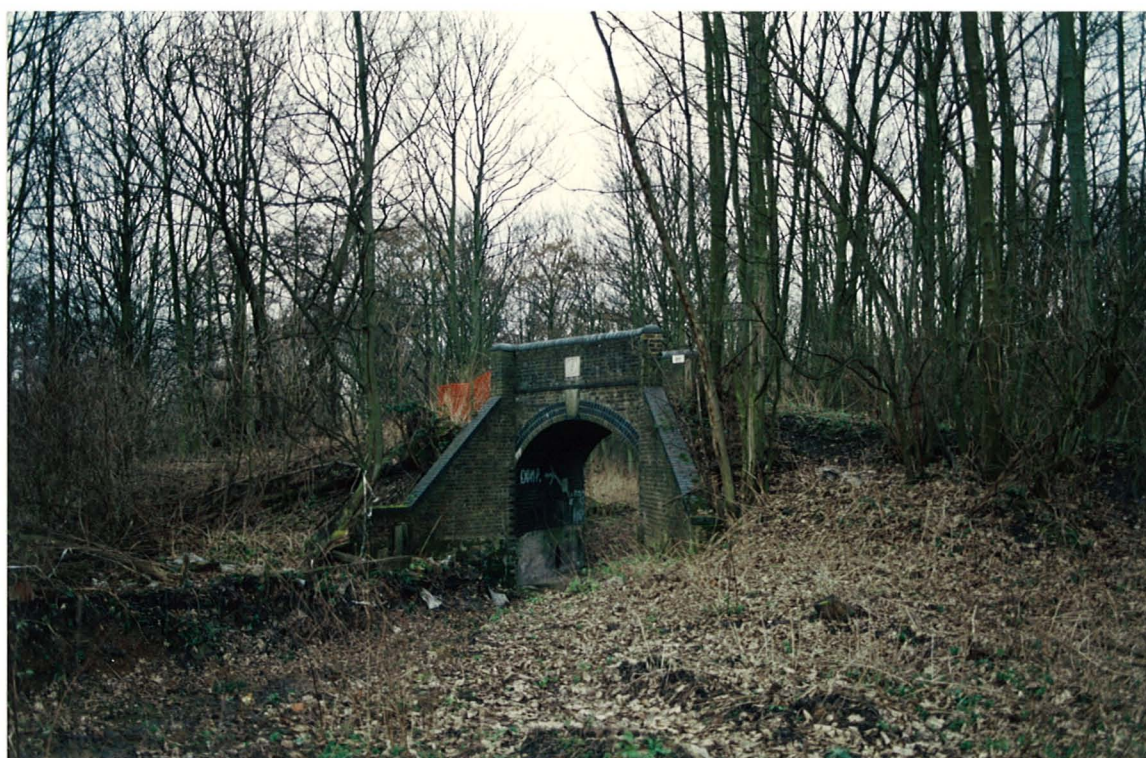
WALTHAM ABBEY RARDE SITE BRIDGE REPORT		
SITE NO.	RCHME NO.	BRIDGE TYPE
BR 16	113	Brick Arch Bridge
CONSTRUCTION DATE	GRID REF.	INITIAL CONDITION
1878/9	TL 37548 01761	Good
DESCRIPTION and CONDITION		
<p>This brick arch bridge is similar in design to 10 with blue engineers bricks and red/yellow stocks.  Refer to Roughtons survey report for details of condition and drawings.  A stone plaque inset into the parapet reads, " RGPF VR 1878"</p>		
PHOTO NO.	DIMENSIONS	
(RCHME) 206/H/24    206/Q/26 BB92/26104 BB92/26459 WAP94 CP003	L.- 7.30m W.- 3.10m Ht.- 4.75m (parapet to canal base)	
DOCUMENTARY SOURCES		
1993 Roughtons <u>Bridge Assessment</u> p.119-126 Drg. No. 16/ 1-2 May 1993 1993 RCHME <u>Royal Gunpowder Factory Waltham Abbey Report</u> (unpublished)

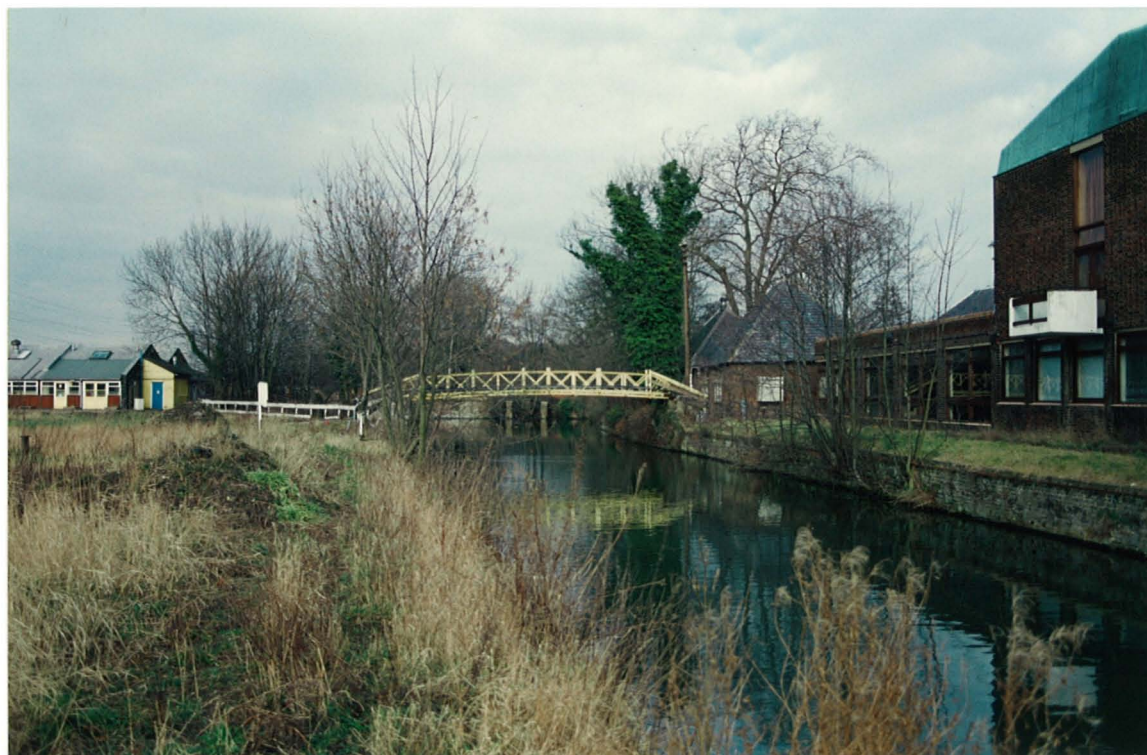
WALTHAM ABBEY RARDE SITE BRIDGE REPORT		
SITE NO.	RCHME NO.	BRIDGE TYPE
BR 17	134	Footbridge
CONSTRUCTION DATE	GRID REF.	INITIAL CONDITION
pre 1947	TL 37676 00931	Fair
DESCRIPTION and CONDITION		
<p>The footbridge is constructed of steel trusses rivetted together supporting a timber deck. To the west the abutment is concrete, to the east the bridge is set upon a brick pier.</p> <p>Refer to Roughtons survey report for details of condition and drawings.</p> <p>The bridge also supports a number of pipes and cables.</p>		
PHOTO NO.		DIMENSIONS
(RCHME) WAP94 CP024 206/K/6 206/S/33 206/S/34		L.- 12.60m W.- 1.30m
DOCUMENTARY SOURCES		
<p>1993 Roughton Bridge Assessment p.127-136 Drg. No. 17 April 1993</p> <p>1993 RCHME <u>Royal Gunpowder Factory Waltham Abbey Report</u> (unpublished)</p>

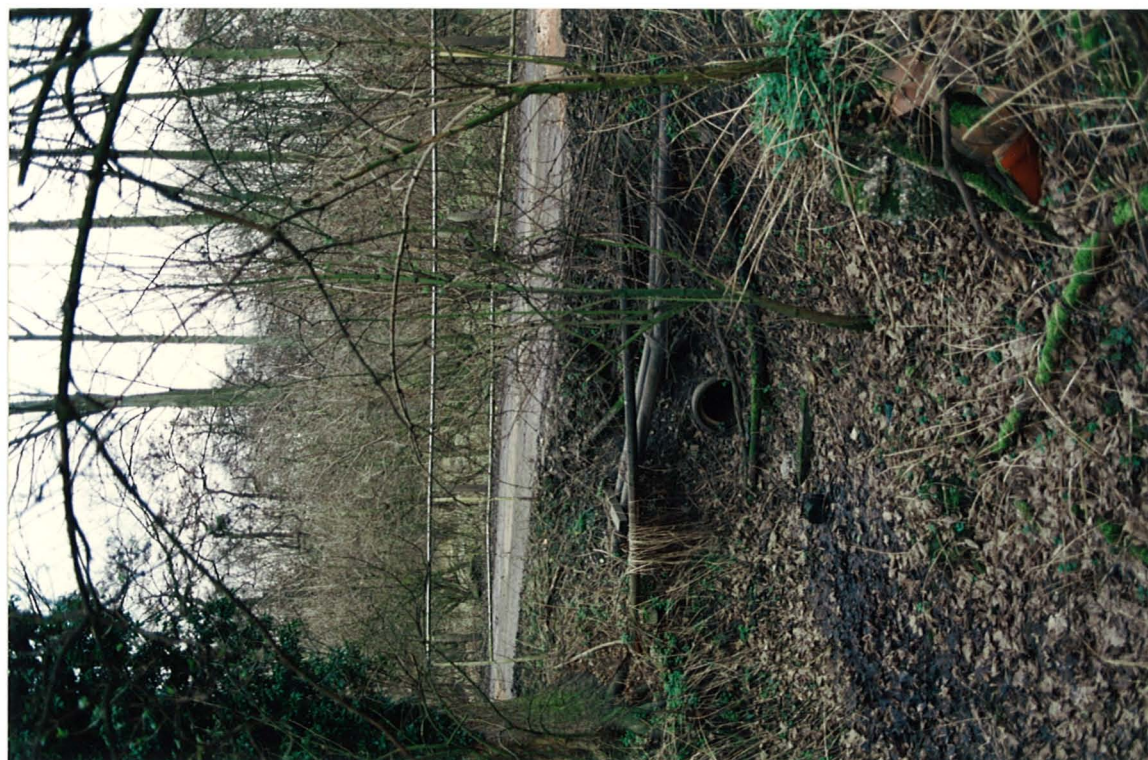
WALTHAM ABBEY RARDE SITE BRIDGE REPORT		
SITE NO.	RCHME NO.	BRIDGE TYPE
BR 18	508	Culvert Bridge
CONSTRUCTION DATE	GRID REF.	INITIAL CONDITION
unknown	TL 37476 01783	Poor
DESCRIPTION and CONDITION		
<p>The structure consists of a single vitrified pipe running under Long Walk with brick head walls east and west. Refer to Roughtons survey report for details of condition and drawings.</p>		
PHOTO NO.	DIMENSIONS	
WAP94 CP004	L.- 6.60m W.- 0.45m	
DOCUMENTARY SOURCES		
1993 Roughton <u>Bridge Assessment</u> p.137-140 Drg. No. 18 April 1993
