Waltham Abbey Royal Gunpowder Factory  
( Former RARDE North Site )

Bridge Report

February 1994

Adam Ford  
Consultant Archaeologist

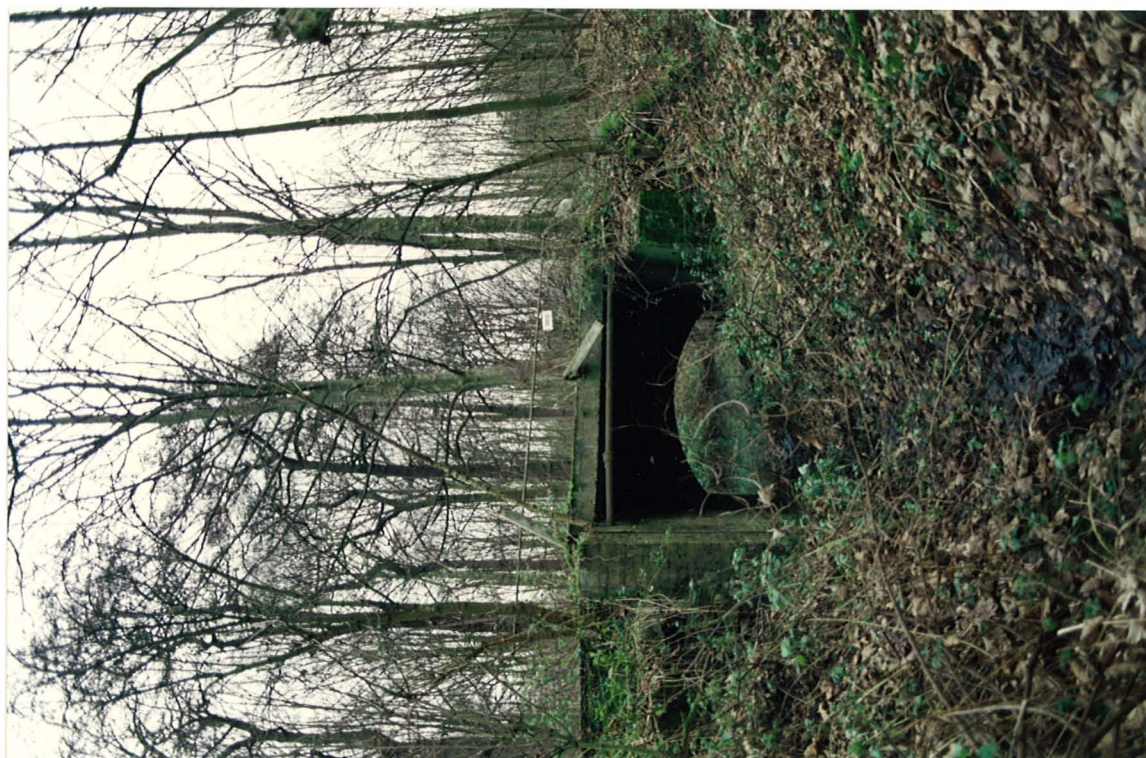
WALTHAM ABBEY RARDE SITE BRIDGE REPORT		
SITE NO.	RCHME NO.	BRIDGE TYPE
BR 19	230	Road Bridge
CONSTRUCTION DATE	GRID REF.	INITIAL CONDITION
1878? repair ?	TL 37516 01795	Poor
DESCRIPTION and CONDITION		
<p>This bridge displays various phases of construction. It was originally a brick and masonry arch and was subsequently extensively repaired with concrete. Refer to Roughtons survey report for details of condition and drawings.</p>		
PHOTO NO.	DIMENSIONS	
WAP93 CP015	L.- 4.80m W.- 3.15m Ht.- 2.50m	
DOCUMENTARY SOURCES		
1993 Roughton <u>Bridge Assessment</u> p.140-142 1993 RCHME <u>Royal Gunpowder Factory Waltham Abbey Report</u> (unpublished)

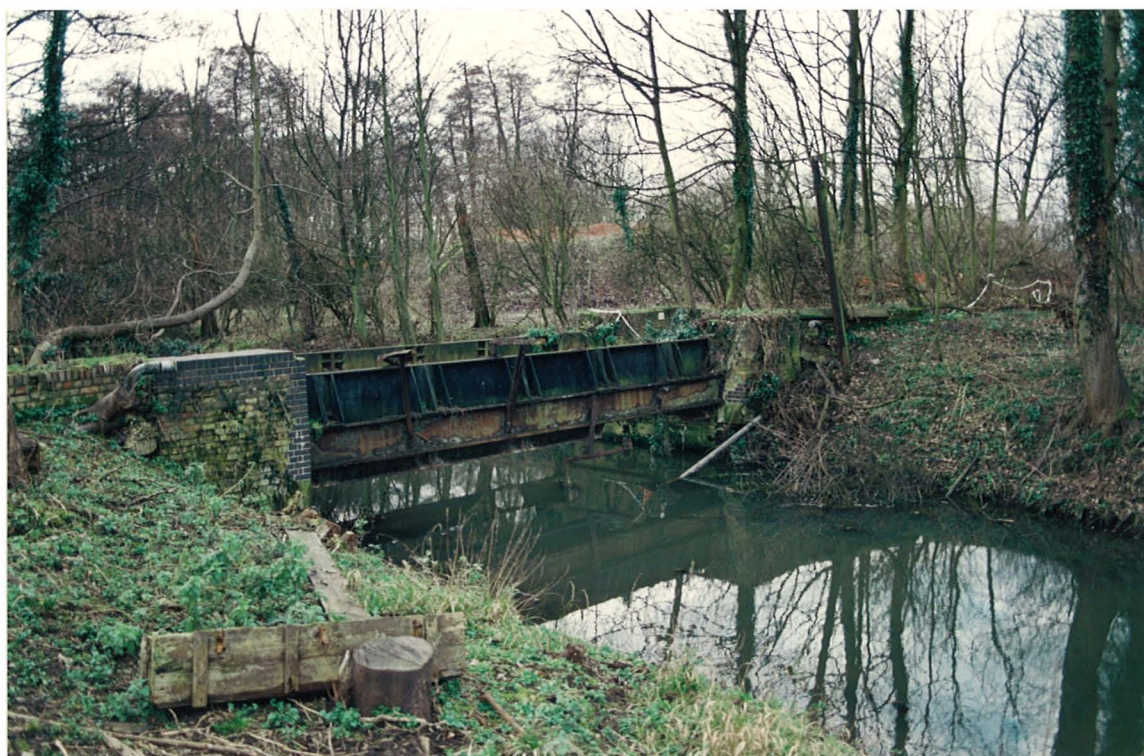
WALTHAM ABBEY RARDE SITE BRIDGE REPORT		
SITE NO.	RCHME NO.	BRIDGE TYPE
BR 20	250	Cast Iron Aqueduct
CONSTRUCTION DATE	GRID REF.	INITIAL CONDITION
1914?	TL 37610 02175	Poor(damaged)
DESCRIPTION and CONDITION		
<p>This is a later example of a cast iron aqueduct. The sides of the trough are made up of smaller panels of cast iron which are bolted together, as was the trough base. Most of the base is missing and a number of the side panels are severely damaged. Refer to Roughtons survey report for details of condition and drawings.</p>		
PHOTO NO.	DIMENSIONS	
(RCHME) 206/O/24 206/O/25 206/O/29 BB92/26289 WAP94 CP009	L.- 14.00m W.- 3.80m Ht.- 1.30m	
DOCUMENTARY SOURCES		
1993 Roughton <u>Bridge Assessment</u> p.143-149 Drg. No. 20 May 1993 1993 RCHME <u>Royal Gunpowder Factory Waltham Abbey Report</u> (unpublished)

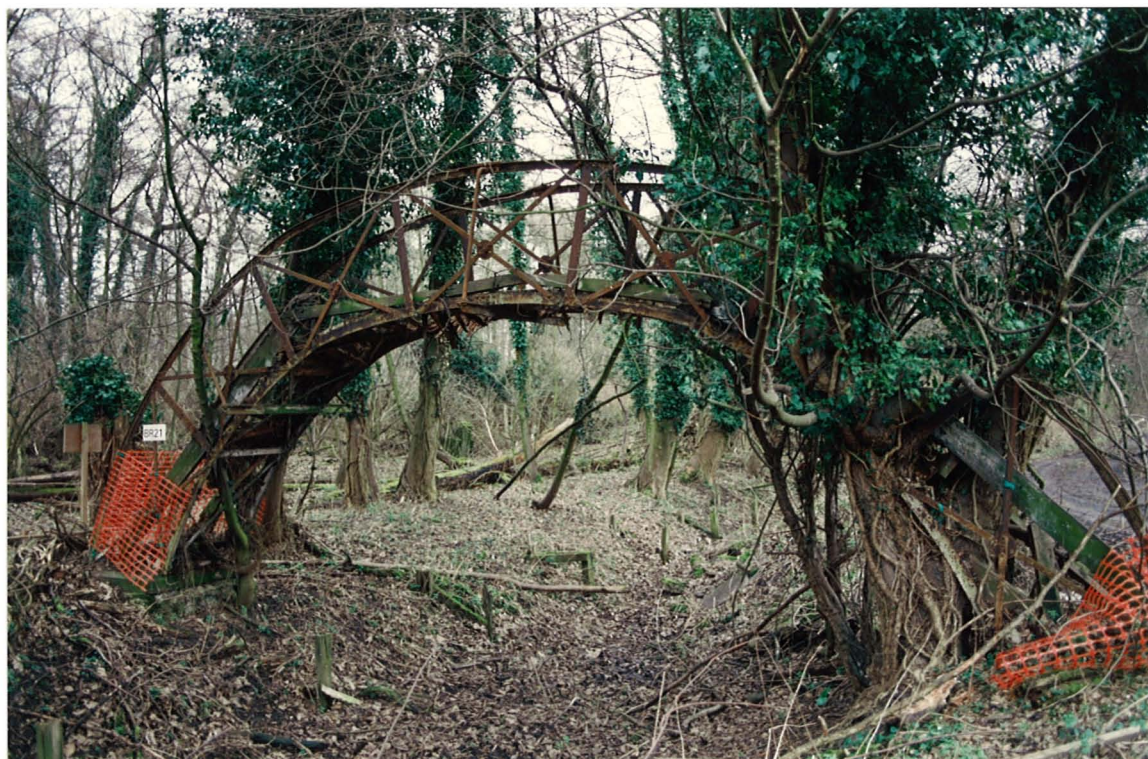
WALTHAM ABBEY RARDE SITE BRIDGE REPORT		
SITE NO.	RCHME NO.	BRIDGE TYPE
BR 21	264	Footbridge
CONSTRUCTION DATE	GRID REF.	INITIAL CONDITION
1880s?	TL 37545 02370	Poor/Fair
DESCRIPTION and CONDITION		
<p>The bridge is constructed of an angle iron frame forming a semi circular arch with timber steps and deck. The bridge is attached to brick and concrete abutments by means of vertical bolts set into sandstone blocks. A boot scraper is situated on the south west corner of the bridge. The steel frame although corroded appears sound as do the abutments. The main problem as in many cases is with vegetative damage caused by young trees.</p>		
PHOTO NO.		DIMENSIONS
(RCHME) WAP94 CP007 206/Q/4		L.- 9.45m W.- 0.97m
DOCUMENTARY SOURCES		
1993 RCHME <u>Royal Gunpowder Factory Waltham Abbey Report</u> (unpublished)

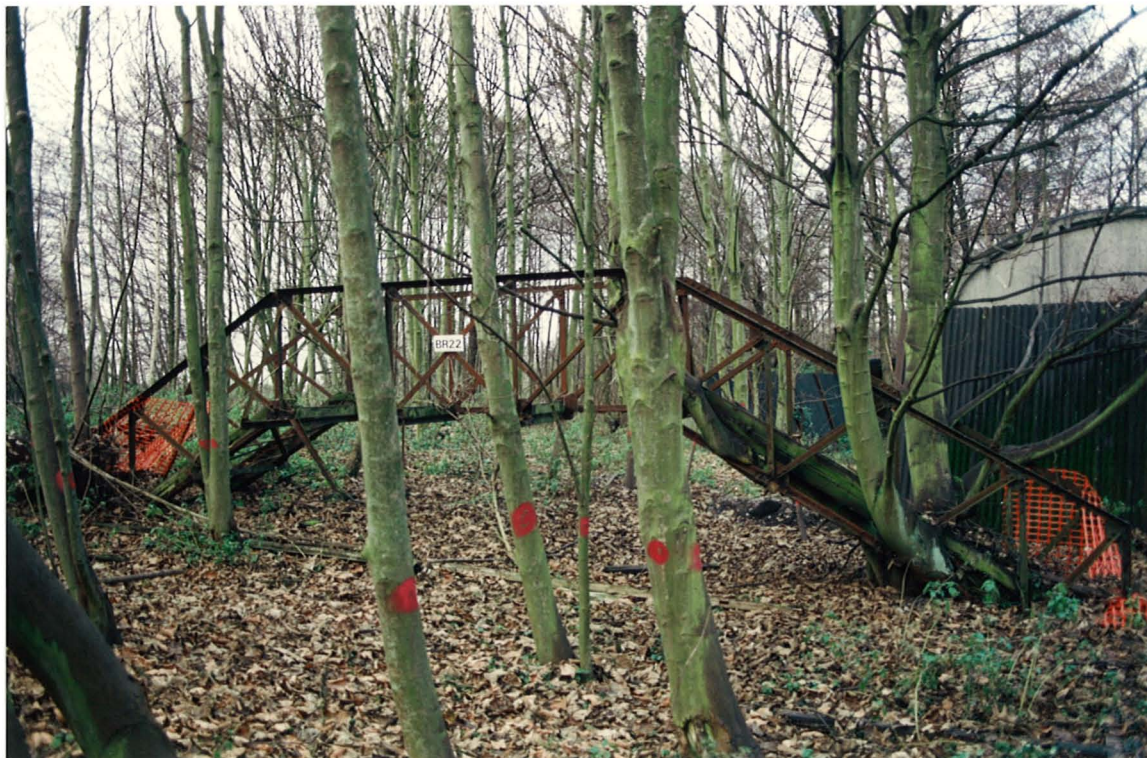
WALTHAM ABBEY RARDE SITE BRIDGE REPORT		
SITE NO.	RCHME NO.	BRIDGE TYPE
BR 22	182	Footbridge
CONSTRUCTION DATE	GRID REF.	INITIAL CONDITION
1890?	TL 37437 02290	Poor
DESCRIPTION and CONDITION		
<p>This footbridge is built from angle irons which once supported steps and a timber deck both have long since rotten away. A number of the iron members are severely corroded and extensive damage has been caused by the encroaching trees.</p>		
PHOTO NO.	DIMENSIONS	
(RCHME) 206/B/33	WAP93 CP033	L.- 10.95m W.- 1.59m
DOCUMENTARY SOURCES		
1993 RCHME <u>Royal Gunpowder Factory Waltham Abbey Report</u> (unpublished)

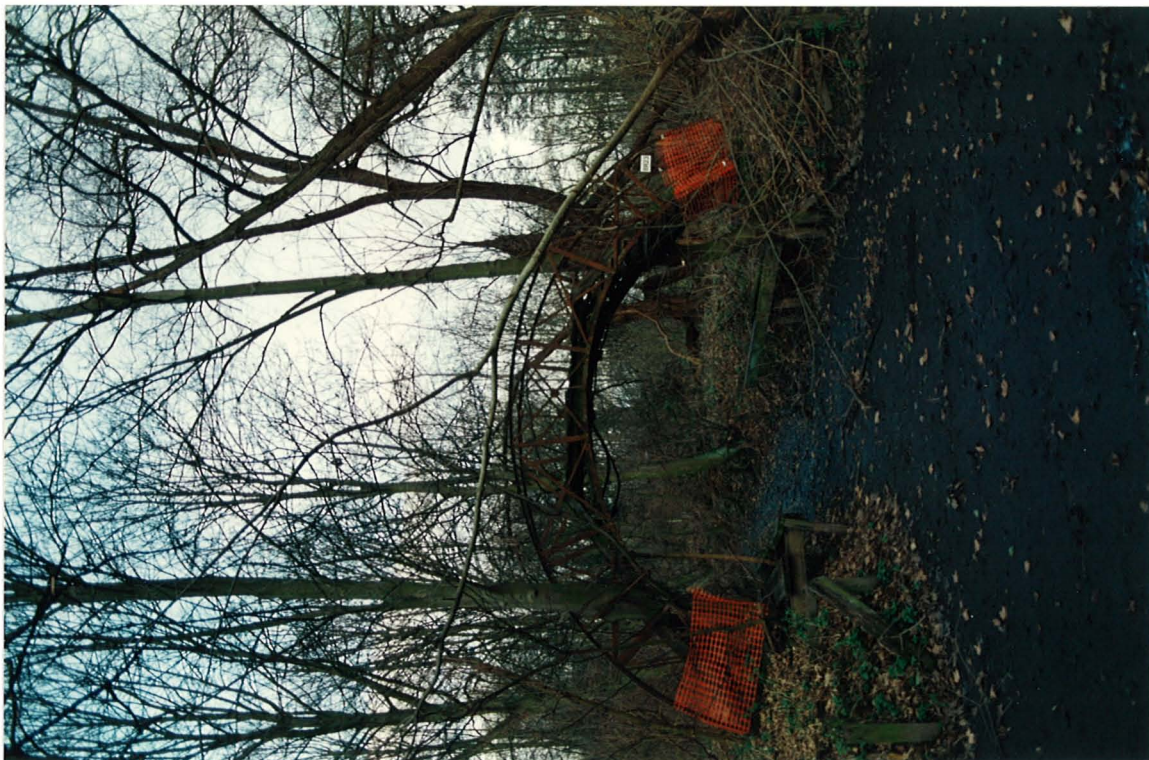
WALTHAM ABBEY RARDE SITE BRIDGE REPORT		
SITE NO.	RCHME NO.	BRIDGE TYPE
BR 23	255	Footbridge
CONSTRUCTION DATE	GRID REF.	INITIAL CONDITION
1880s?	TL 37507 02235	Fair/Poor
DESCRIPTION and CONDITION		
<p>This bridge is very similar in construction to 21; semi circular arch built of angle irons and timber. The supporting piers are also similar. The timber has all but gone leaving a fairly stable frame.</p>		
PHOTO NO.		DIMENSIONS
(RCHME) WAP93 CPO46 206/O/31 206/O/32		L.- 9.48m W.- 0.97m Ht.- 3.60m(above canal base)
DOCUMENTARY SOURCES		
1993 RCHME <u>Royal Gunpowder Factory Waltham Abbey Report</u> (unpublished)

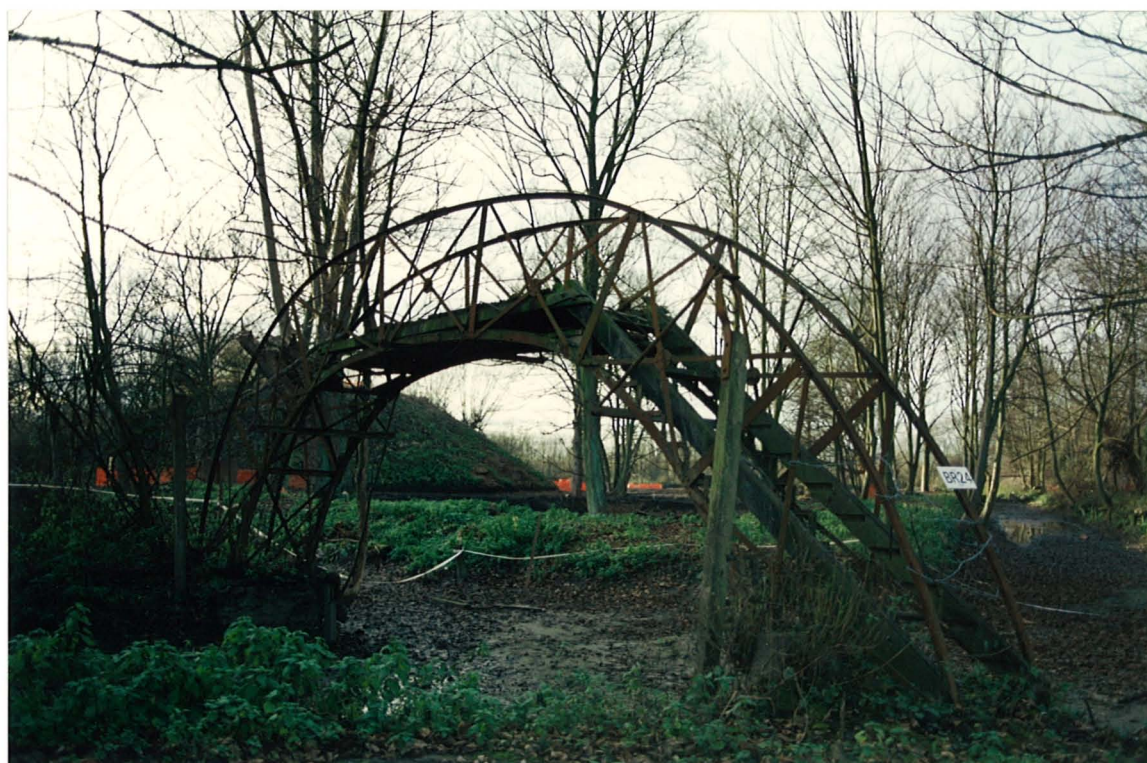
WALTHAM ABBEY RARDE SITE BRIDGE REPORT		
SITE NO.	RCHME NO.	BRIDGE TYPE
BR 24	254	Footbridge
CONSTRUCTION DATE	GRID REF.	INITIAL CONDITION
1880s?	TL 37585 02200	Fair
DESCRIPTION and CONDITION		
This bridge is similar to 21 and 23 in construction and condition. Less affected by tree damage.		
PHOTO NO.	DIMENSIONS	
(RCHME) WAP93 CP039 206/O/30 BB92/26287	L.- 9.48m W.- 0.98m Ht.- 3.60m(above canal base)	
DOCUMENTARY SOURCES		
1993 RCHME <u>Royal Gunpowder Factory Waltham Abbey</u> Report (unpublished)

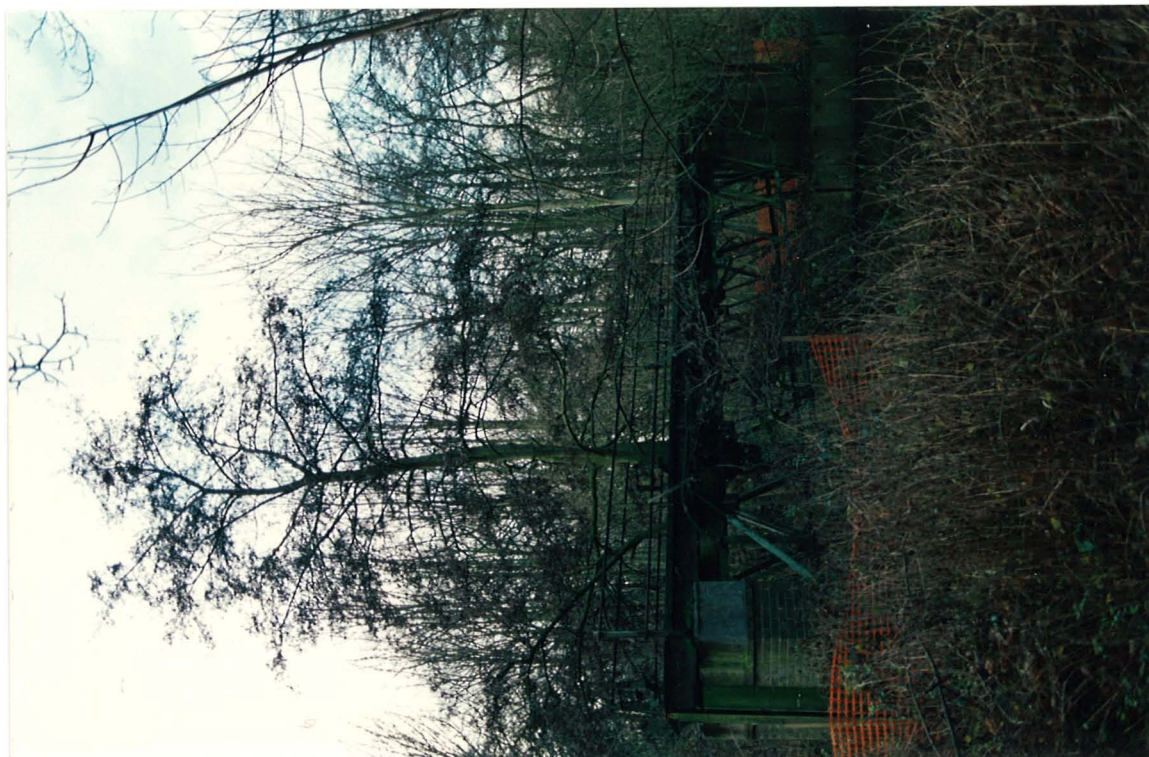
WALTHAM ABBEY RARDE SITE BRIDGE REPORT		
SITE NO.	RCHME NO.	BRIDGE TYPE
BR 25	102	Pipebridge
CONSTRUCTION DATE	GRID REF.	INITIAL CONDITION
1940	TL 37575 01973	Fair/Poor
DESCRIPTION and CONDITION		
<p>This bridge carried an acid pipe, compressed air pipe and a steam main from the acid factory to the new nitroglycerine plant on New Hill over the Cornmill Stream. It is believed that the acid pipe was never used. The bridge is constructed of angle irons forming a single span. Although corroded the main supporting member appear to be sound.</p>		
PHOTO NO.		DIMENSIONS
(RCHME) WAP93 CP038 206/I/20 206/N/7		L.- 14.00m W.- 1.80m
DOCUMENTARY SOURCES		
1993 RCHME <u>Royal Gunpowder Factory Waltham Abbey</u> Report (unpublished)

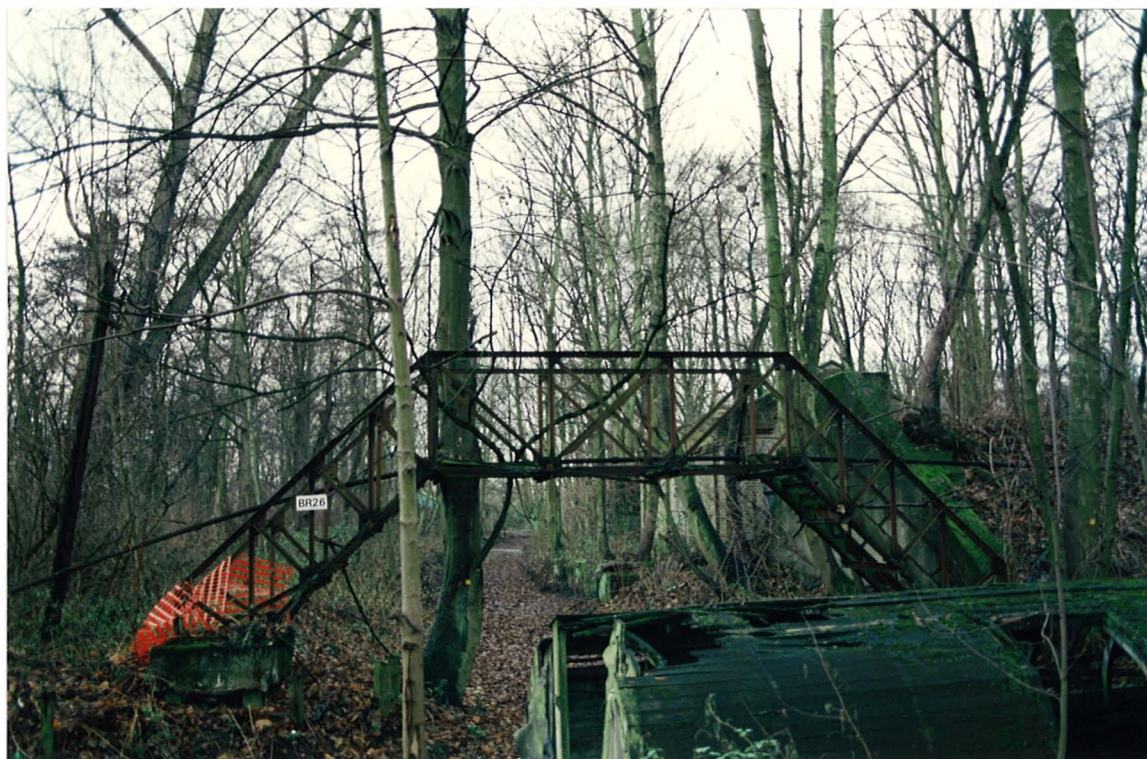
WALTHAM ABBEY RARDE SITE BRIDGE REPORT		
SITE NO.	RCHME NO.	BRIDGE TYPE
BR 26	103	Footbridge
CONSTRUCTION DATE	GRID REF.	INITIAL CONDITION
1904?	TL 37602 01884	Fair/Poor
DESCRIPTION and CONDITION		
<p>This Bridge is another example of the semi circular arched footbridges. As with the others the timber decking and steps have decayed but the angle iron frame appears to be intact.</p>		
PHOTO NO.	DIMENSIONS	
(RCHME) WAP93 CP043 206/I/24 206/T/15 BB92/26170	L.- 9.40m W.- 1.73m Ht.- 2.3m(above Canal Base)	
DOCUMENTARY SOURCES		
1993 RCHME <u>Royal Gunpowder Factory Waltham Abbey Report</u> (unpublished)

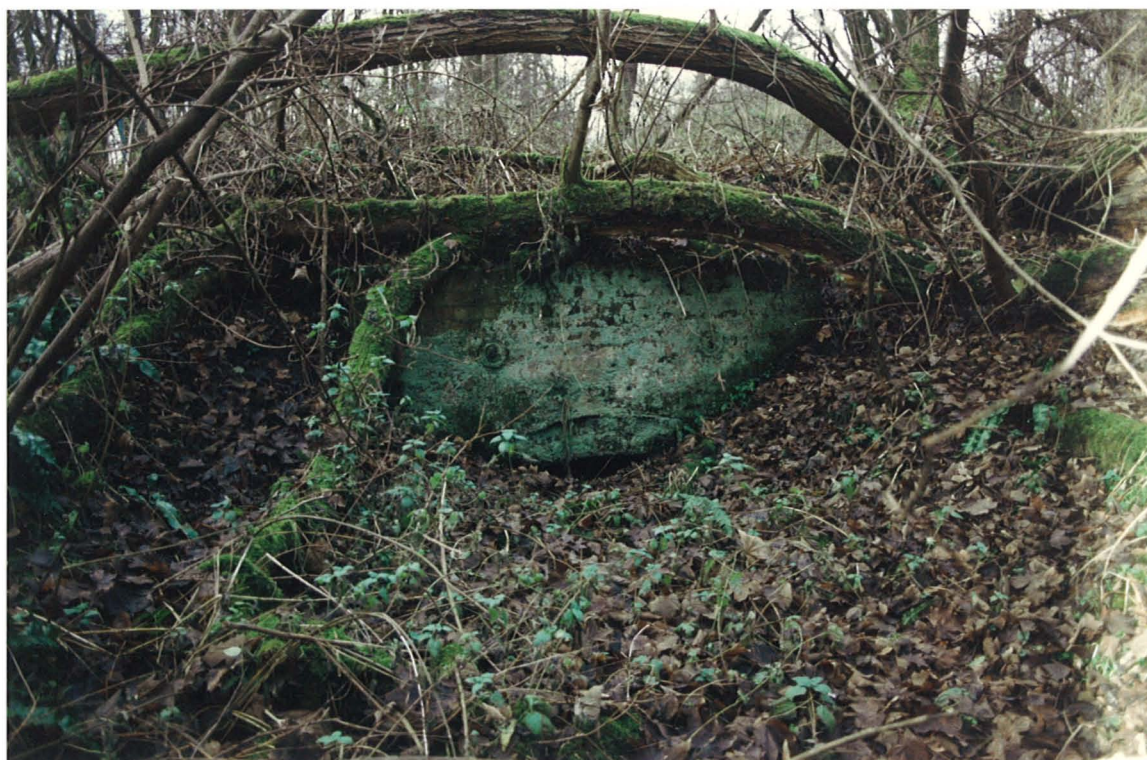
WALTHAM ABBEY RARDE SITE BRIDGE REPORT		
SITE NO.	RCHME NO.	BRIDGE TYPE
BR 27	180	Aqueduct
CONSTRUCTION DATE	GRID REF.	INITIAL CONDITION
1878	TL 37552 01598	Poor/Fair
DESCRIPTION and CONDITION		
<p>The aqueduct is constructed of brick with brick head walls which have tie-rods running through its length.</p> <p>The over lying canal has been completely filled in, the lower canal has silted up. The western head wall is collapsing outward.</p>		
PHOTO NO.	DIMENSIONS	
WAP93 CP027	L.- 2.80m W.- 12.10m	
DOCUMENTARY SOURCES		
1993 RCHME <u>Royal Gunpowder Factory Waltham Abbey</u> Report (unpublished)

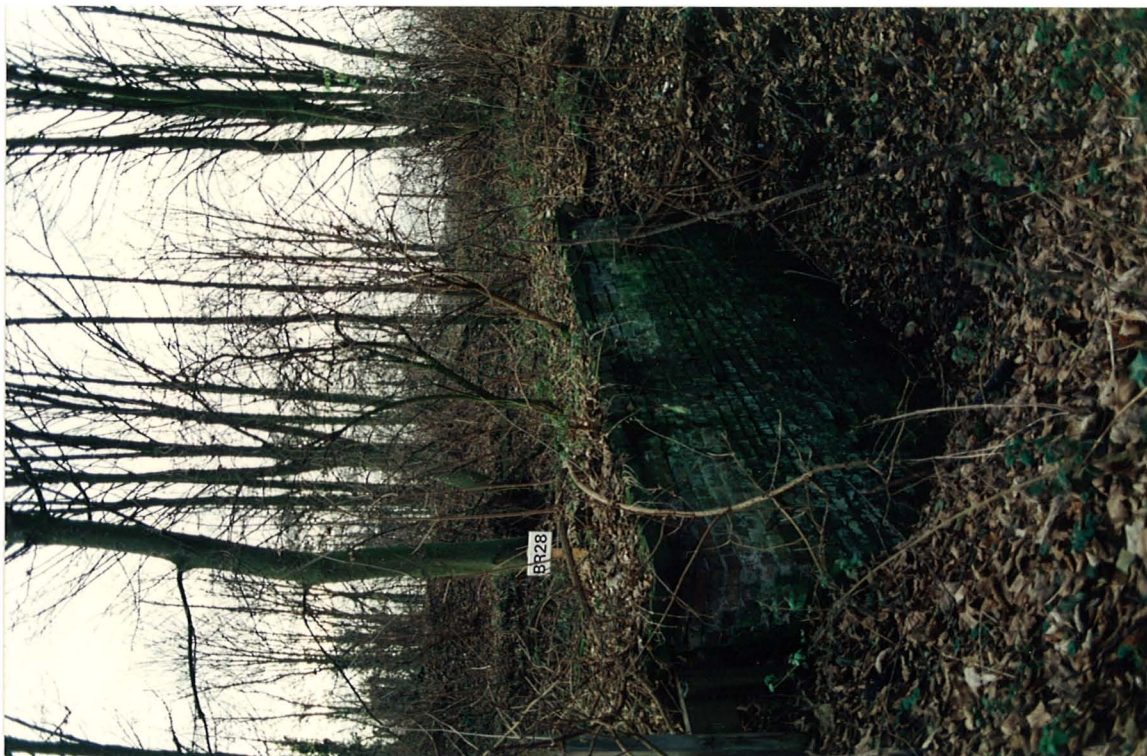
WALTHAM ABBEY RARDE SITE BRIDGE REPORT		
SITE NO.	RCHME NO.	BRIDGE TYPE
BR 28	170	Aqueduct
CONSTRUCTION DATE	GRID REF.	INITIAL CONDITION
1806-27	TL 37442 01640	Good/ Fair
DESCRIPTION and CONDITION		
<p>This aqueduct is constructed of brick and has earth embankments to carry the main press house canal over a lower drain. Although both waterways are redundant the brick head walls and earth embankments are in reasonable condition. Concrete blocks on the tow path perhaps represent the position of a footbridge.</p>		
PHOTO NO.	DIMENSIONS	
WAP93 CP008	L.- 6.40m W.- 12.55m Ht.- 2.25m	
DOCUMENTARY SOURCES		
1993 RCHME <u>Royal Gunpowder Factory Waltham Abbey Report</u> (unpublished)

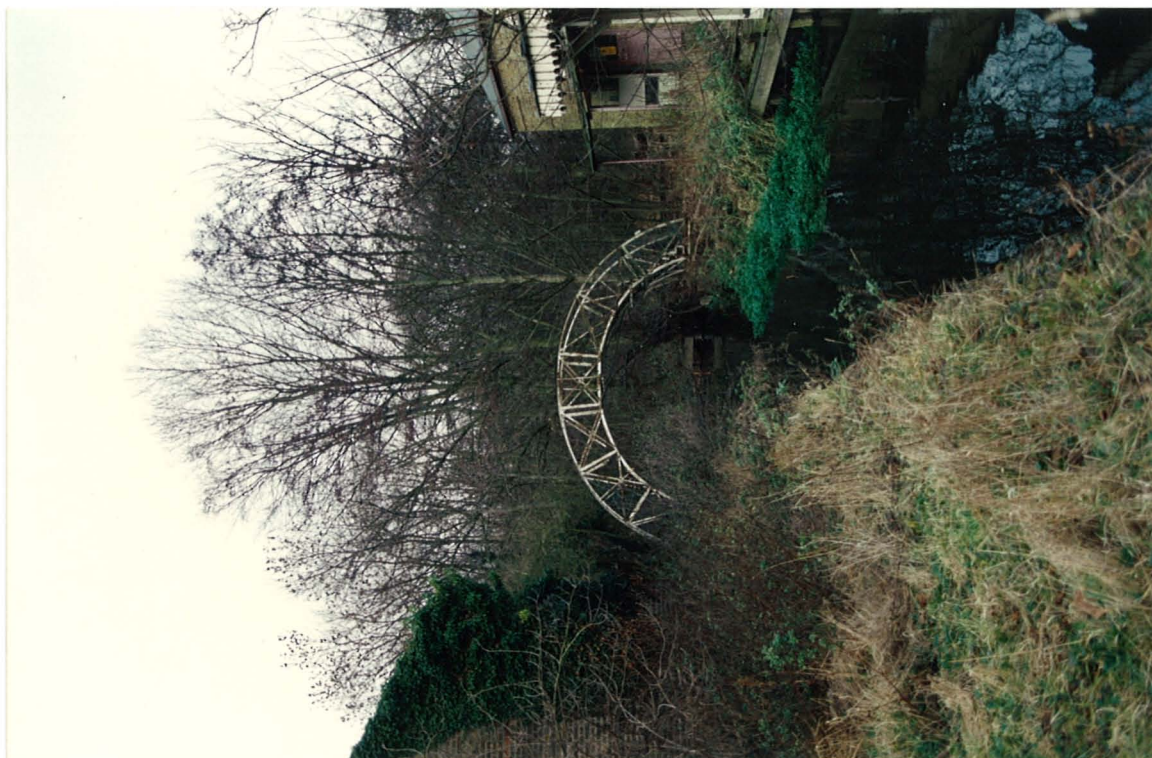
WALTHAM ABBEY RARDE SITE BRIDGE REPORT		
SITE NO.	RCHME NO.	BRIDGE TYPE
BR 29	184	Footbridge
CONSTRUCTION DATE	GRID REF.	INITIAL CONDITION
1880s?	TL 37654 01449	Fair
DESCRIPTION and CONDITION		
<p>This span is another example of the semicircular bridges. As with the other cases the framework is complete but the timber is either missing or in an advanced stage of decay.</p>		
PHOTO NO.	DIMENSIONS	
(RCHME) WAP93 CP037 206/C/16	L.- 9.50m W.- 0.96m Ht.- 3.50m(above canal fill)	
DOCUMENTARY SOURCES		
1993 RCHME <u>Royal Gunpowder Factory Waltham Abbey Report</u> (unpublished)

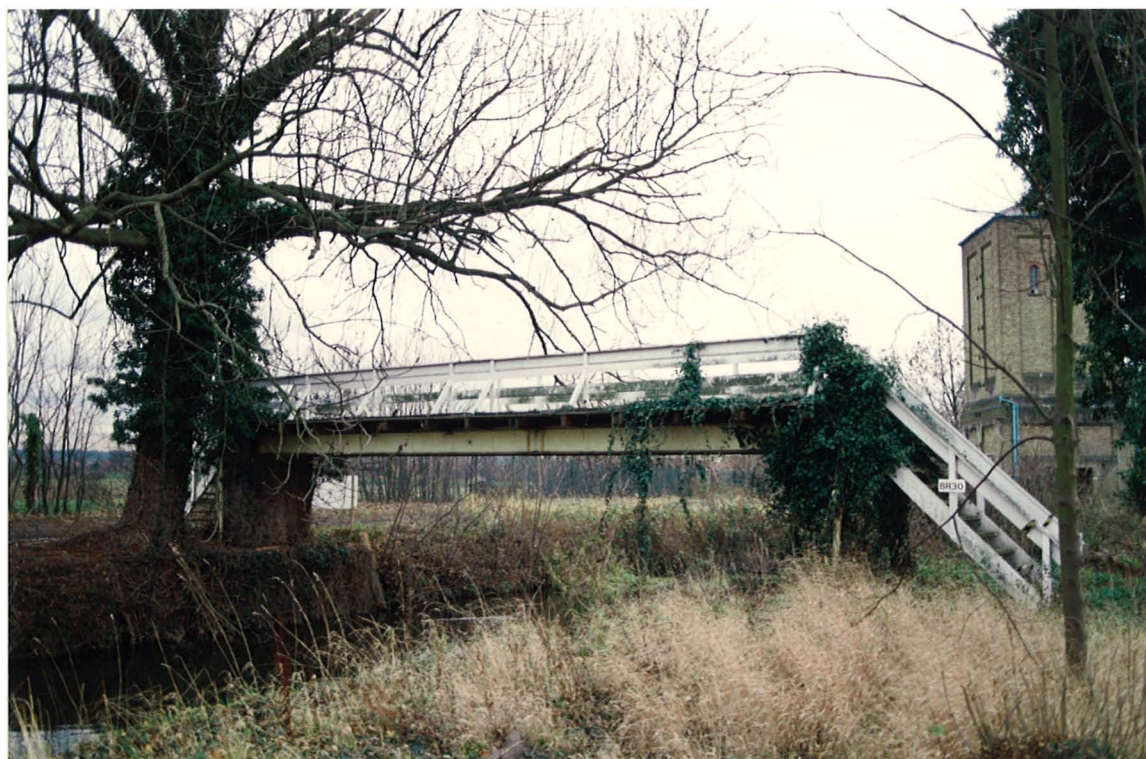
WALTHAM ABBEY RARDE SITE BRIDGE REPORT		
SITE NO.	RCHME NO.	BRIDGE TYPE
BR 30	123	Footbridge
CONSTRUCTION DATE	GRID REF.	INITIAL CONDITION
1950s /1960s?	TL 37805 01065	Fair
DESCRIPTION and CONDITION		
<p>The footbridge is constructed of one large RSJ supported on tall brick piers. Wooden steps on either side access a timber deck which lies on the beam. Two timber hand rails are attached to this deck. Some of the timbers need replacing and perhaps the hand rails but the rest of the structure seems to be stable.</p>		
PHOTO NO.		DIMENSIONS
(RCHME) WAP93 CP022 206/E/7		L.- 17.50m W.- 1.70m Ht.- 2.65m
DOCUMENTARY SOURCES		
1993 RCHME <u>Royal Gunpowder Factory Waltham Abbey</u> Report (unpublished)

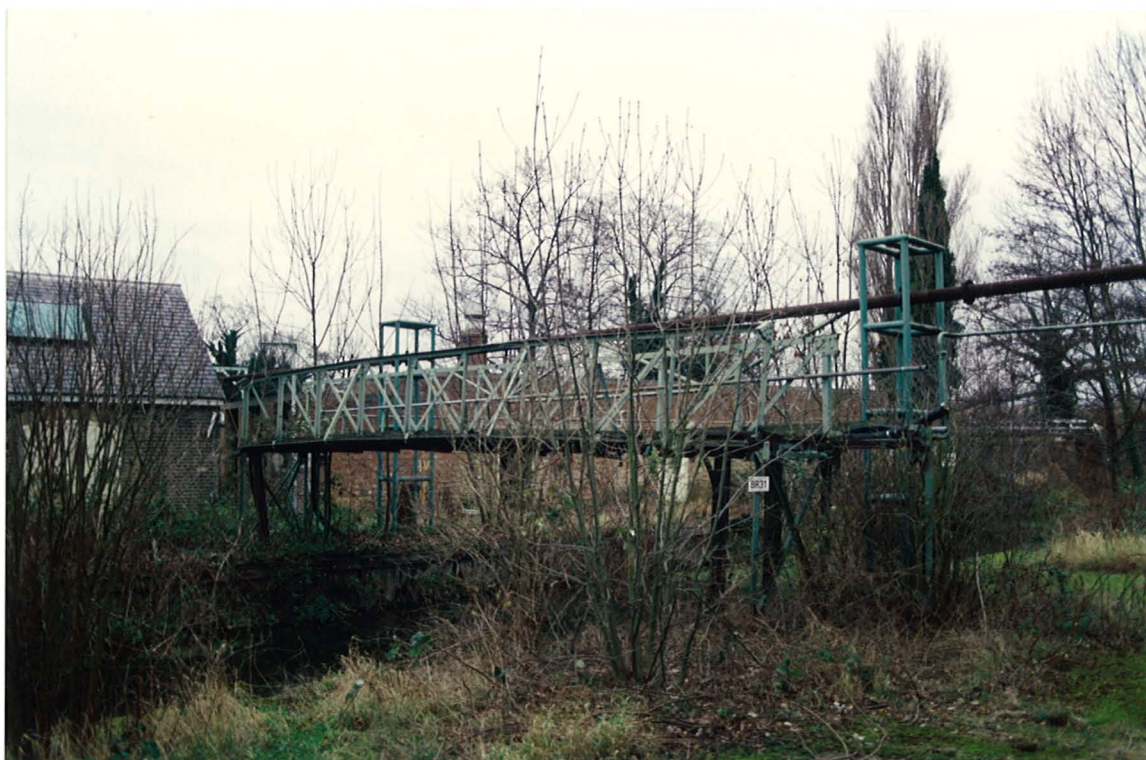
WALTHAM ABBEY RARDE SITE BRIDGE REPORT		
SITE NO.	RCHME NO.	BRIDGE TYPE
BR 31	126	Footbridge/Pipe bridge
CONSTRUCTION DATE	GRID REF.	INITIAL CONDITION
pre 1945	TL 37765 01017	Poor
DESCRIPTION and CONDITION		
<p>Bridge constructed of angle irons braced with cross pieces. Most members are rivetted. The metal structure supports a timber deck, now mostly rotten. The steps on either end have been removed and the structure is leaning. It appears to have been a pipe bridge after the removal of the steps.</p>		
PHOTO NO.	DIMENSIONS	
(RCHME) WAP93 CP019 206/E/8	L.- 14.00m W.- 1.40m Ht.- 2m	
DOCUMENTARY SOURCES		
1993 RCHME <u>Royal Gunpowder Factory Waltham Abbey</u> Report (unpublished)

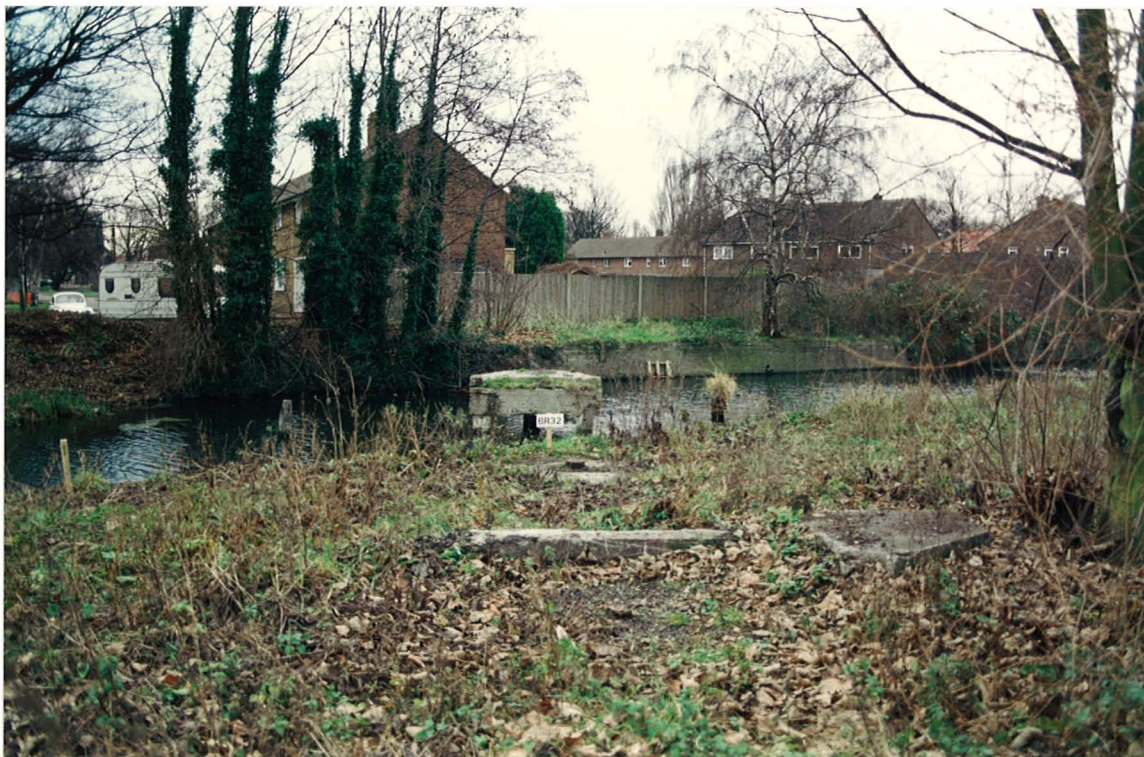
WALTHAM ABBEY RARDE SITE BRIDGE REPORT		
SITE NO.	RCHME NO.	BRIDGE TYPE
BR 32	100	Swing Bridge
CONSTRUCTION DATE	GRID REF.	INITIAL CONDITION
unknown	TL 37700 00683	Demolished
DESCRIPTION and CONDITION		
<p>Remains of a narrow gauge railway swing bridge. Consist of a triangular concrete pier set in the middle of Millhead Stream. This pier is supported above the water level by three concrete piles. Surrounding this are a number of timber piles of unknown function. On the west bank is an iron pivot set into concrete 2.80m to the west of this stands the concrete mounting point for the bridge.</p> <p>There are three steps to the south up to the level of the railway causeway. The concrete block has a curved face to the east to allow the end of the bridge to swing into place. There is no evidence of the rest of the structure.</p>		
PHOTO NO.	DIMENSIONS	
WAP93 CP034	Not Available	
DOCUMENTARY SOURCES		
1993 RCHME <u>Royal Gunpowder Factory Waltham Abbey Report</u> (unpublished)

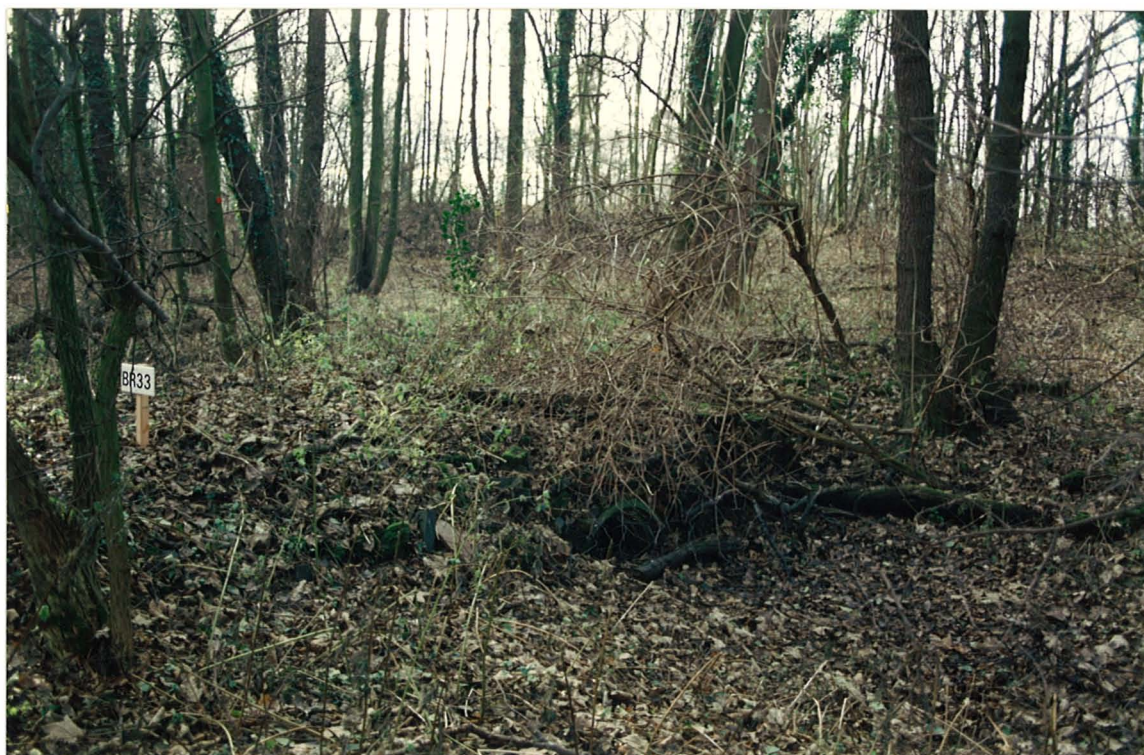
WALTHAM ABBEY RARDE SITE BRIDGE REPORT		
SITE NO.	RCHME NO.	BRIDGE TYPE
BR 33	120	Bridge
CONSTRUCTION DATE	GRID REF.	INITIAL CONDITION
unknown	TL 37465 01487	Poor
<b>DESCRIPTION and CONDITION</b>		
<p>Rough bridge constructed of unmortared bricks, a precast concrete pipe and railway sleepers. There are two earthwork causeways leading up to the bridge. Overgrown and not very stable.</p>		
PHOTO NO.	DIMENSIONS	
WAP93 CP010	L.- 7.00m W.- 4.50m	
<b>DOCUMENTARY SOURCES</b>		
1993 RCHME <u>Royal Gunpowder Factory Waltham Abbey</u> Report (unpublished)

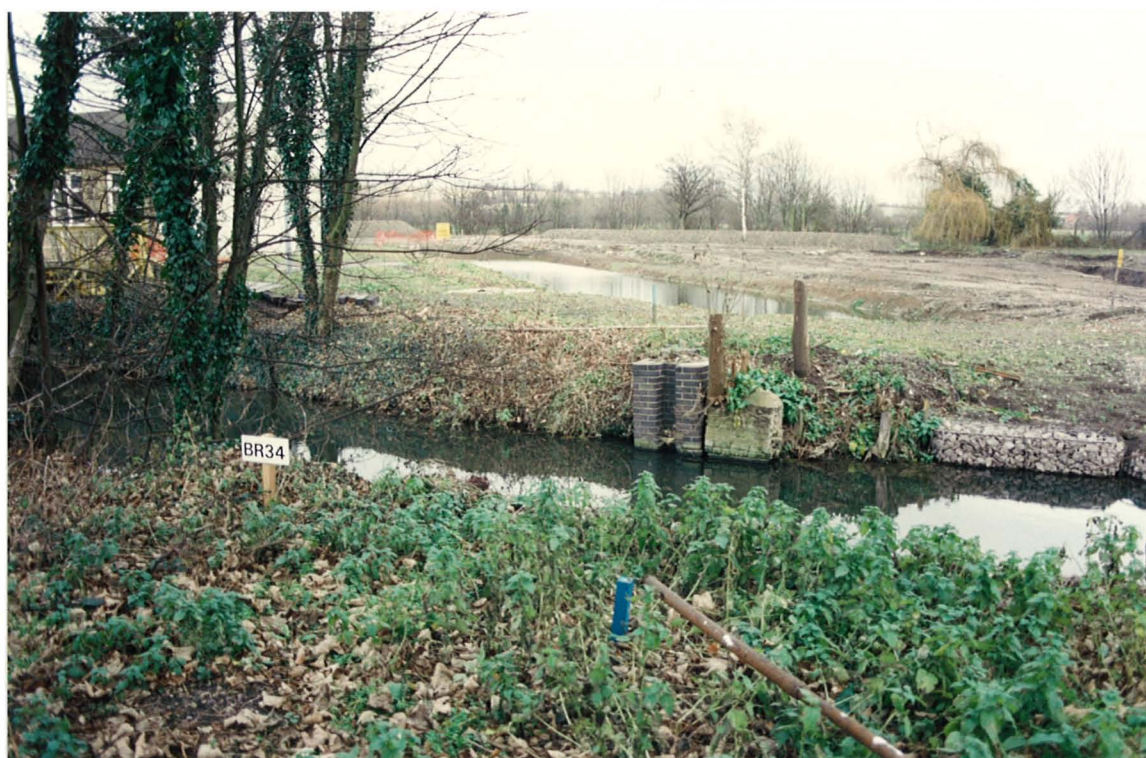
WALTHAM ABBEY RARDE SITE BRIDGE REPORT		
SITE NO.	RCHME NO.	BRIDGE TYPE
BR 34	122	Foot/Pipe Bridge
CONSTRUCTION DATE	GRID REF.	INITIAL CONDITION
1878?/1940s?	TL 37800 01095	Fair
DESCRIPTION and CONDITION		
<p>The present structure is built of timber and used to carry steam pipes across the canal. Immediately to the north are brick abutments of a former footbridge. Slots incorporated into the the brickwork appear to have allowed a board to be lowered into place to seal the channel. The bricks and style are similar to the 1878 bridges.</p>		
PHOTO NO.	DIMENSIONS	
WAP93 CP023	L.- N/A W.- 2.50m Ht.- 1.95m	
DOCUMENTARY SOURCES		
1993 RCHME <u>Royal Gunpowder Factory Waltham Abbey Report</u> (unpublished)

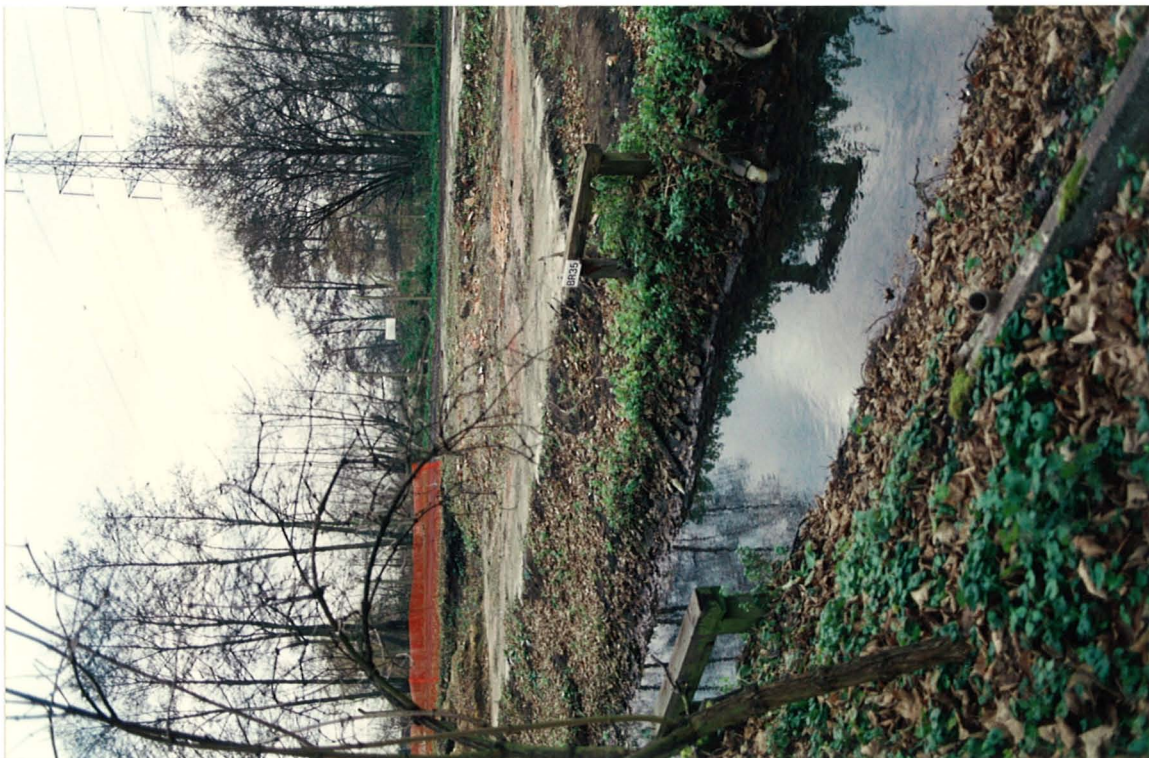
WALTHAM ABBEY RARDE SITE BRIDGE REPORT		
SITE NO.	RCHME NO.	BRIDGE TYPE
BR 35	191	Footbridge
CONSTRUCTION DATE	GRID REF.	INITIAL CONDITION
unknown	TL 37424 01922	Very Poor
DESCRIPTION and CONDITION		
Only two timber trestles remain of this crossing on the east and west banks of the disused canal.		
PHOTO NO.	DIMENSIONS	
WAP93 CP016	Est. L.- 5.60m W.- 1.40m	
DOCUMENTARY SOURCES		
1993 RCHME <u>Royal Gunpowder Factory Waltham Abbey Report</u> (unpublished)

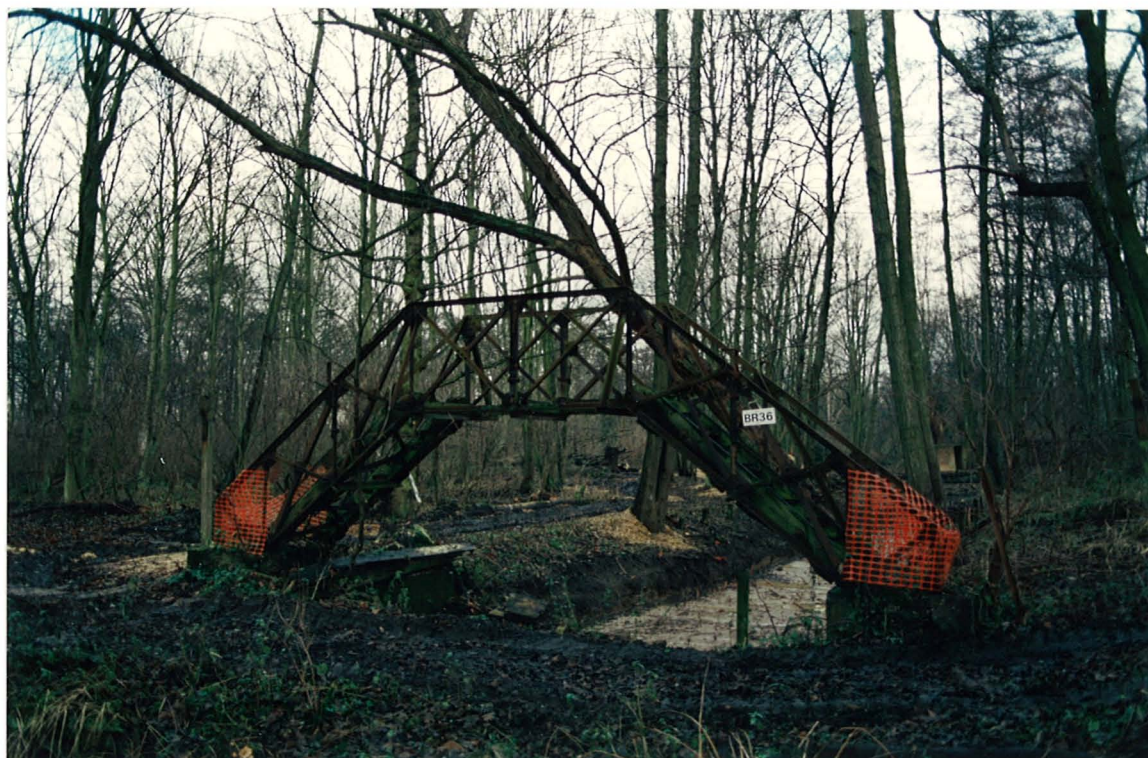
WALTHAM ABBEY RARDE SITE BRIDGE REPORT		
SITE NO.	RCHME NO.	BRIDGE TYPE
BR 36	202	Footbridge
CONSTRUCTION DATE	GRID REF.	INITIAL CONDITION
1890s?	TL 37643 02044	Fair
DESCRIPTION and CONDITION		
The footbridge consists of an angle iron frame supporting a timber deck. Serivce pipes were also carried by hoops attached to either side of the bridge.		
PHOTO NO.	DIMENSIONS	
WAP93 CP042	L.- 8.50m W.- 1.30m Ht.- 2.25m	
DOCUMENTARY SOURCES		
1993 RCHME <u>Royal Gunpowder Factory Waltham Abbey</u> Report (unpublished)

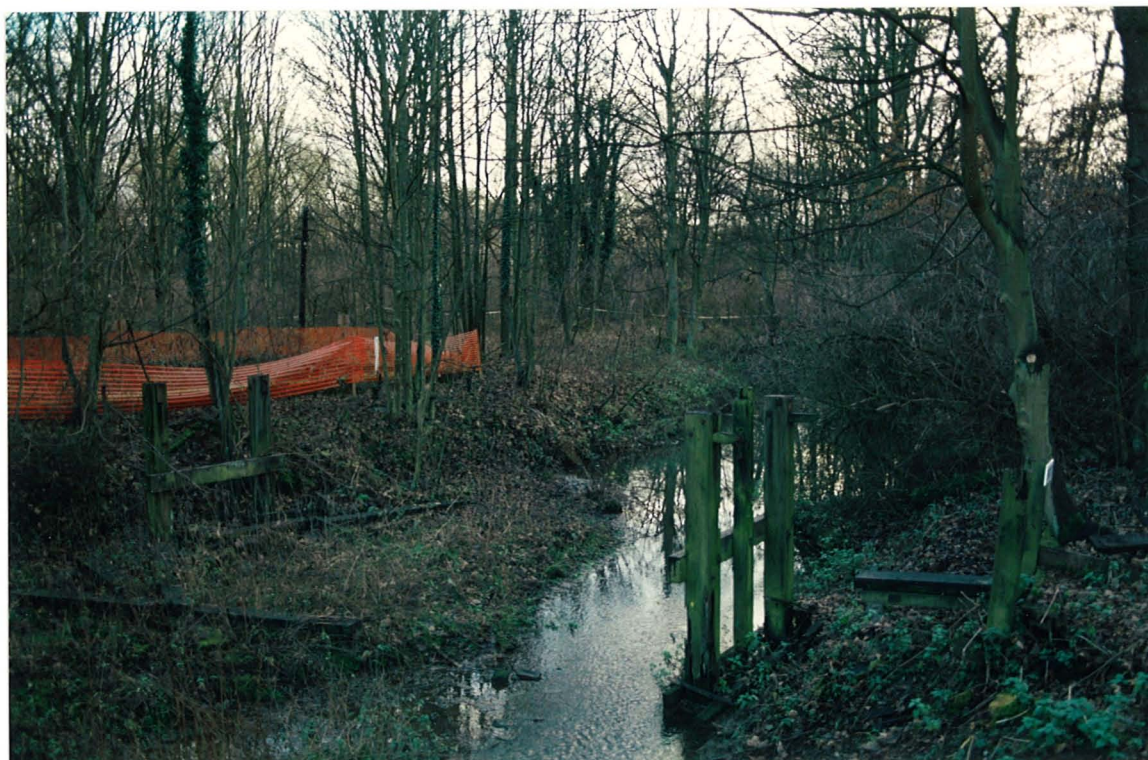
WALTHAM ABBEY RARDE SITE BRIDGE REPORT		
SITE NO.	RCHME NO.	BRIDGE TYPE
BR 37	212	Pipe Bridge
CONSTRUCTION DATE	GRID REF.	INITIAL CONDITION
1895?	TL 37575 02116	Poor
DESCRIPTION and CONDITION		
<p>This bridge is constructed of timber for the most part and is supported by two timber trestles on the north and south banks. The bridge also supported a walkway on the eastern side. Carried wash water from the nitrator E2 to E4.</p>		
PHOTO NO.	DIMENSIONS	
WAP93 CP041	L.- 13.20m W.- 2.20m Ht.- 2.35m	
DOCUMENTARY SOURCES		
1993 RCHME <u>Royal Gunpowder Factory Waltham Abbey Report</u> (unpublished)

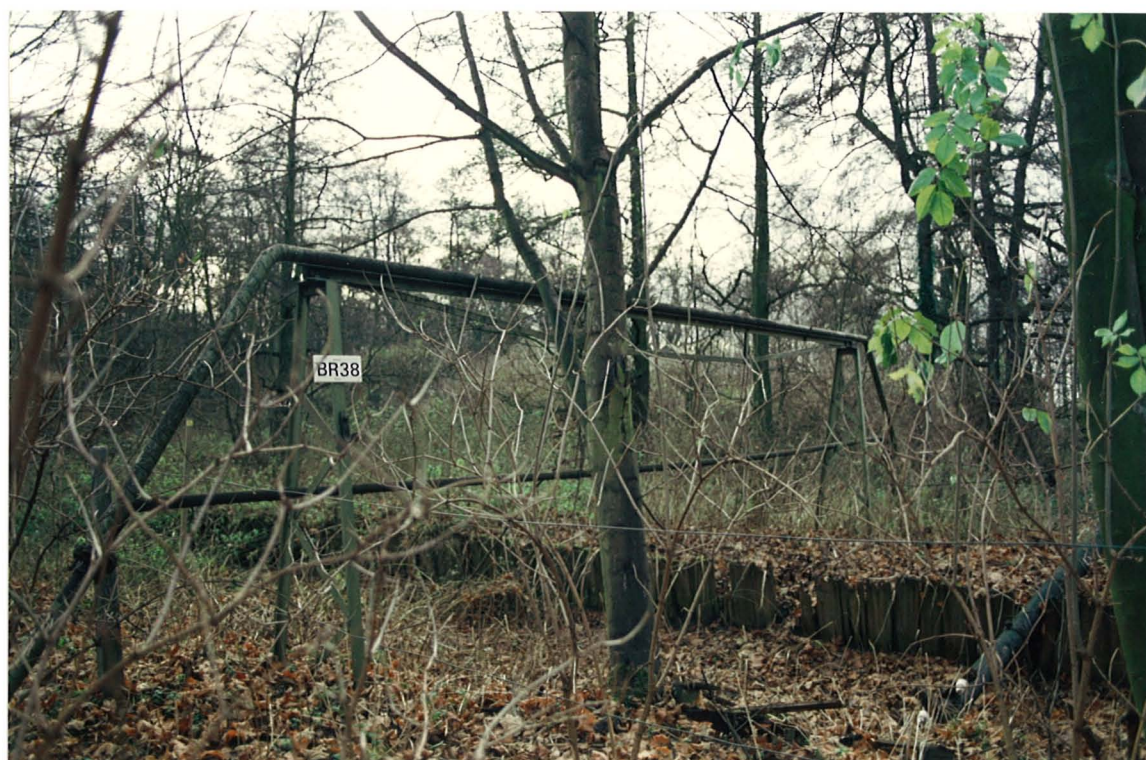
WALTHAM ABBEY RARDE SITE BRIDGE REPORT		
SITE NO.	RCHME NO.	BRIDGE TYPE
BR 38	173	Pipebridge
CONSTRUCTION DATE	GRID REF.	INITIAL CONDITION
1890s-1900?	TL 37523 01648	Fair
DESCRIPTION and CONDITION		
Steel framed bridge carrying two steam mains over the canal. appears to be sound with no serious corrosion.		
PHOTO NO.	DIMENSIONS	
WAP93 CP004	L.- 8.05m W.- 0.75m Ht.- 2.40m	
DOCUMENTARY SOURCES		
1993 RCHME <u>Royal Gunpowder Factory Waltham Abbey</u> Report (unpublished)

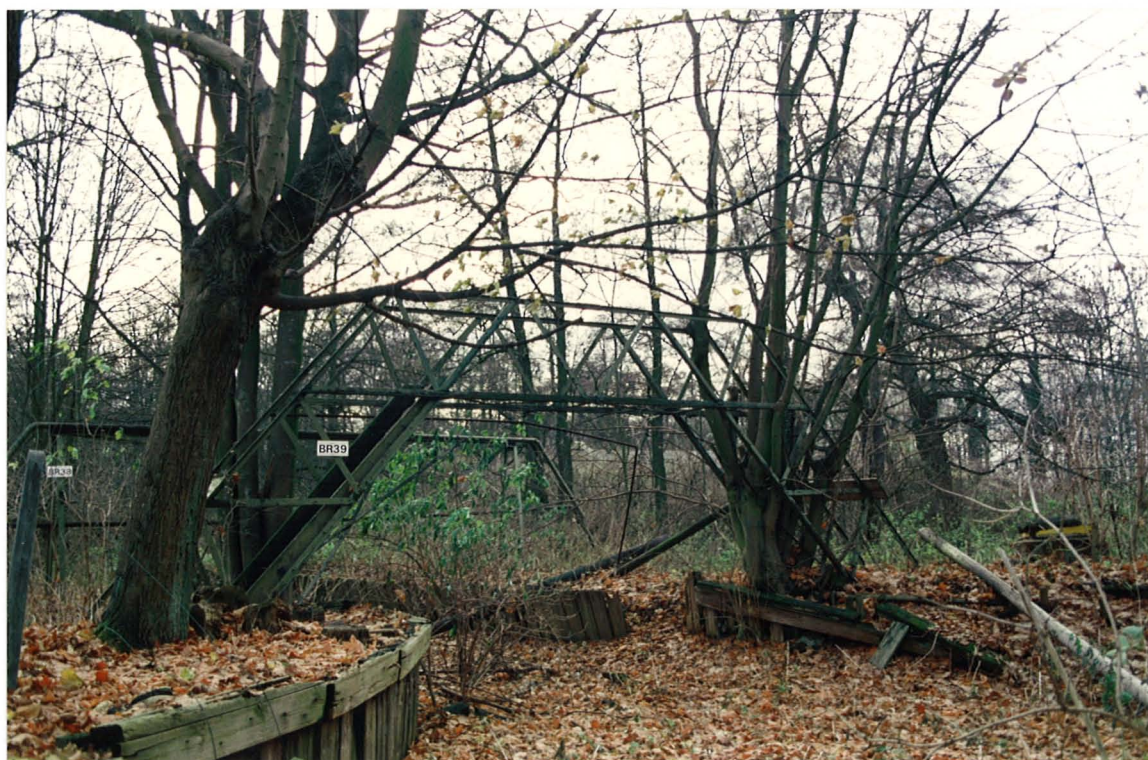
WALTHAM ABBEY RARDE SITE BRIDGE REPORT		
SITE NO.	RCHME NO.	BRIDGE TYPE
BR 39	174	Footbridge
CONSTRUCTION DATE	GRID REF.	INITIAL CONDITION
1880s-1890s	TL 37523 01653	Fair
DESCRIPTION and CONDITION		
<p>The footbridge is constructed of angle irons which support timber steps and decking similar in design to BR 22 but rising higher above the canal. Most of the timbers are rotten and some of the angle irons are badly corroded.</p>		
PHOTO NO.	DIMENSIONS	
WAP93 CP003	L.- 9.30m W.- 1.05m Ht.- 2.25m	
DOCUMENTARY SOURCES		
1993 RCHME <u>Royal Gunpowder Factory Waltham Abbey</u> Report (unpublished)
