Waltham Abbey Royal Gunpowder Factory  
( Former RARDE North Site )

Bridge Report

February 1994

Adam Ford  
Consultant Archaeologist

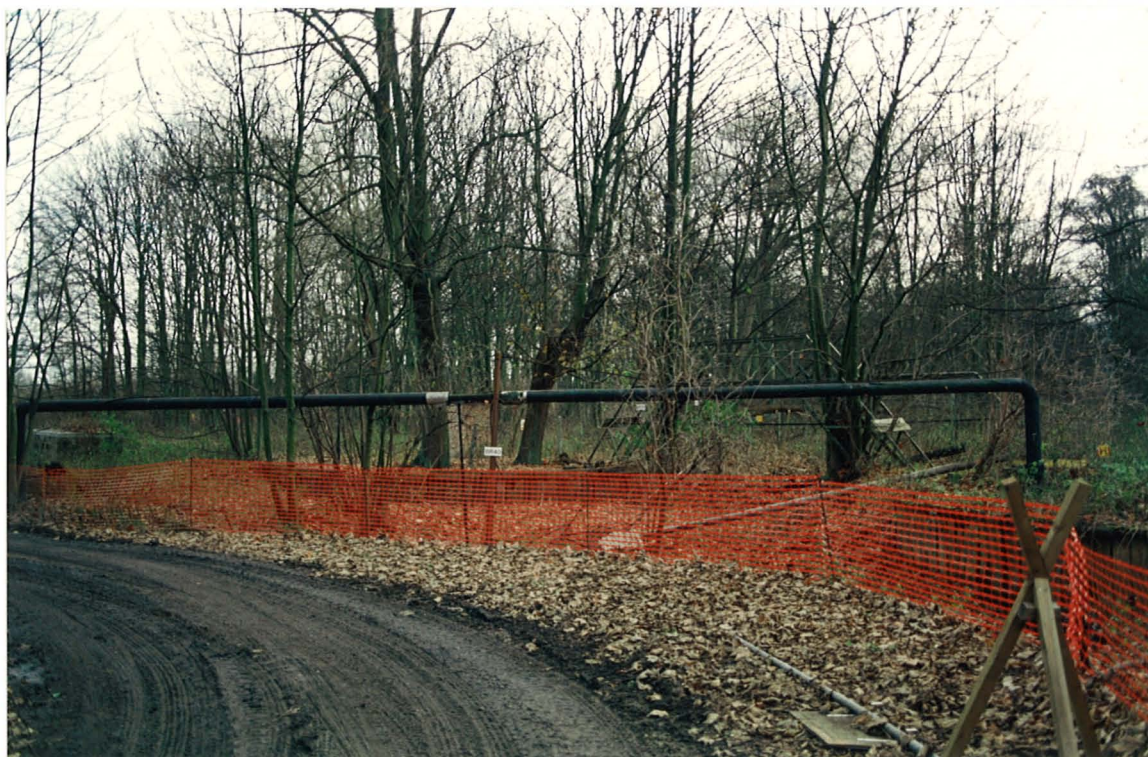
WALTHAM ABBEY RARDE SITE BRIDGE REPORT		
SITE NO.	RCHME NO.	BRIDGE TYPE
BR 40	176	Pipe Bridge
CONSTRUCTION DATE	GRID REF.	INITIAL CONDITION
1940-1950s	TL 37498 01667 37500 01652	Fair
DESCRIPTION and CONDITION		
<p>This is actually a large pipe probably carrying steam which has been shaped to cross the canal allowing access for barges underneath. The pipe is supported by two metal cables attached to the centre of the span and to two tall concrete posts set in either bank. The posts are damaged as are the cables the pipe is at present supported by a later timber pile in the center of the span.</p>		
PHOTO NO.	DIMENSIONS	
WAP93 CP005	L.- 15.80m W.- 0.70m Ht.- 3.15m	
DOCUMENTARY SOURCES		
1993 RCHME <u>Royal Gunpowder Factory Waltham Abbey Report</u> (unpublished)

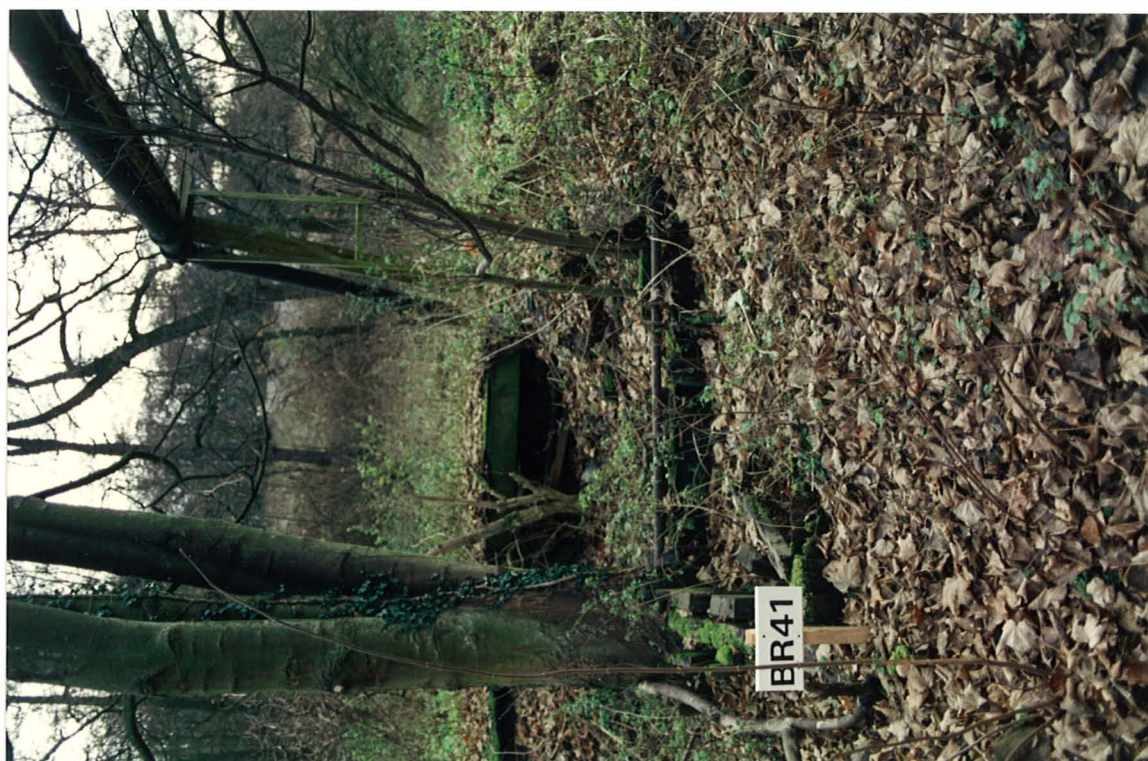
WALTHAM ABBEY RARDE SITE BRIDGE REPORT		
SITE NO.	RCHME NO.	BRIDGE TYPE
BR 41	177	Lifting Footbridge
CONSTRUCTION DATE	GRID REF.	INITIAL CONDITION
pre 1940	TL 37501 01661	Poor
DESCRIPTION and CONDITION		
<p>Remains of a lifting footbridge constructed of a timber box on the north bank (2.5m by 2.15m) with an iron pivot bar. The bridge spanned the canal (4.25m). On the south bank is a concrete landing with two catch plates. Most of the timber is rotten.</p>		
PHOTO NO.	DIMENSIONS	
WAP93 CP007	L.- 6.90m W.- 2.55m	
DOCUMENTARY SOURCES		
1993 RCHME <u>Royal Gunpowder Factory Waltham Abbey Report</u> (unpublished)

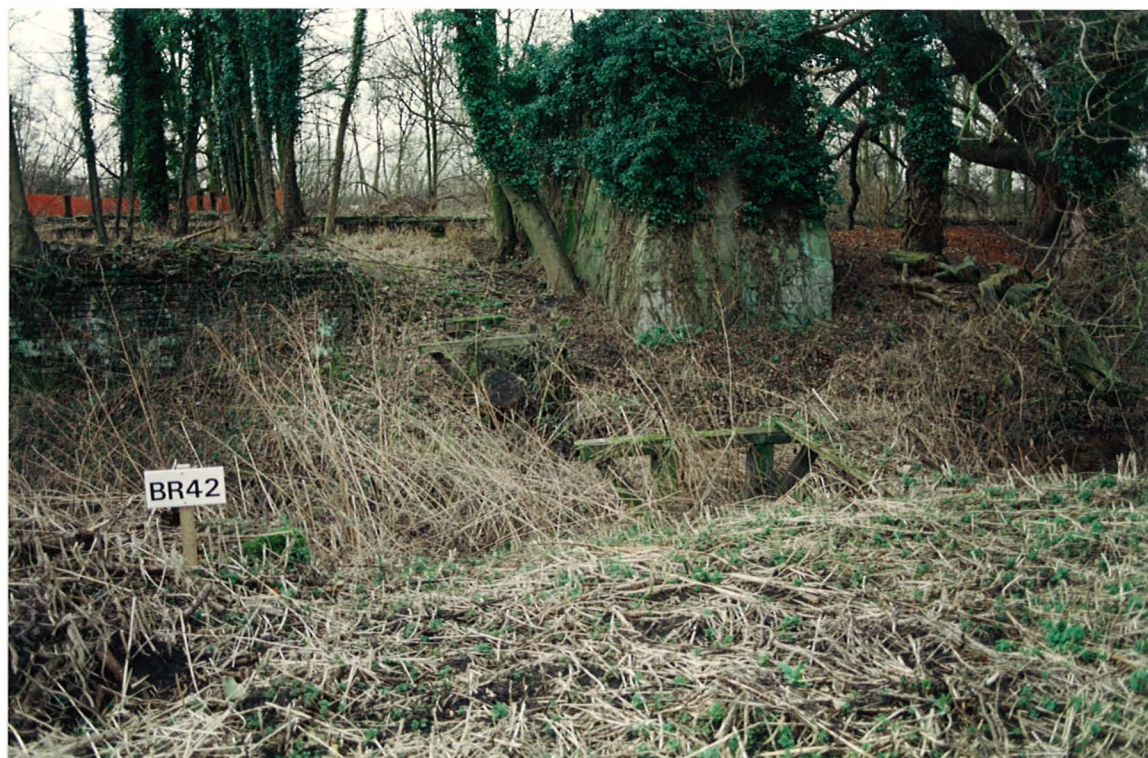
WALTHAM ABBEY RARDE SITE BRIDGE REPORT		
SITE NO.	RCHME NO.	BRIDGE TYPE
BR 42	223	Footbridge
CONSTRUCTION DATE	GRID REF.	INITIAL CONDITION
1880s	TL 37586 01264	Poor
<b>DESCRIPTION and CONDITION</b>		
Only the two supporting timber trestles survive on either side of the canal. Originally carried the path between the dusting house 159 and the shoe room 157.		
PHOTO NO.	DIMENSIONS	
WAP94 CP019	L.- 9.00m W.- 1.80m	
<b>DOCUMENTARY SOURCES</b>		
1993 RCHME <u>Royal Gunpowder Factory Waltham Abbey</u> Report (unpublished)

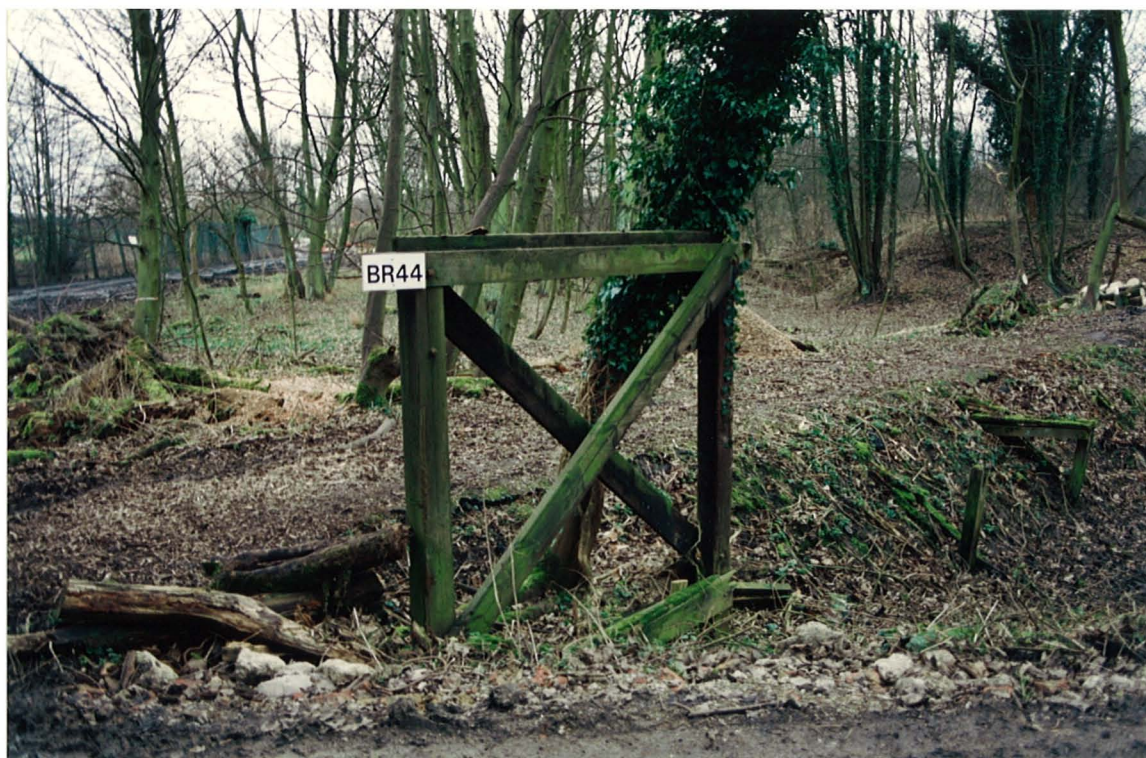
WALTHAM ABBEY RARDE SITE BRIDGE REPORT		
SITE NO.	RCHME NO.	BRIDGE TYPE
BR 44	505	Pipe/ Footbridge
CONSTRUCTION DATE	GRID REF.	INITIAL CONDITION
unknown	TL 37545 02348	Poor/demolished
DESCRIPTION and CONDITION		
Only one timber trestle survives on the west bank of the canal. Actual function unknown.		
PHOTO NO.	DIMENSIONS	
WAP94 CP006	W.- 2.20m	
DOCUMENTARY SOURCES

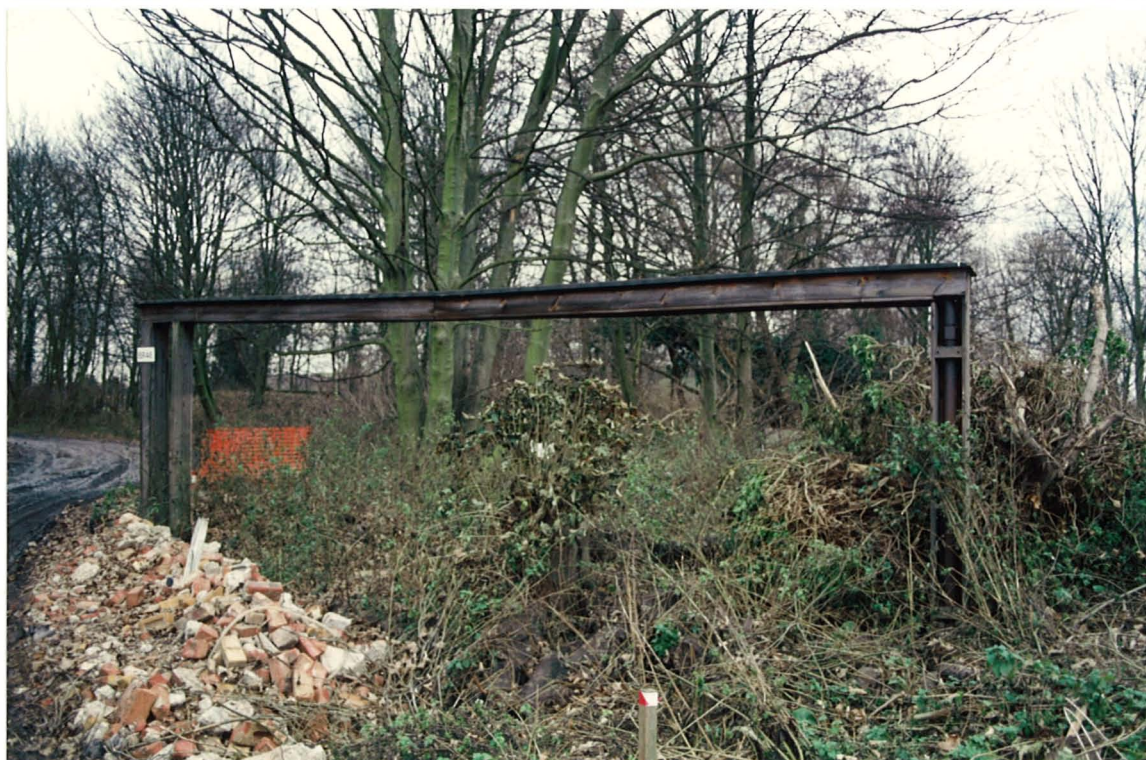
WALTHAM ABBEY RARDE SITE BRIDGE REPORT		
SITE NO.	RCHME NO.	BRIDGE TYPE
BR 46	510	Pipe Bridge
CONSTRUCTION DATE	GRID REF.	INITIAL CONDITION
unknown	TL 37452 02240	Fair
DESCRIPTION and CONDITION		
The bridge consists of a timber box surrounding the pipe(s). Roofing felt caps the structure over the span. The timber and felt is in reasonable condition.		
PHOTO NO.	DIMENSIONS	
WAP93 CP017	L.- 8.70m W.- 0.20m	
DOCUMENTARY SOURCES

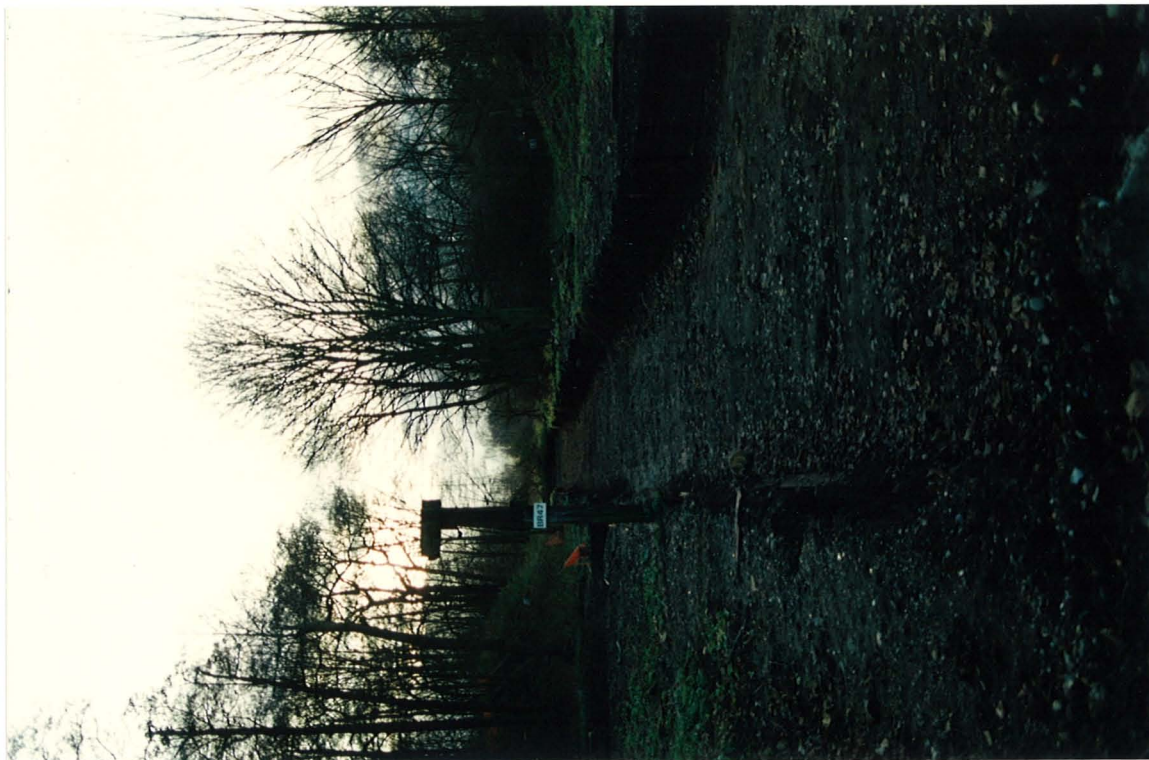
WALTHAM ABBEY RARDE SITE BRIDGE REPORT		
SITE NO.	RCHME NO.	BRIDGE TYPE
BR 47	511	Pipe Bridge
CONSTRUCTION DATE	GRID REF.	INITIAL CONDITION
1890s	TL 37543 021163	Poor(demolished)
DESCRIPTION and CONDITION		
One timber support remains of this bridge which carried the guttering for nitroglycerine from the nitrator E2 to the washing house E3.		
PHOTO NO.	DIMENSIONS	
WAP93 CP040	Not Available	
DOCUMENTARY SOURCES

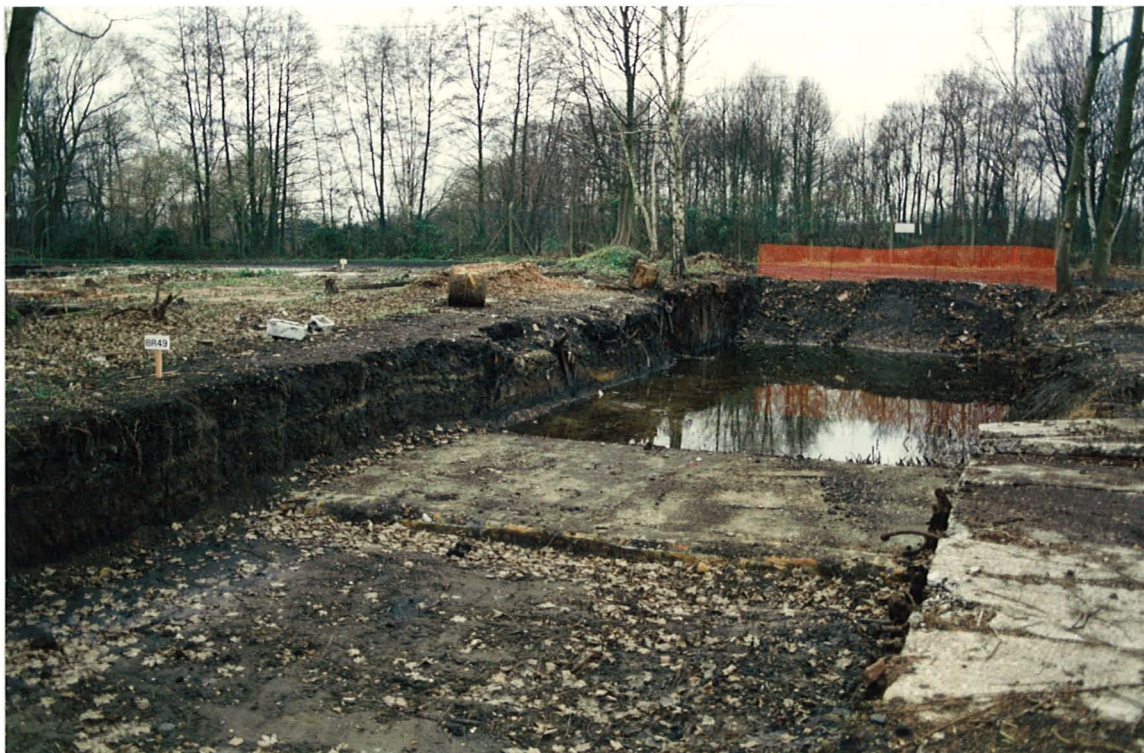
WALTHAM ABBEY RARDE SITE BRIDGE REPORT		
SITE NO.	RCHME NO.	BRIDGE TYPE
BR 49	513	Aqueduct
CONSTRUCTION DATE	GRID REF.	INITIAL CONDITION
pre 1886	TL 37418 01977	Fair
DESCRIPTION and CONDITION		
Subterranean aqueduct/culvert constructed of brick and concrete. Precise construction unknown.		
PHOTO NO.	DIMENSIONS	
WAP93 CP024	L.- unknown W.- 4.00m	
DOCUMENTARY SOURCES

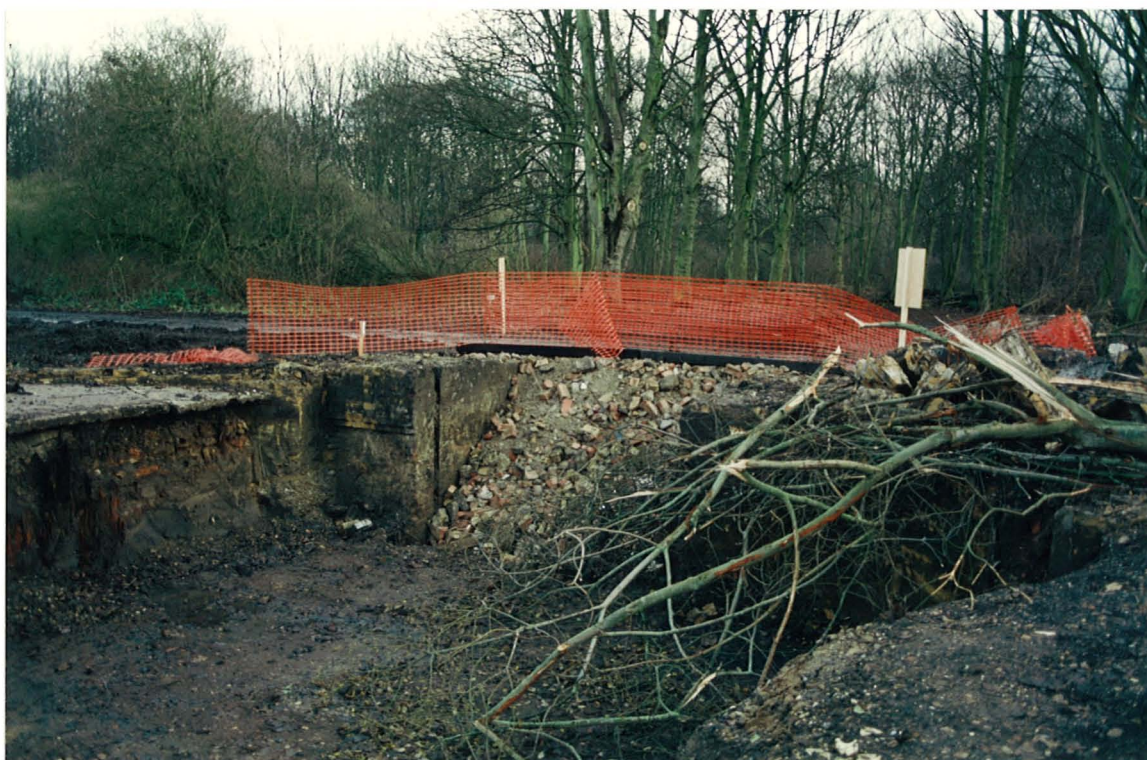
WALTHAM ABBEY RARDE SITE BRIDGE REPORT		
SITE NO.	RCHME NO.	BRIDGE TYPE
BR 50	514	Brick Road Bridge
CONSTRUCTION DATE	GRID REF.	INITIAL CONDITION
1850-86	TL 37455 01976	Poor(partially demolished)
DESCRIPTION and CONDITION		
<p>Yellow brick road bridge in English Bond. The spanning structure is missing but the embankment walls and abutments survive in good condition. Grooves can be observed in the brickwork where it is presumed boards could be fitted to dam up sections of the canal.</p>		
PHOTO NO.	DIMENSIONS	
WAP93 CP044	L.- 3.30m W.- approx 3.00m	
DOCUMENTARY SOURCES

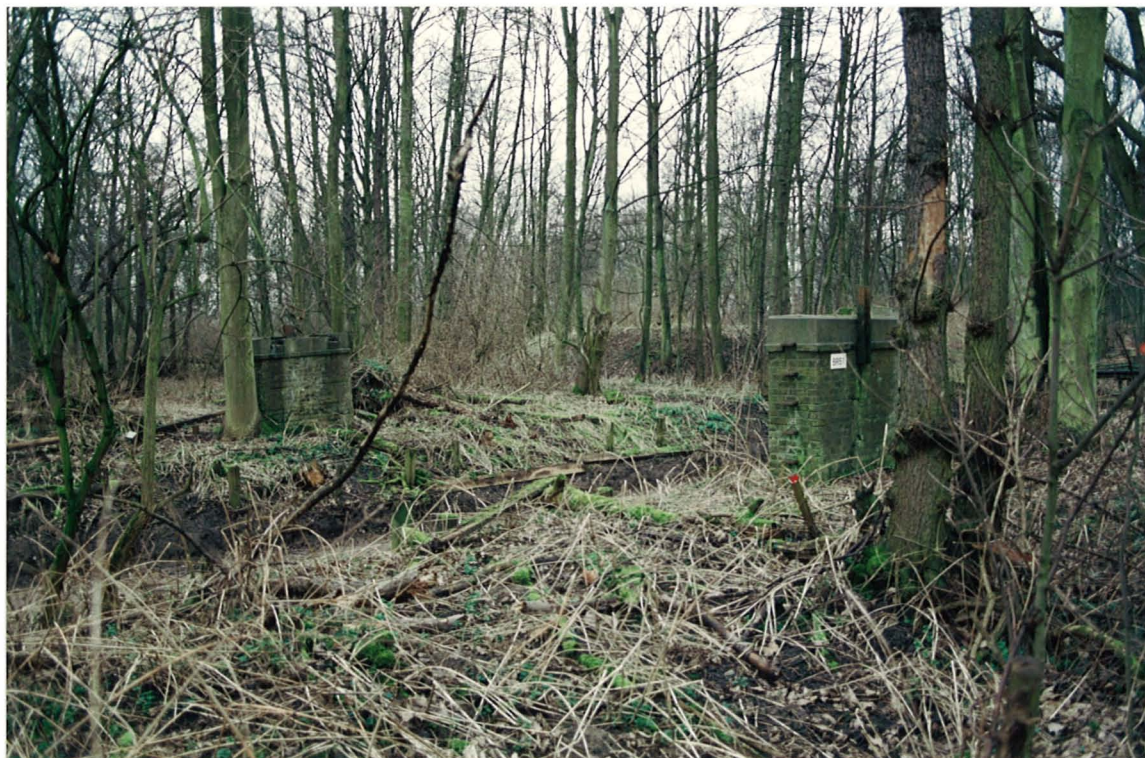
WALTHAM ABBEY RARDE SITE BRIDGE REPORT		
SITE NO.	RCHME NO.	BRIDGE TYPE
BR 51	515	Footbridge/pipe Bridge
CONSTRUCTION DATE	GRID REF.	INITIAL CONDITION
1940?	TL 37665 01976	Demolished
DESCRIPTION and CONDITION		
<p>Only two brick piers remain on either side of a disused canal. Built of yellow stocks in Flemish Bond with concrete capping. Steel loop steps are set into the brickwork on both piers. Pipe supports have been bolted on at a later date.</p>		
PHOTO NO.	DIMENSIONS	
WAP94 CP002	L.- 12.00m W.- 1.40m	
DOCUMENTARY SOURCES

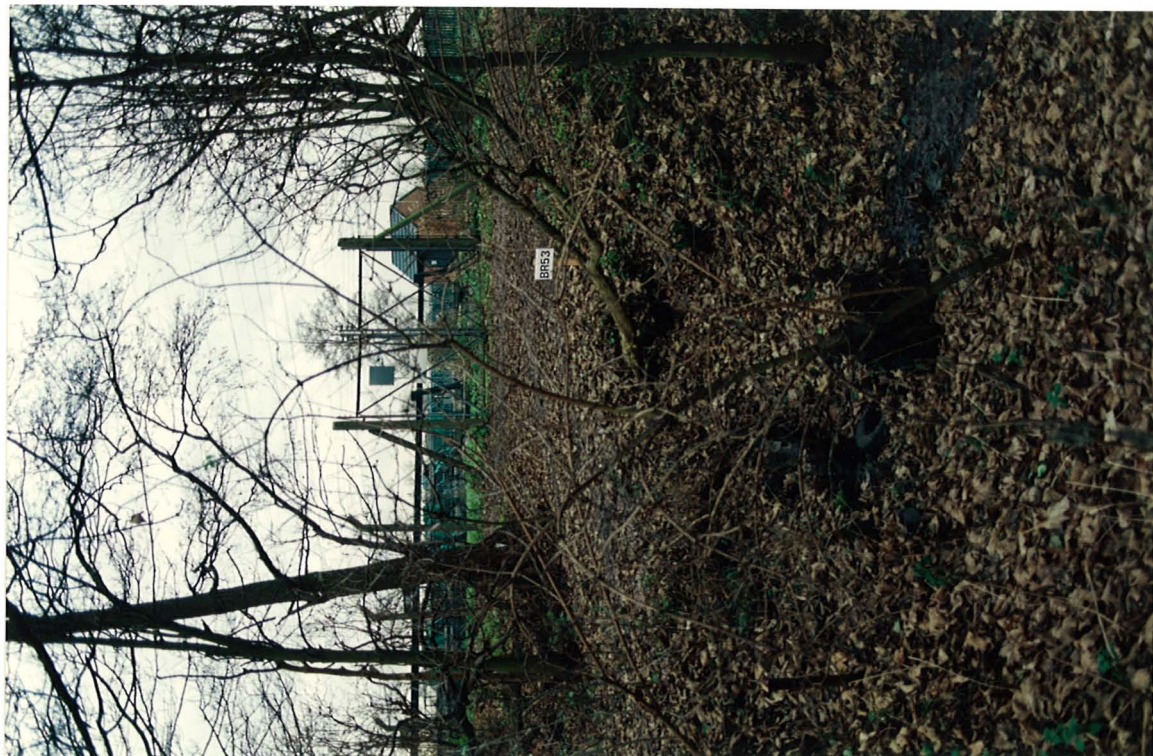
WALTHAM ABBEY RARDE SITE BRIDGE REPORT		
SITE NO.	RCHME NO.	BRIDGE TYPE
BR 53	517	Pipe culvert
CONSTRUCTION DATE	GRID REF.	INITIAL CONDITION
unknown	TL 37435 01825	Fair
DESCRIPTION and CONDITION		
Very crude construction, one concrete pipe surrounded by unmortared brickwork. Seems to be in a stable condition.		
PHOTO NO.	DIMENSIONS	
WAP93 CP002	L.- 3.20m W.- 2.90m pipe dia. 0.60m	
DOCUMENTARY SOURCES

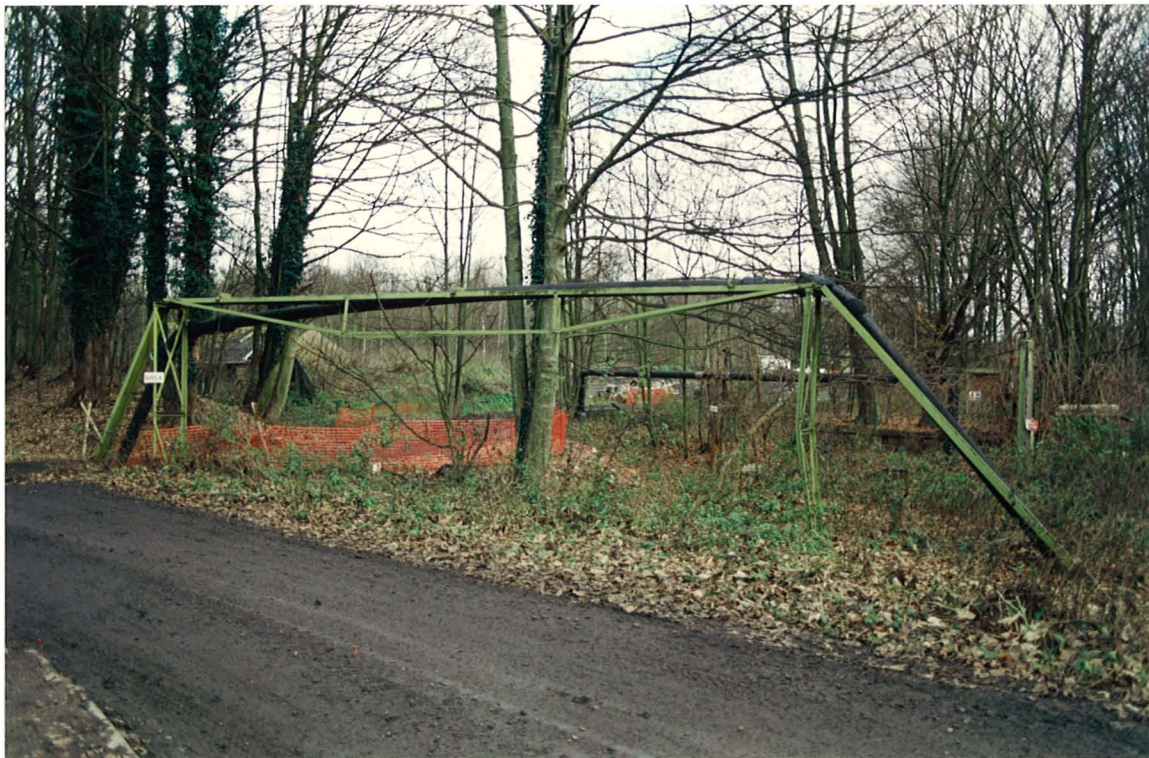
WALTHAM ABBEY RARDE SITE BRIDGE REPORT		
SITE NO.	RCHME NO.	BRIDGE TYPE
BR 54	518	Pipe Bridge
CONSTRUCTION DATE	GRID REF.	INITIAL CONDITION
pre 1940	TL 37497 01660	Fair
DESCRIPTION and CONDITION		
Constructed of an angle iron frame with flat cross pieces. This supports a narrow timber deck together with a large steam pipe to one side.		
PHOTO NO.	DIMENSIONS	
WAP93 CP006	L.- 15.70m W.- 0.80m	
DOCUMENTARY SOURCES

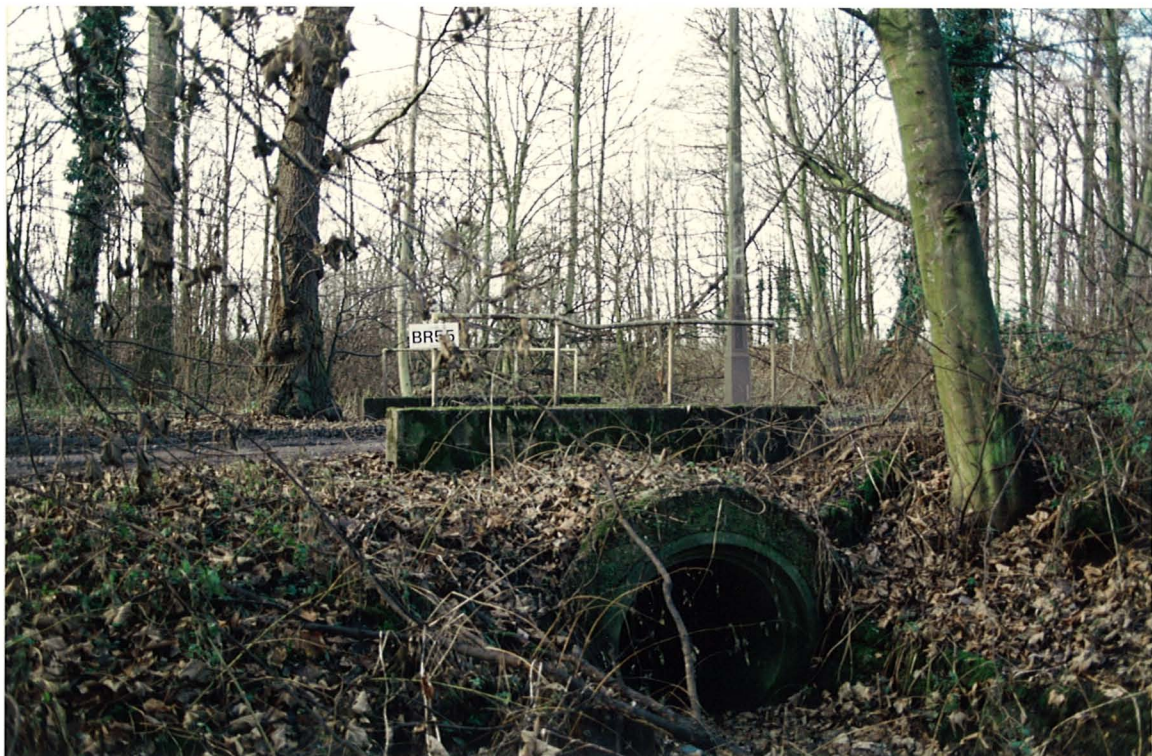
WALTHAM ABBEY RARDE SITE BRIDGE REPORT		
SITE NO.	RCHME NO.	BRIDGE TYPE
BR 55	519	Pipe Culvert
CONSTRUCTION DATE	GRID REF.	INITIAL CONDITION
unknown	TL 37472 01586	Good/Fair
DESCRIPTION and CONDITION		
<p>Constructed of a large concrete pipe encased in concrete. Two side capping pieces either side of the road in which are set hand rails. The banks are retained by concrete sand bags.</p>		
PHOTO NO.	DIMENSIONS	
WAP93 CP009	L.- 12.30m W.- 3.10m pipe dia 1.10m	
DOCUMENTARY SOURCES

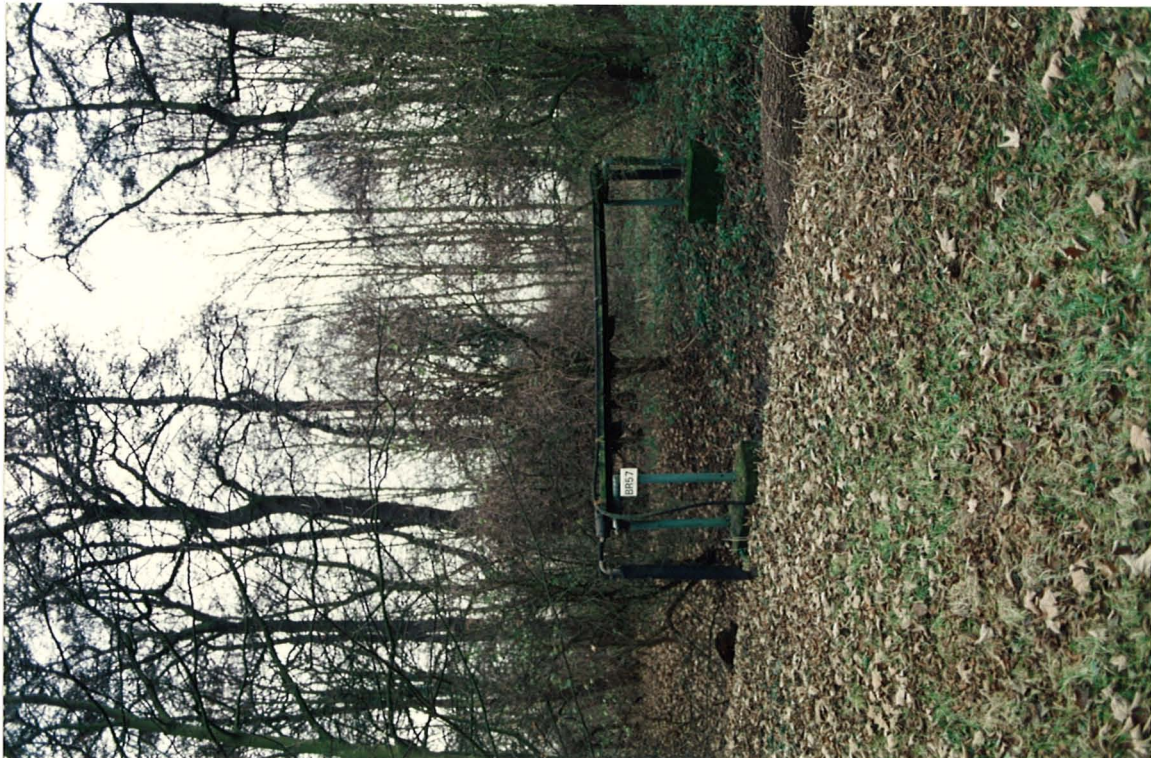
WALTHAM ABBEY RARDE SITE BRIDGE REPORT		
SITE NO.	RCHME NO.	BRIDGE TYPE
BR 57	521	Pipe Bridge
CONSTRUCTION DATE	GRID REF.	INITIAL CONDITION
post 1947	TL 37550 01340	Fair(disused)
DESCRIPTION and CONDITION		
<p>This bridge is constructed for at least four pipes. Built of two steel tube stanchions which support a metal pipe held on by "U" bolts. This pipe has four hooks suspended beneath it and has disused pipes attached to either side.</p>		
PHOTO NO.	DIMENSIONS	
WAP93 CP011	L.- 7.15m W.- 0.85m	
DOCUMENTARY SOURCES

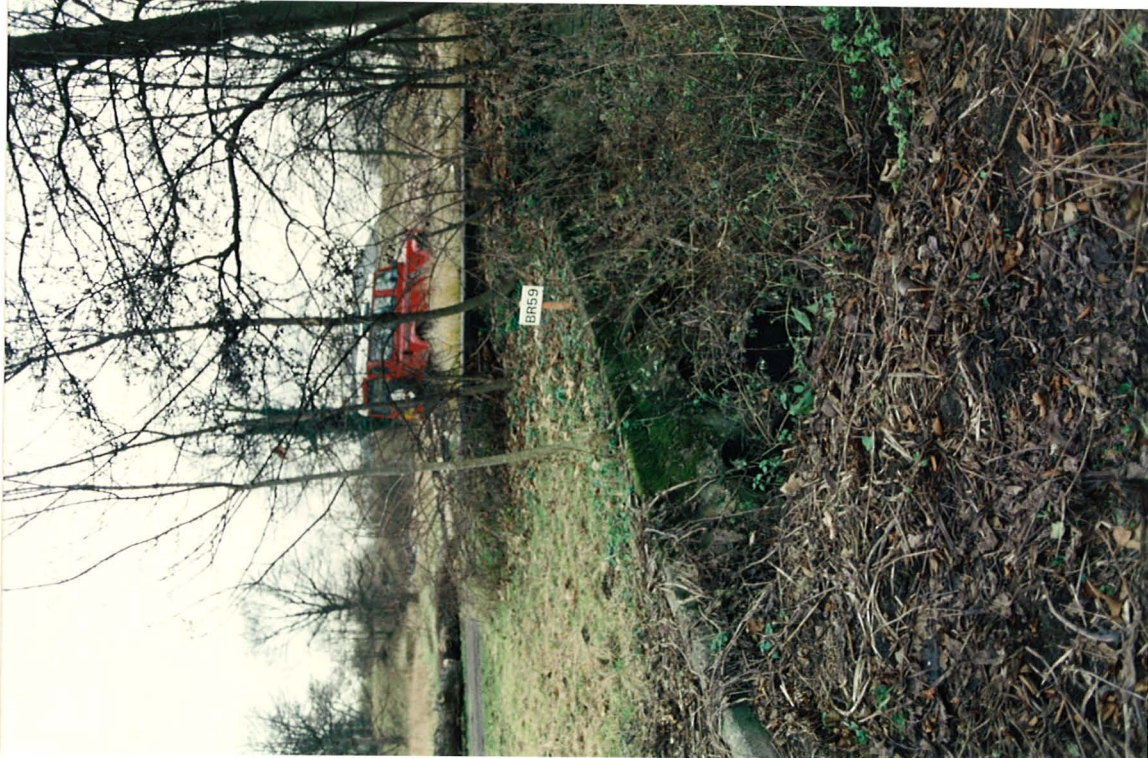
WALTHAM ABBEY RARDE SITE BRIDGE REPORT		
SITE NO.	RCHME NO.	BRIDGE TYPE
BR 59	523	Pipe Culvert
CONSTRUCTION DATE	GRID REF.	INITIAL CONDITION
between 1955 and 1965	TL 37627 01162	Good/Fair
DESCRIPTION and CONDITION		
<p>Constructed of six concrete pipes dia. 0.60m laid next to each other across the canal. Head walls are made of concrete. Although the canal has silted up the structure appears to be sound.</p>		
PHOTO NO.	DIMENSIONS	
WAP93 CP012	L.- 19.80m W.- 7.50m pipe dia 0.60m	
DOCUMENTARY SOURCES

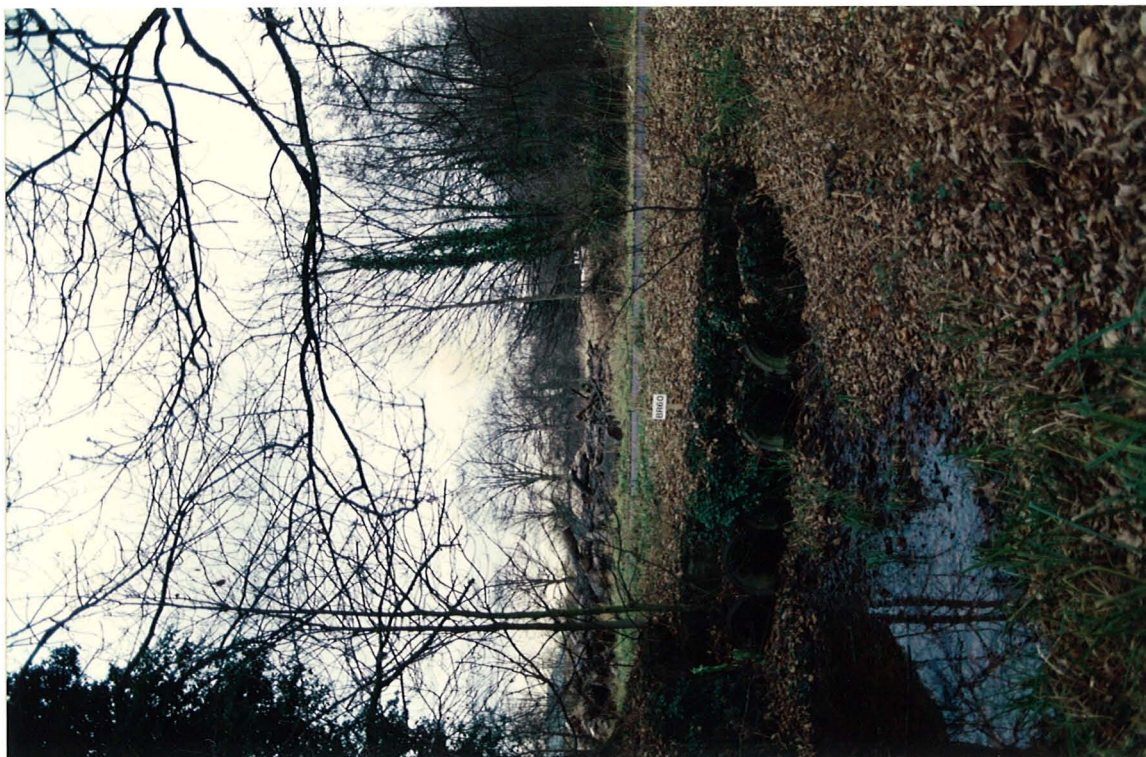
WALTHAM ABBEY RARDE SITE BRIDGE REPORT		
SITE NO.	RCHME NO.	BRIDGE TYPE
BR 60	524	Pipe Culvert
CONSTRUCTION DATE	GRID REF.	INITIAL CONDITION
1957?	TL 37660 01051	Good/Fair
DESCRIPTION and CONDITION		
Similar in design to BR 59 with six pipes and concrete head walls, the pipe are slightly larger with a 0.90m diameter.		
PHOTO NO.	DIMENSIONS	
WAP93 CP014	L.- 16.00m W.- 6.00m pipe dia 0.90m	
DOCUMENTARY SOURCES

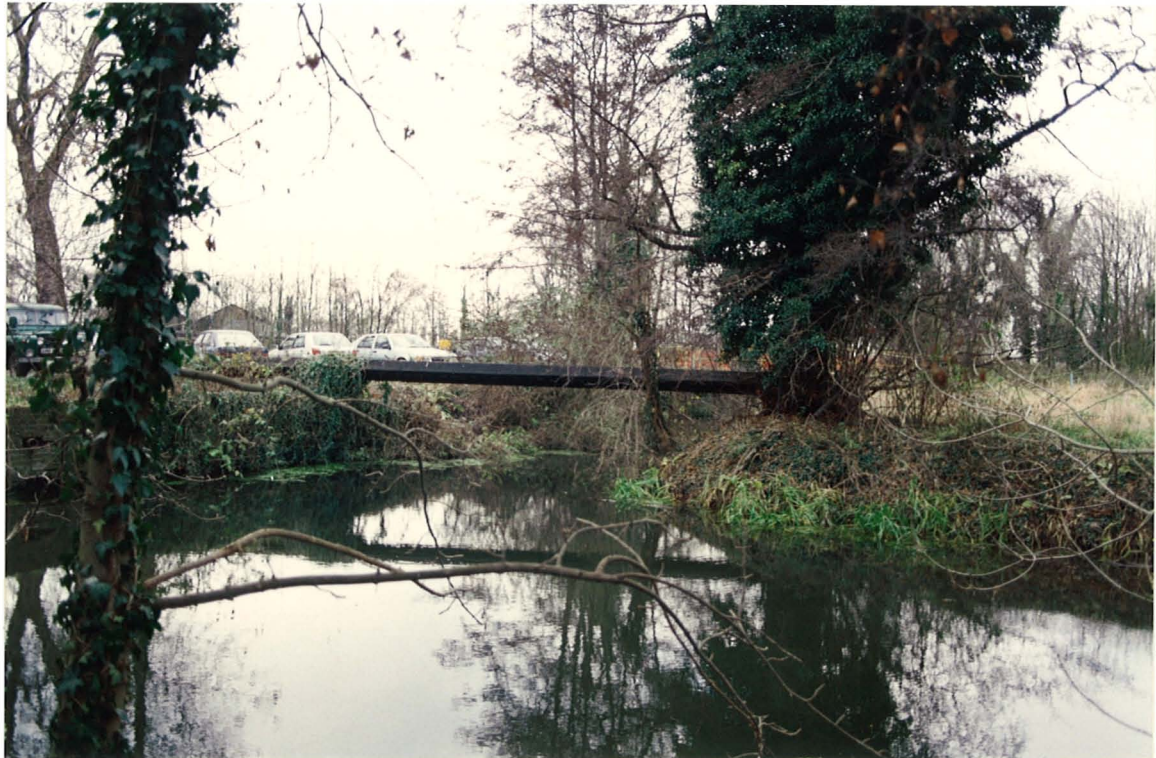
WALTHAM ABBEY RARDE SITE BRIDGE REPORT		
SITE NO.	RCHME NO.	BRIDGE TYPE
BR 61	525	Pipe Bridge
CONSTRUCTION DATE	GRID REF.	INITIAL CONDITION
post 1947	TL 37710 00882	Fair
<b>DESCRIPTION and CONDITION</b>		
<p>This structure is basically a timber and roofing felt cover for a pipe crossing the canal at low level. The timber of the box section cover is in fair condition, there are small portions of the felt missing.</p>		
PHOTO NO.	DIMENSIONS	
WAP93 CP020	L.- 12.50m W.- 0.30m	
<b>DOCUMENTARY SOURCES</b>

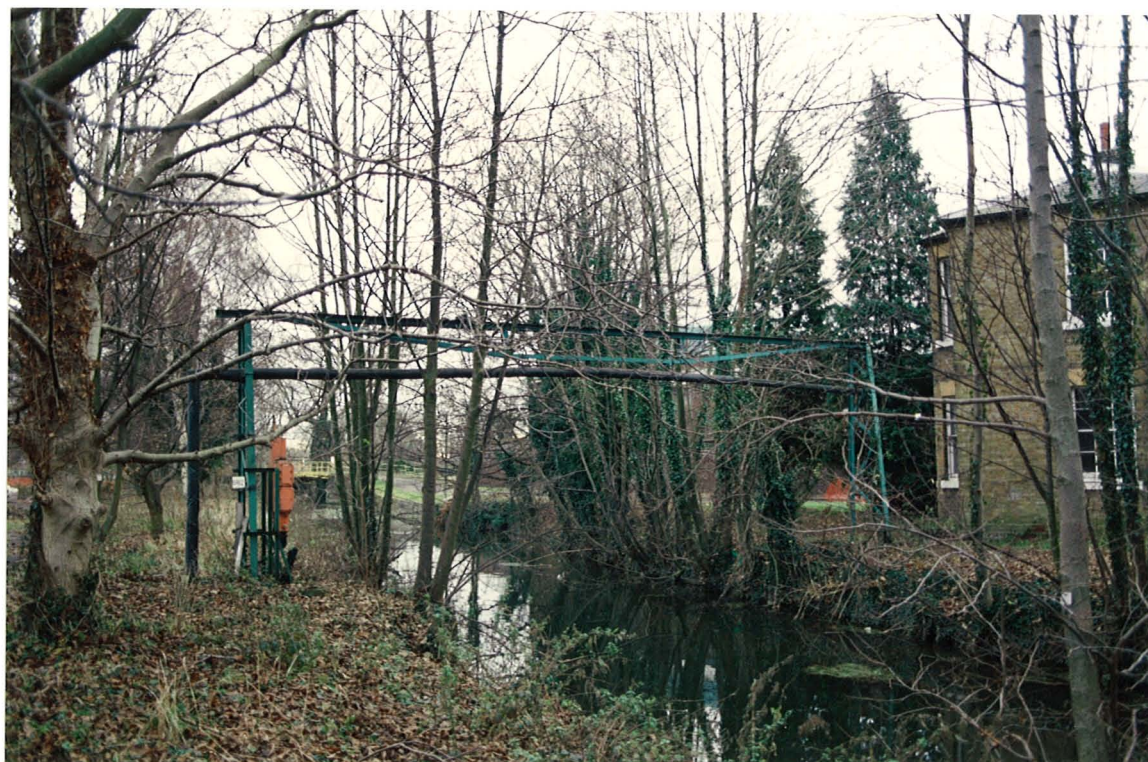
WALTHAM ABBEY RARDE SITE BRIDGE REPORT		
SITE NO.	RCHME NO.	BRIDGE TYPE
BR 62	526	Pipe Bridge
CONSTRUCTION DATE	GRID REF.	INITIAL CONDITION
pre 1945	TL 37725 00858	Fair/Good
<b>DESCRIPTION and CONDITION</b>		
Pipe bridge constructed of an angle iron frame which supports the pipe. Structure appears sound with little corrosion.		
PHOTO NO.	DIMENSIONS	
WAP93 CP018 WAP94 CP038	L.- 12.40m W.- 1.00m	
<b>DOCUMENTARY SOURCES</b>

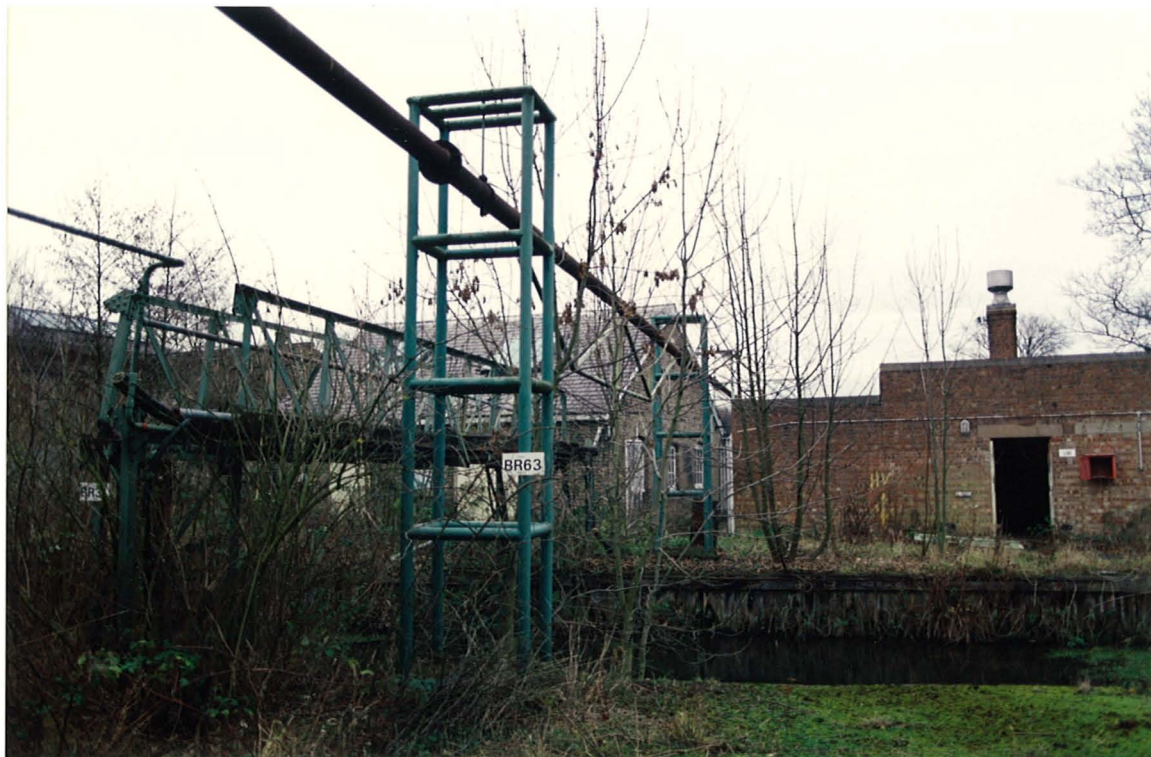
WALTHAM ABBEY RARDE SITE BRIDGE REPORT		
SITE NO.	RCHME NO.	BRIDGE TYPE
BR 63	527	Pipe Bridge
CONSTRUCTION DATE	GRID REF.	INITIAL CONDITION
1960s?	TL 37767 01022	Good
DESCRIPTION and CONDITION		
Modern steam carrier constructed of two box shaped steel tube stanchions. Pipe is suspended between, extra welded braces have been added to the pipe at the span.		
PHOTO NO.	DIMENSIONS	
WAP93 CP021	Dims of stanchions 0.65m by 0.95m	
DOCUMENTARY SOURCES

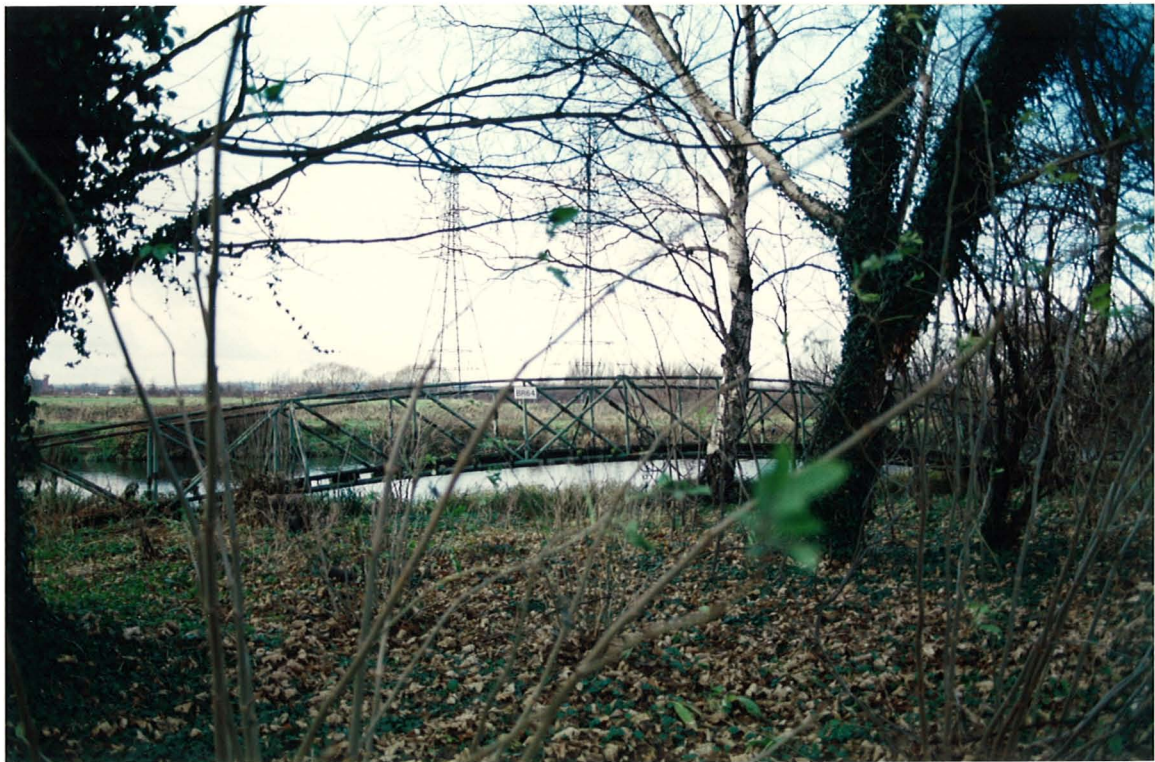
WALTHAM ABBEY RARDE SITE BRIDGE REPORT		
SITE NO.	RCHME NO.	BRIDGE TYPE
BR 64	528	Footbridge
CONSTRUCTION DATE	GRID REF.	INITIAL CONDITION
1940-50s	TL 37592 00852	Fair
<b>DESCRIPTION and CONDITION</b>		
<p>A steel tube formed arch bridge with a timber deck which originally spanned the Horsemill Stream. It now rests on the eastern bank of the sme stream just outside the preimeter fence. The deck may need to be replaced but the frame appears undamaged.</p>		
PHOTO NO.	DIMENSIONS	
WAP93 CP045	Not Available	
<b>DOCUMENTARY SOURCES</b>

WALTHAM ABBEY RARDE SITE BRIDGE REPORT		
SITE NO.	RCHME NO.	BRIDGE TYPE
BR 64	528	Footbridge
CONSTRUCTION DATE	GRID REF.	INITIAL CONDITION
1		
<p><b>BRIDGE 64-</b></p> <p>Disposed of with the Sale of the land to Wilken. Confirmed with Wilken that WAPSEM Make no claim on this 11/3/00.</p> <p>Checked with S. Chaddock on historic value, there is none.</p> <p><i>S. Leonard.</i></p>		
A steel tu Horsemill the preime undamage		
WAP93 C

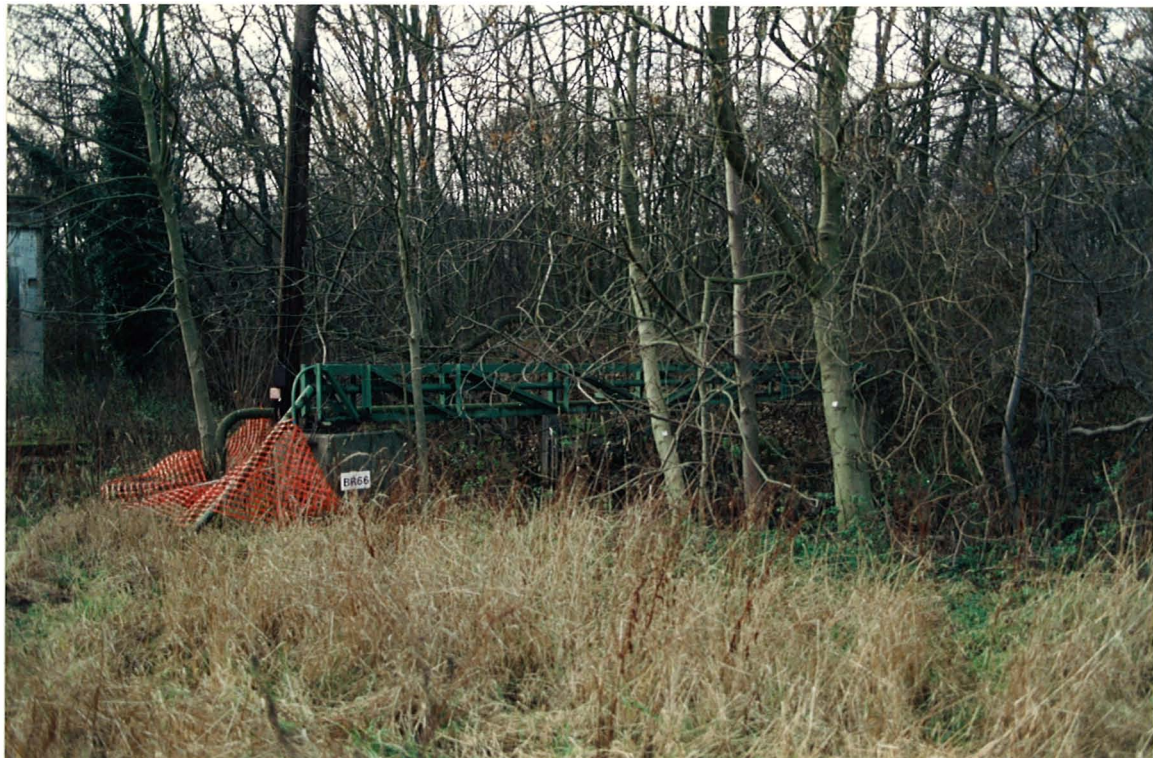
WALTHAM ABBEY RARDE SITE BRIDGE REPORT		
SITE NO.	RCHME NO.	BRIDGE TYPE
BR 66	531	Pipe Bridge
CONSTRUCTION DATE	GRID REF.	INITIAL CONDITION
post 1947	TL 37705 01490	Fair
DESCRIPTION and CONDITION		
Built of an angle iron supporting frame with a box section, held up by concrete piers. The piers and the frame seem to be in good condition.		
PHOTO NO.	DIMENSIONS	
WAP93 CP026	L.- 15.00m W.- 0.45m	
DOCUMENTARY SOURCES

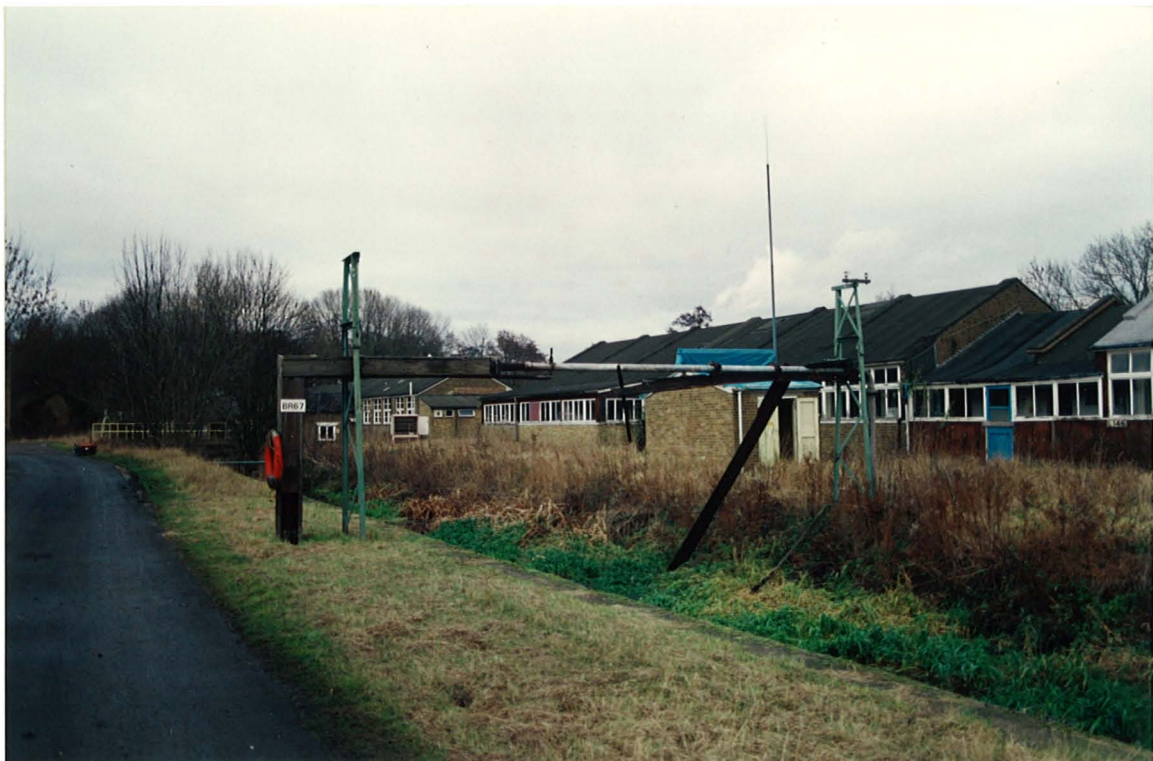
WALTHAM ABBEY RARDE SITE BRIDGE REPORT		
SITE NO.	RCHME NO.	BRIDGE TYPE
BR 67	532	Pipe Bridge
CONSTRUCTION DATE	GRID REF.	INITIAL CONDITION
post 1947	TL 37700 01343	Fair/ Poor
DESCRIPTION and CONDITION		
Two angle iron framed stanchions support a delapidated timber box housing. Carried one pipe and telegraph wires.		
PHOTO NO.	DIMENSIONS	
WAP93 CP025	L.- 6.80m W.- 0.75m	
DOCUMENTARY SOURCES

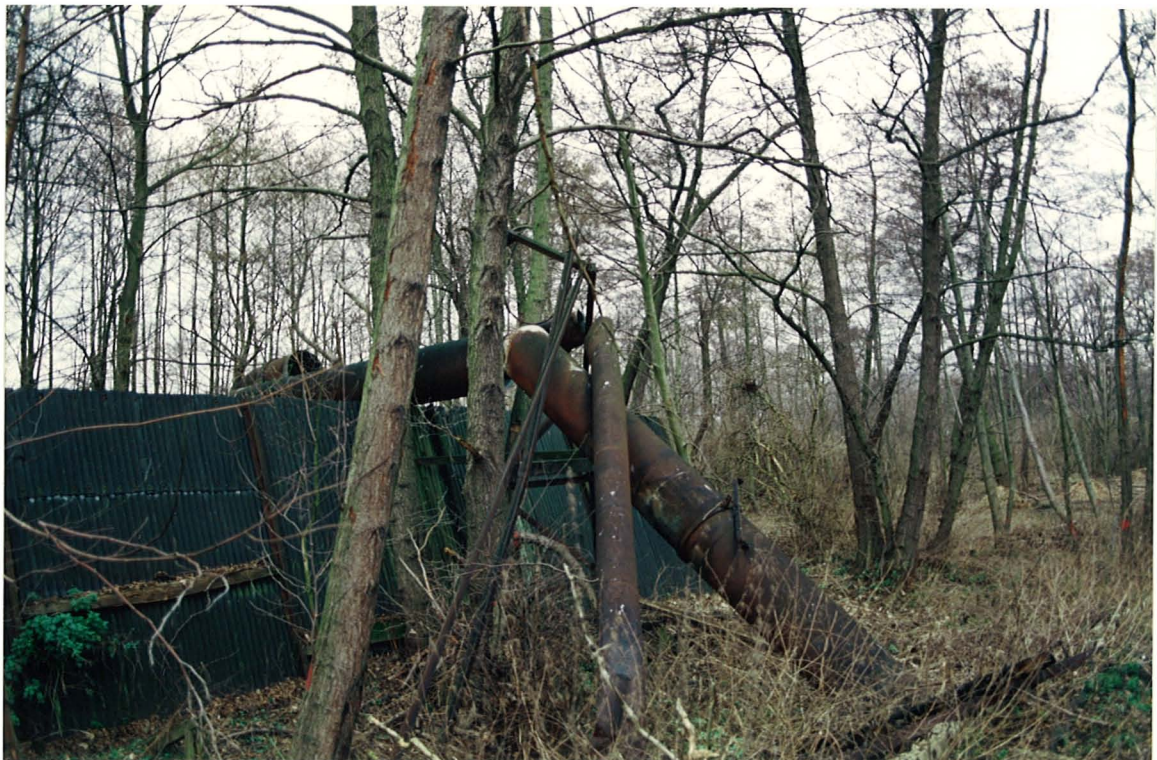
WALTHAM ABBEY RARDE SITE BRIDGE REPORT		
SITE NO.	RCHME NO.	BRIDGE TYPE
BR 69	556	Pipe Bridge
CONSTRUTION DATE	GRID REF.	INITIAL CONDITION
1936	TL 37442 02314	Poor
DESCRIPTION and CONDITION		
<p>The bridge consists of three supports carrying large steam and air pipes over the canal in front of the Quinan Stove. Supports are steel angles the pipes are galvanized steel. The complex was recently burnt out as part of the decontamination process.</p>		
PHOTO NO.	DIMENSIONS	
WAP94 CP001	Approx L. - 11.00m W. - 2.20m	
DOCUMENTARY SOURCES
