Waltham Abbey Royal Gunpowder Factory
(Former RARDE North Site)

Investigation of the Interfaces Between
Filled Canals and Open Waterways

February 1994

Adam Ford
Consultant Archaeologist

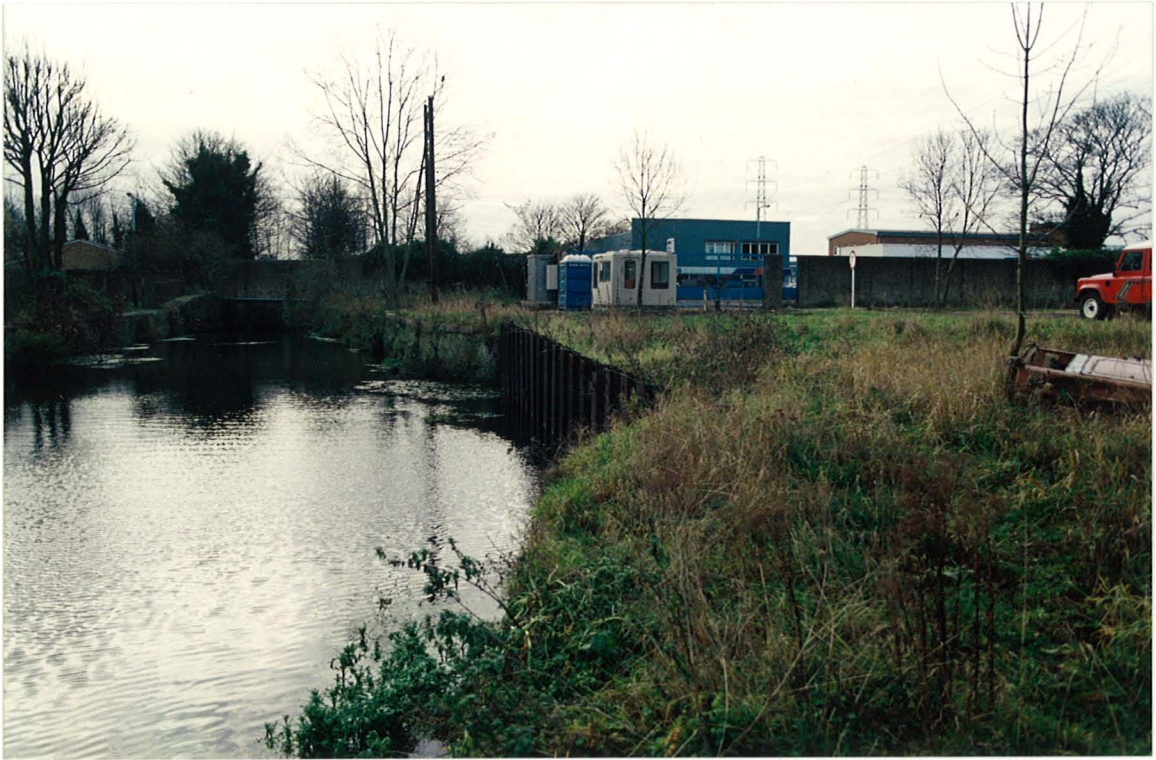
Canal Exit 1

1 Canal RCHM 302**NGR TL 37640 00614**

The canal was constructed before 1783 and linked Horsemill and Millhead Streams. The eastern end has been dammed with steel sheet piles and the western end is approximately 85m from the new line of the Horsemill Stream. An area of reclaimed land lies in between. The canal was filled between 1974 and 1977. The canal has recently been excavated to remove the fill.

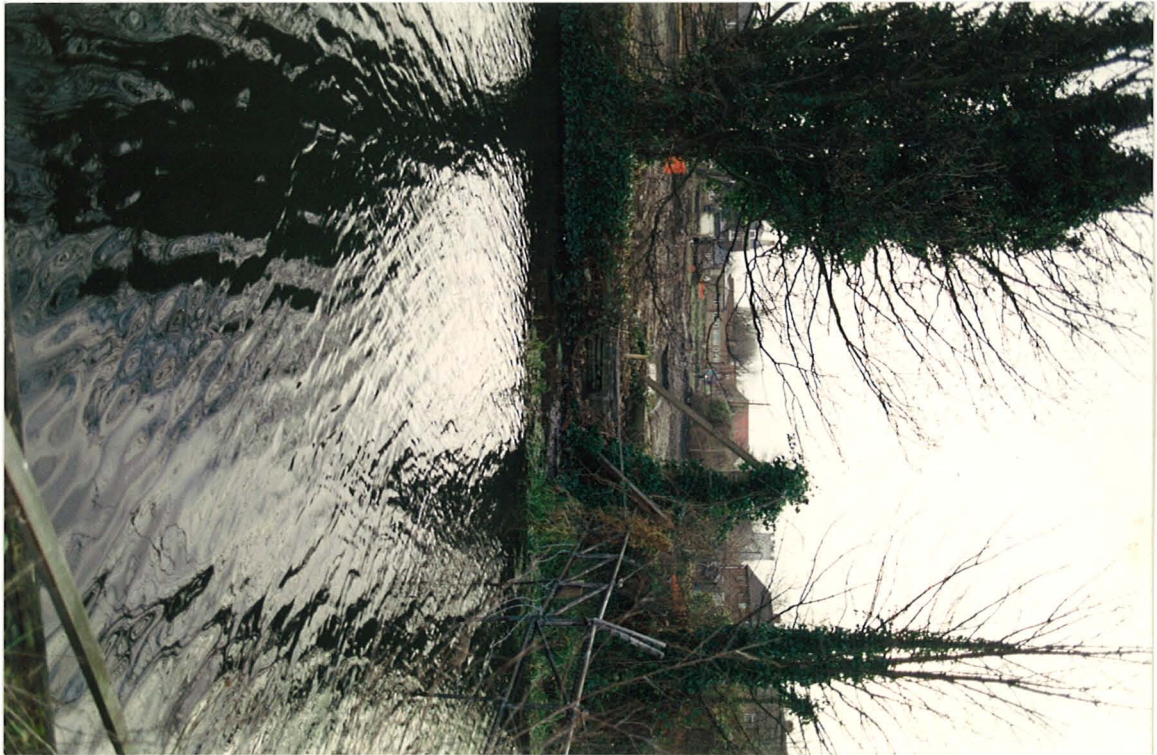
Canal Exit 2

2 Ditch/Leat RCHM 500**NGR TL 37712 00807**

This narrow drainage ditch first appears on maps in 1827 but was probably excavated before that. It is unknown when it was filled, possibly the first half of this century. The western end has a concrete retaining wall which forms part of the bank of Millhead Stream. To the east the leat joins another recently excavated leat in area P. The vertical extent of the concrete is unknown but its condition appears poor.

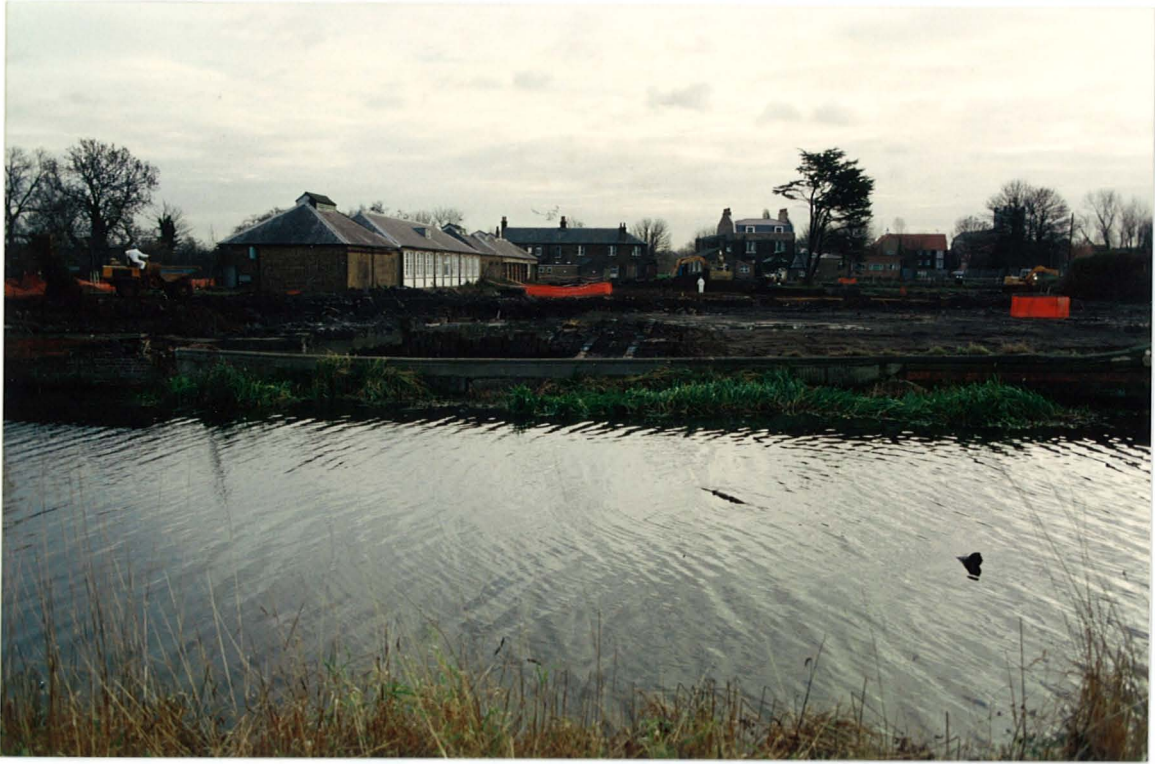
Canal Exit 3

3 Canal/Basin RCHM 501**NGR TL 37725 00860**

The canal was constructed between 1801 and 1827 and possibly linked Millhead Stream and the Old River Lea. By 1865 most of the canal had been filled leaving a short stretch at the Millhead end serving the store buildings to the west of the Administration Block A230 - 234. By 1886 it was shortened again and the mouth was widened to form a basin serving the store buildings and now a shipwrights shop on the south bank.

This basin survived up to the end of the Second World War. A concrete revetment wall was built over the mouth but this does not extend more than a metre down where it is founded on brick rubble. The position of the eastern opening, if it existed has not been located.

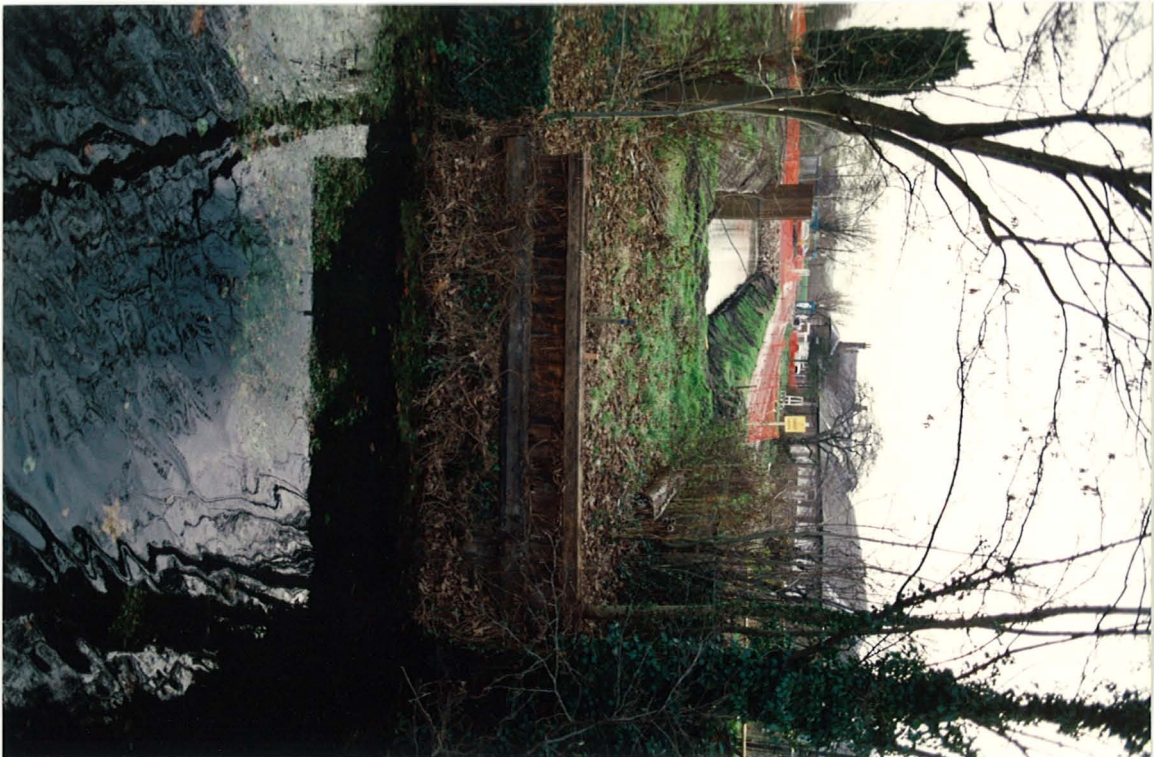
Canal Exit 4

4 Canal RCHM 356**NGR TL 37735 00882**

The canal was constructed between 1801 and 1806. It originally formed a link between Middle Stream and the narrow perimeter ditch which ran along the eastern side of the site. By 1827 it extended eastward to link Middle Stream at Flagstaff Bridge with the Old River Lea opposite the Powdermill Lane Gate. The Last 20m was culverted to allow road access to the Lodge A221.

The canal was filled between 1927 and the beginning of the Second World War with demolition debris and ash/clinker possibly from the near by Power House A210.

At the western end there is a timber retaining wall made from railway sleepers set vertically. Although they appear to be in a fair condition the vertical extent is unknown. To the east a small culvert pipe was uncovered during recent excavations and the possible remains of the grill over the outflow was discovered on the banks of the Old River Lea.

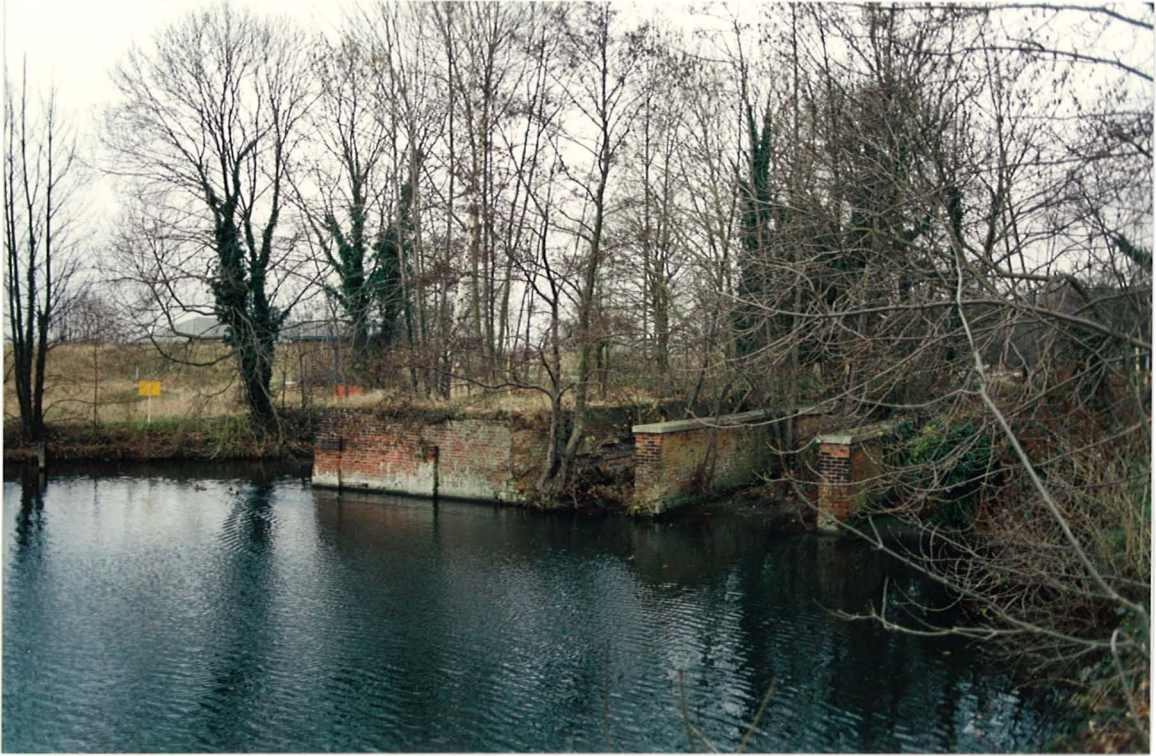
Canal Exit 5

5 Sluices RCHM 135**NGR TL 37650 00994**

The sluices were constructed in the late 18th early 19th Centuries, although the existing features may date to a rebuild in the mid 19th Century. They were constructed to control the water level of the elevated Millhead Stream and to provide foundations for the two Stamp

Mills. The Millhead Stream or canal was filled sometime after 1956 probably with the remains of the gunpowder mills which sat on each bank.

The fill can be seen tumbling out of the sluices into Hoppit Pool. There are no retaining structures.

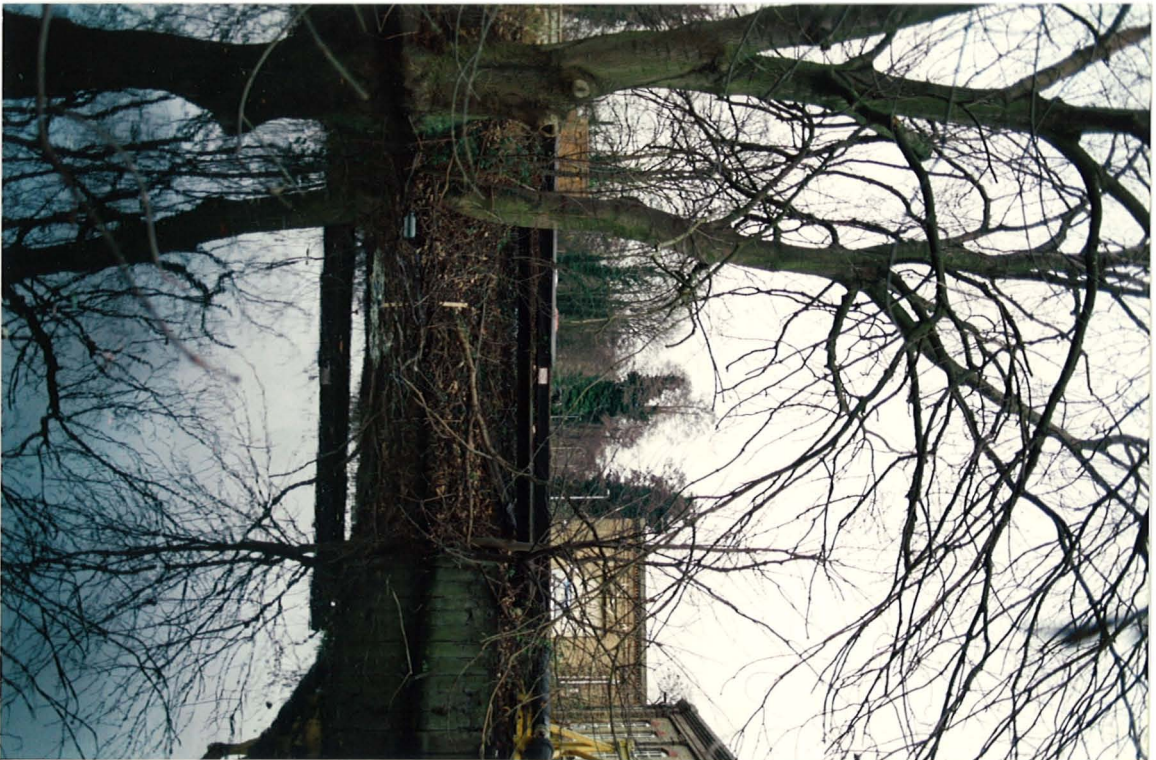
Canal Exit 6

6 Drain/Leat RCHM 299

NGR TL 37420 01961, 37714 00978

This narrow leat was constructed between 1806 and 1827 and ran parallel with Long Walk up to L105. The northern third remains as a dry ditch. In the lower section a slight scarp is the only indication of its position. This lower section may have been filled by the end of the First World War. No damming structure was found where the leat joins Middle Stream.

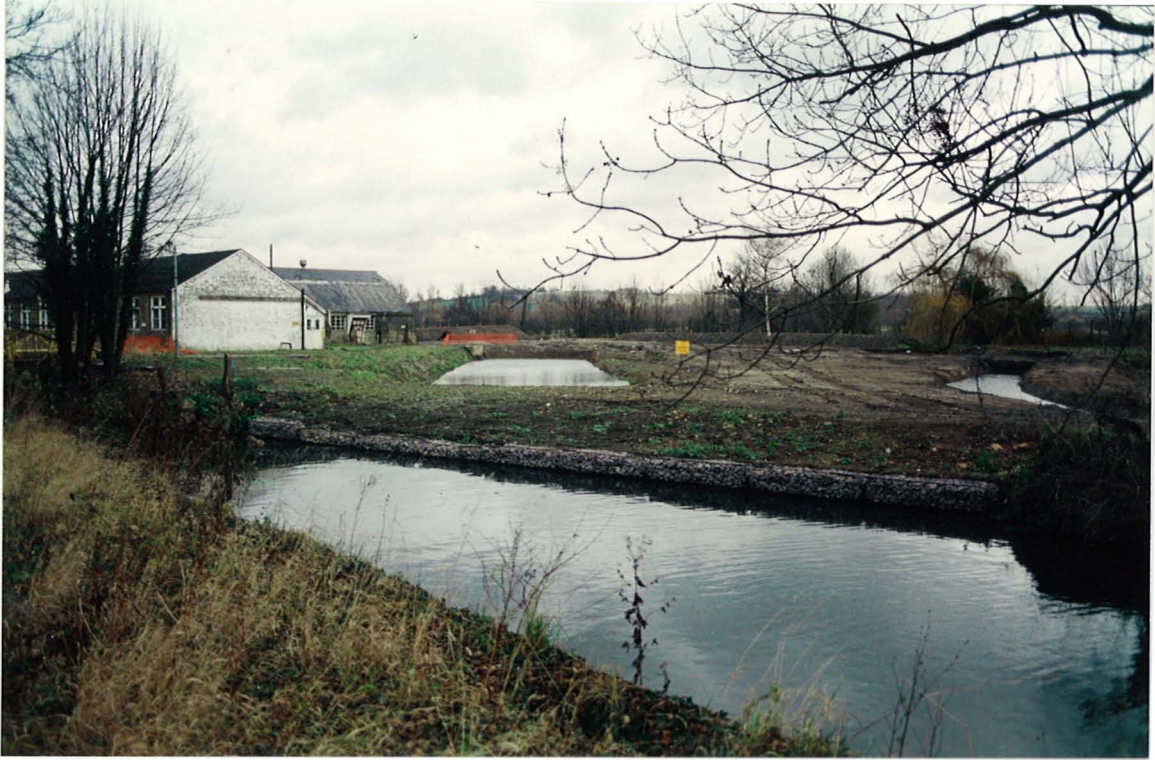
Canal Exit 7

7 Canal RCHM 278

NGR TL 37810 01084

This branch canal was constructed between 1820 and 1830 and served the Charcoal Cylinder House and wood stacking yard and later the Gas Works and boat repair shop. The canal was filled in the late 1940s, it was re-excavated in 1993 and the end was dammed with rock filled gabbions.

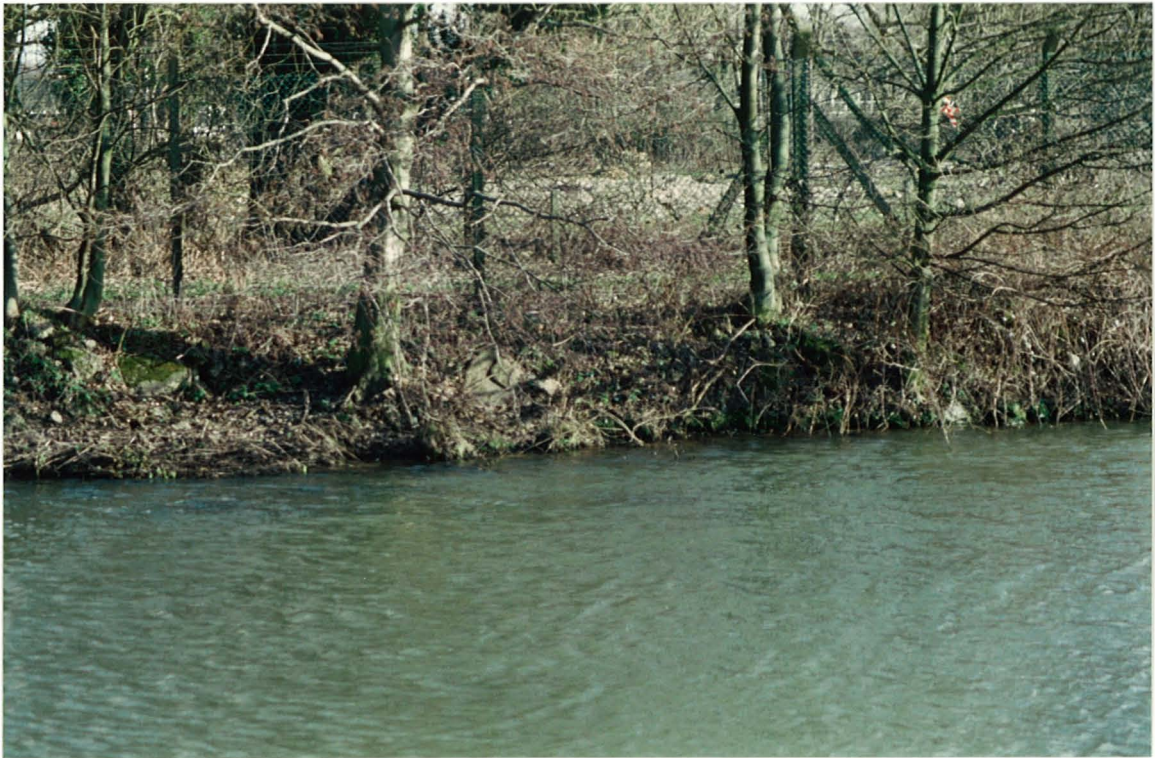
Canal Exit 8

8 Tail Race/Canal RCHM 301

NGR TL 37507 01200, 27588 01212, 37544 00988

This tail race, at a lower level to Millhead, served to take the water away from the mill races to Hoppit pool. The waterway was constructed before 1783, probably in the late 17th Century and was filled in the late 1940s early 1950s. there are no retaining features either at the sluices already described or at the intersection with Horsemill Stream.

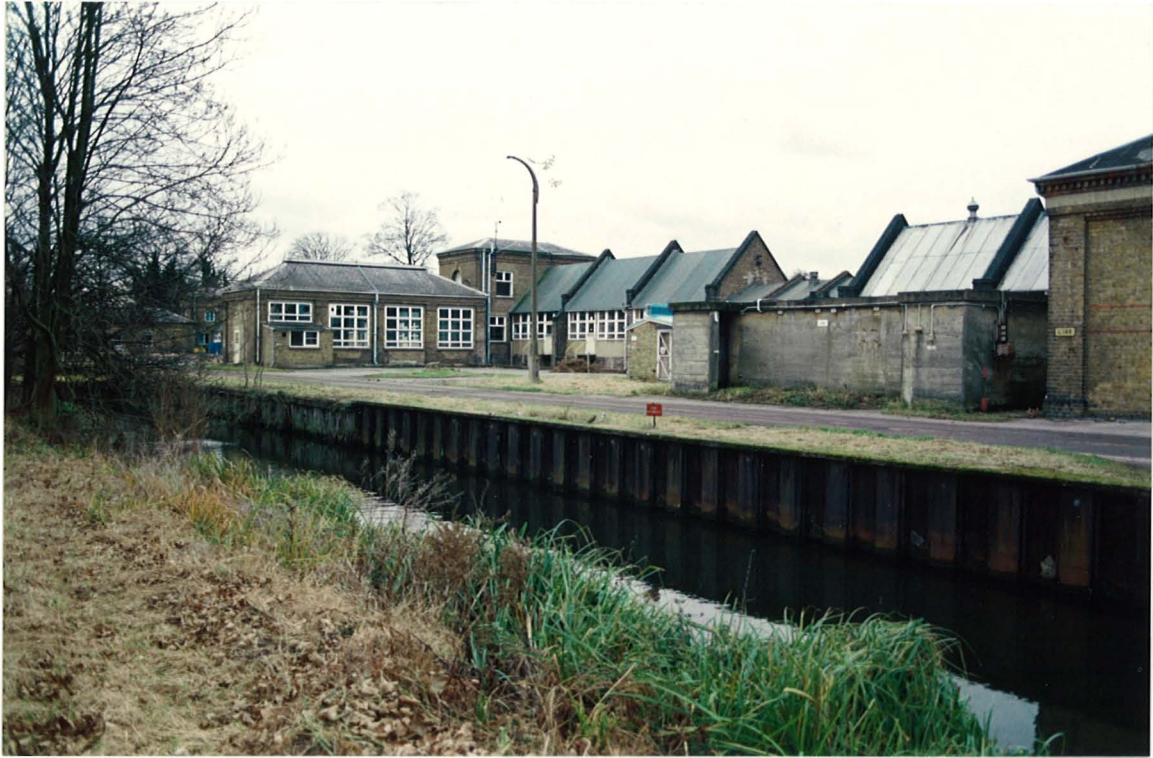
Canal Exit 9

9 Leat RCHM 355

NGR TL 37720 01283

This buried waterway runs roughly east west under Queens Mead connecting leat RCHM 299 and Middle Stream, passing under L148. It was constructed in the 1850s and was filled prior to the construction of L148 in 1888 - 9. The Middle stream is sheet piled for most of this stretch although it is difficult to exactly pinpoint the intersection.

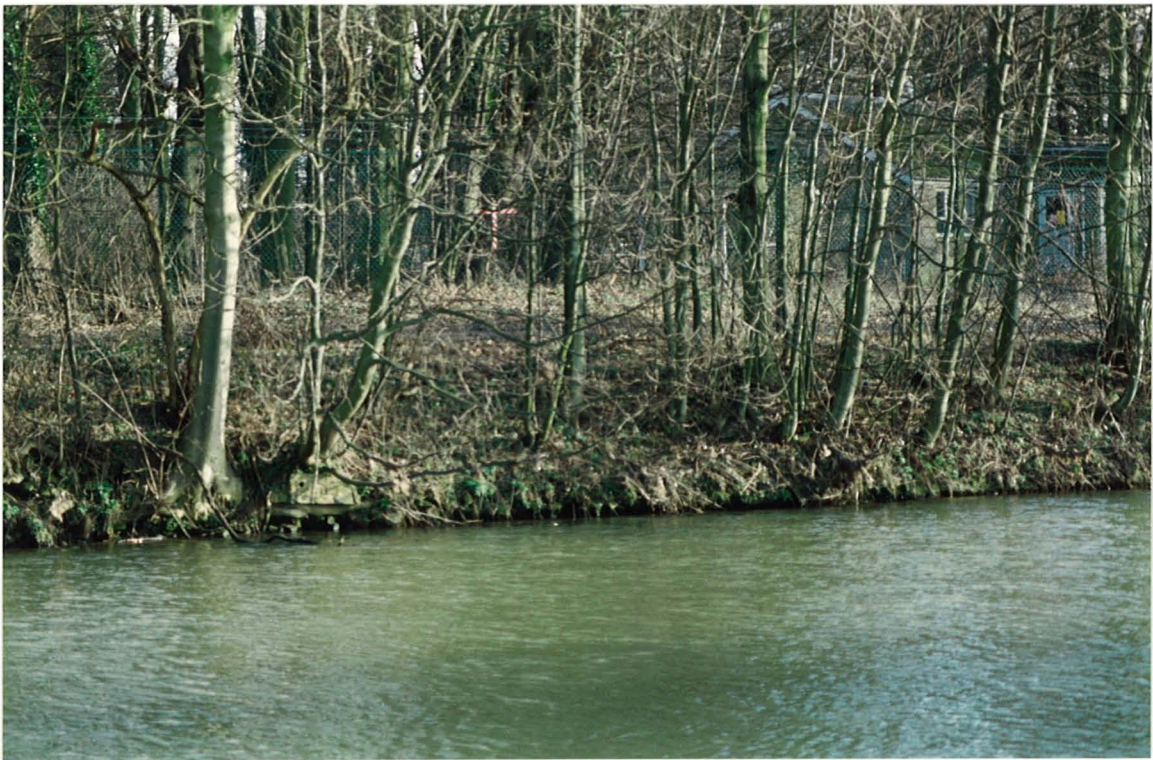
Canal Exit 10

10 Canal RCHM 296

NGR TL 37440 01770, 37517 01796

This is the location where the historic Millhead Stream swung into the site to power the gunpowder mills to the south. Now this spot represents the interface between the widened Horsemill Stream/Flood Relief Channel and Millhead Stream. Horsemill Stream was widened in 1971 -2, Millhead Stream was filled in the Late 1950s early 1960s. Again no damming structures were observed.

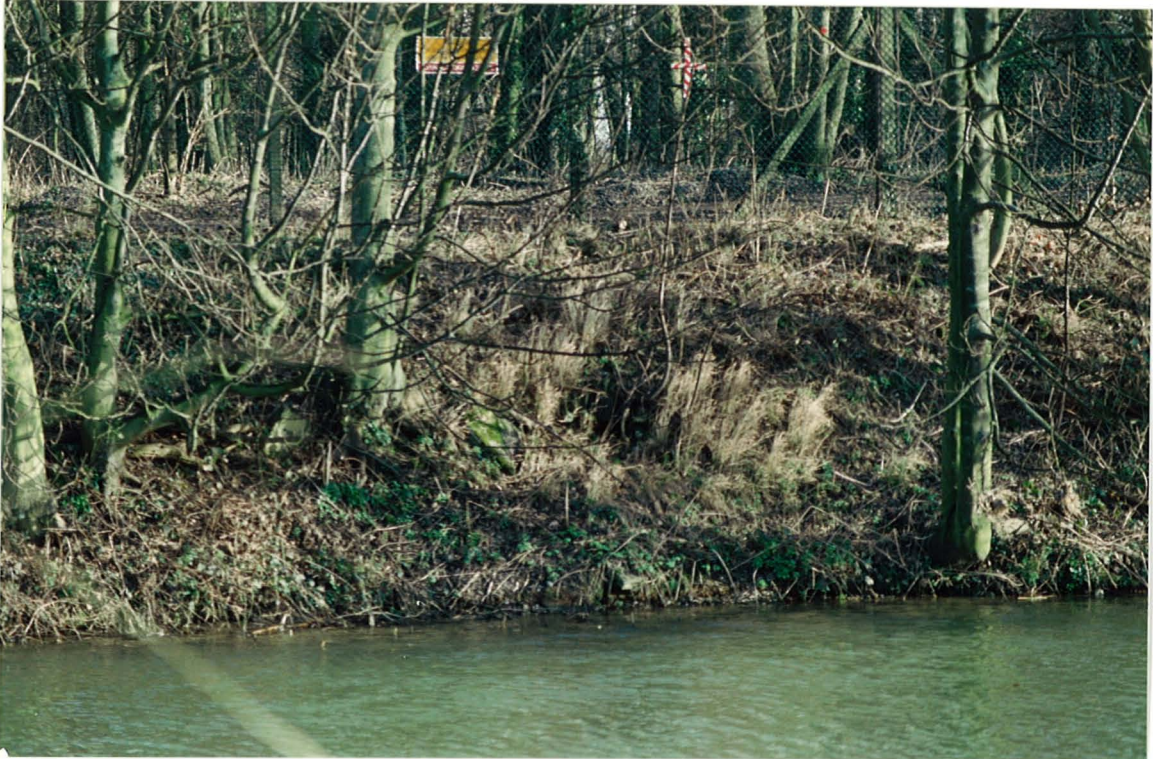
Canal Exit 11

11 Mill Leat RCHM 502

NGR TL 37460 01455

This small race or leat served a glazing and dusting house (the remains destroyed during the widening of Horsemill Stream) which pre dates 1783 and was probably a mid to late 17th Century process building. We can assume that the leat is of the same date. There is no retaining structure at the Horsemill Stream end.

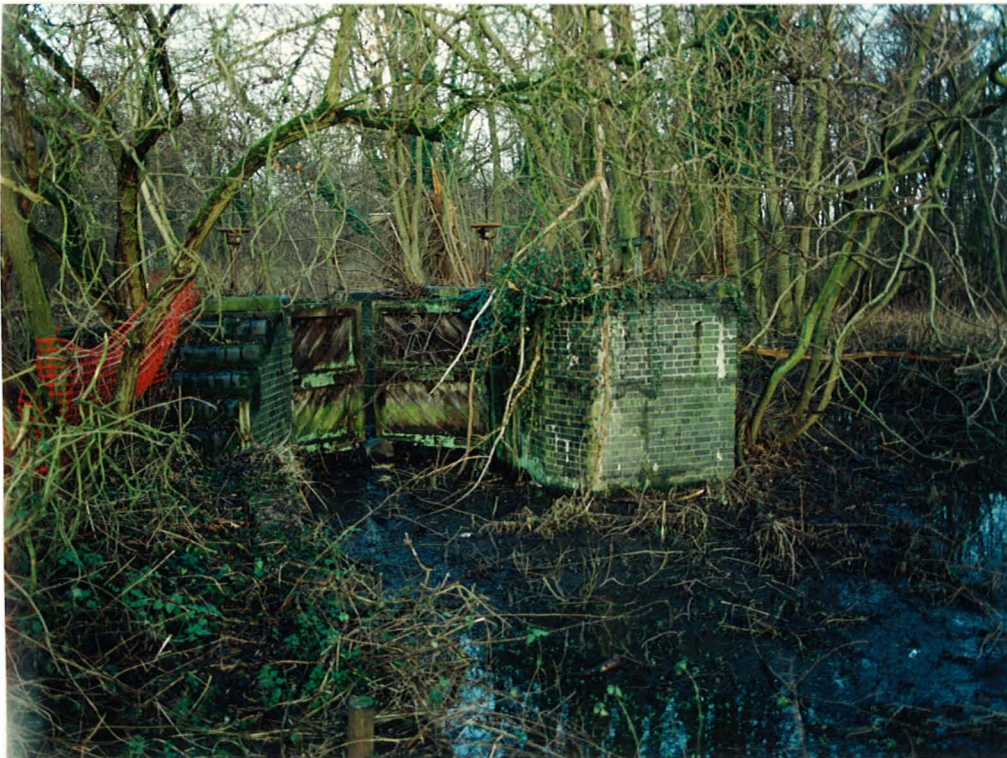
Canal Exit 12

12 Lock RCHM 225**NGR TL 37630 01475**

Both the lock and the canal above it were constructed in 1878, part of a large expansion program carried out at this time. The lock joined canal RCHM 179 with Middle Stream. The lock survives empty and intact, the canal was filled soon after the Second World War. There are no revetment structures and the lock gates are too decayed to be used for this purpose.

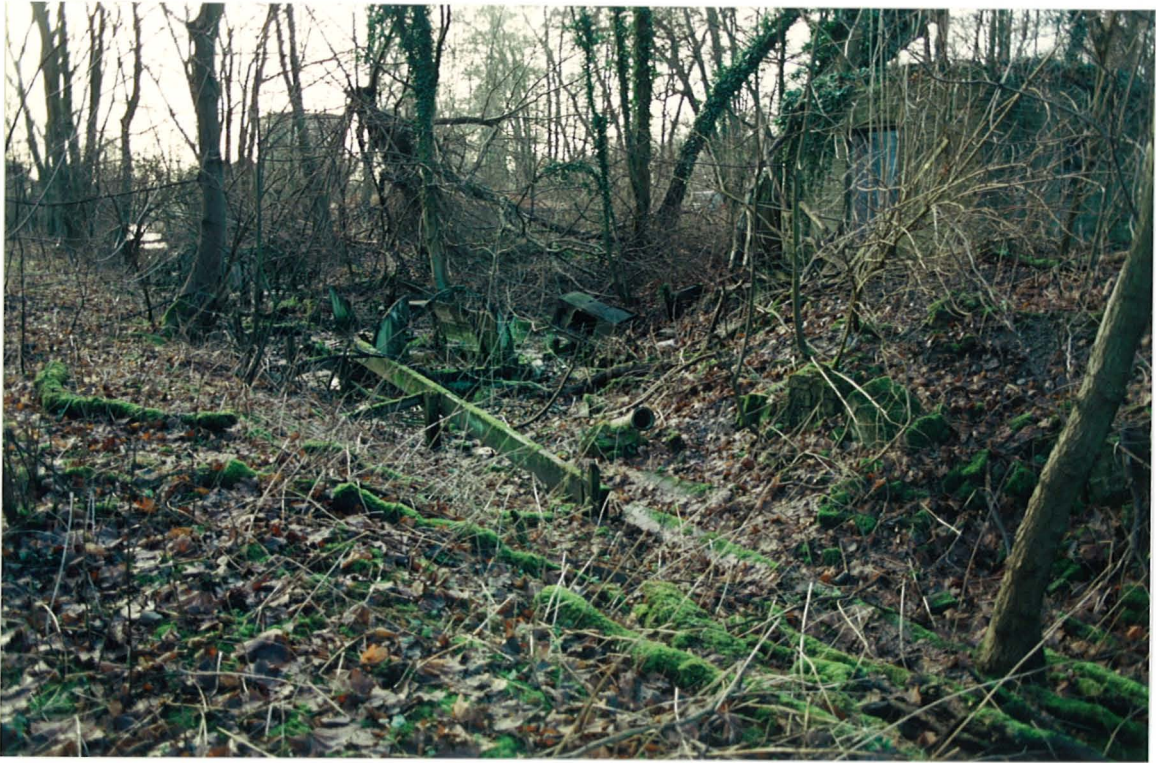
Canal Exit 13

13 Canal RCHM 156**NGR TL 37683 01600, 37645 01473**

This canal, part of the low level system links Middle Stream with the perimeter ditch and Long Walk Leat. It was most likely constructed in the 1880s/1890s. At the northern end it survives as a partially filled, dry ditch. To the south it is half filled with water and vegetation. It also contains the waterlogged remains of four gunpowder barges. This southern end is open to the Middle Stream.

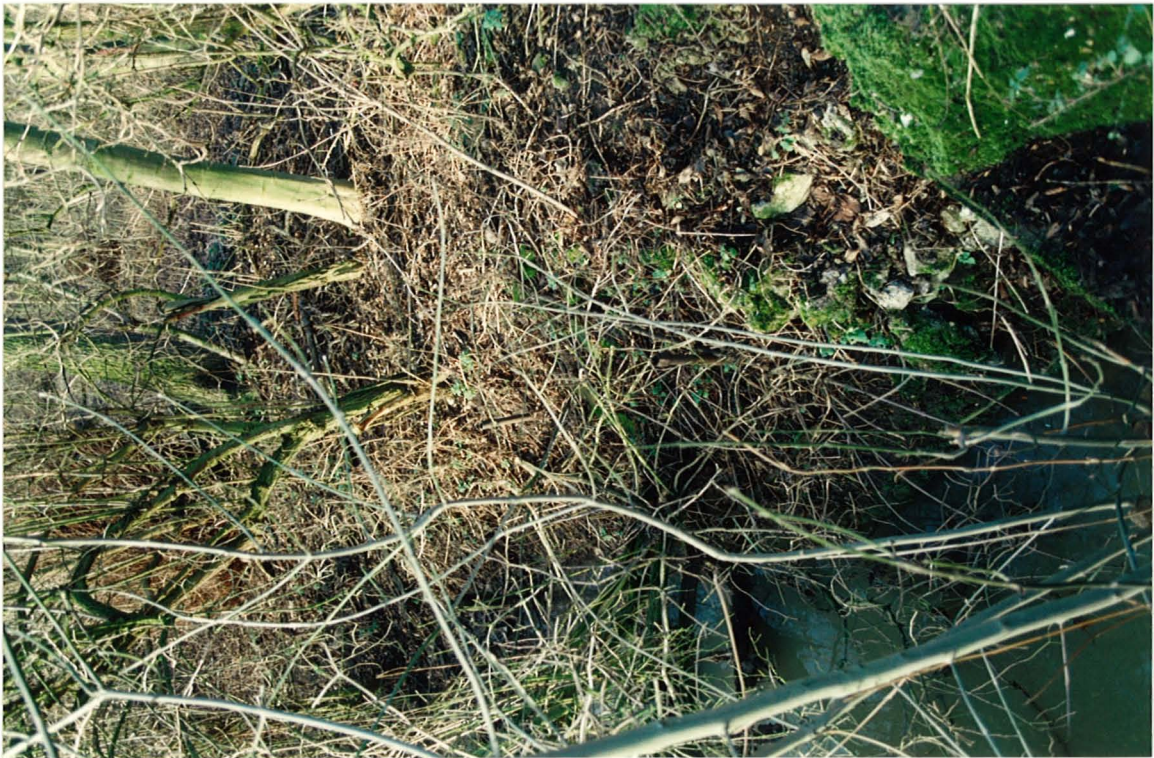
Canal Exit 14

**14 Ditch/Canal RCHM 181
37835 00980****NGR TL 37456 01586, 37670 011623,**

The exact location where the perimeter canal joined canal RCHM 300 (Middle Stream) is unknown. A close inspection of the banks under and adjacent to the road bridge showed no obvious damming features unless the concrete bridge abutments serve a dual purpose.

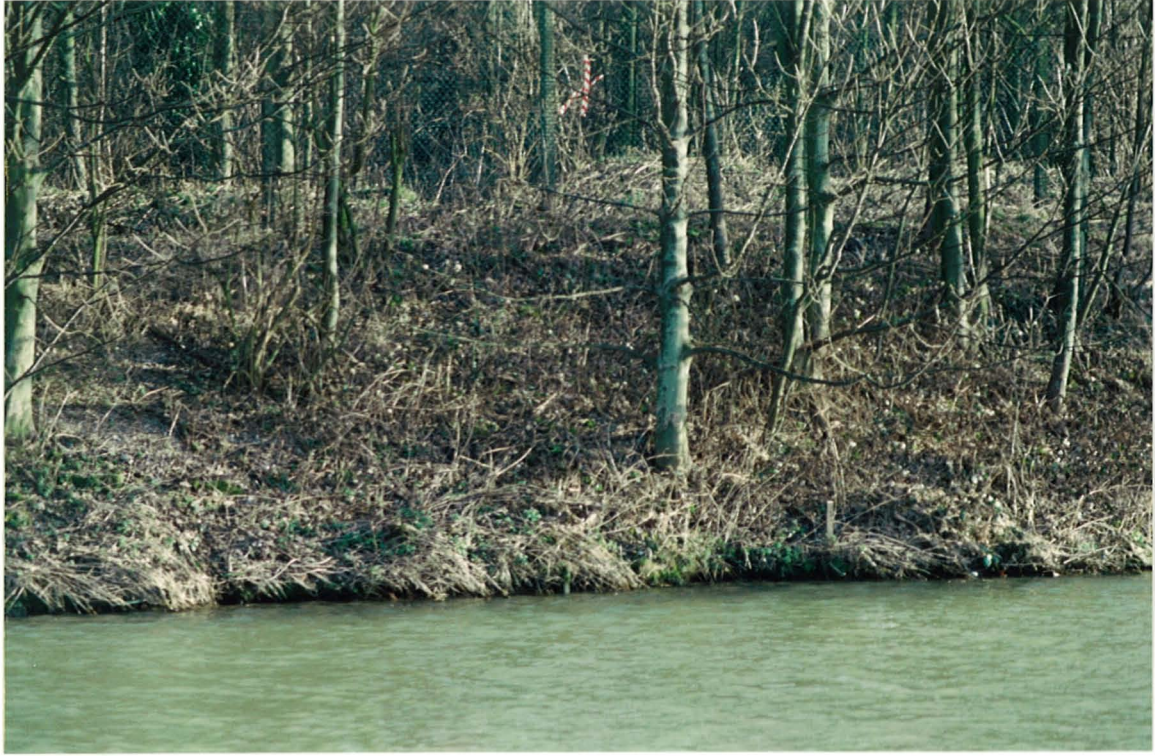
Canal Exit 15

15 Ditch/Canal RCHM 181**(see above for Grid Ref.)**

This intersection was where the perimeter leat and the Long Walk leat linked up with Horsemill Stream, it also served as a race for a corning/granulating house dating to 1827. The leat survives as an earthwork for the most part but next to Horsemill Stream it has been buried by the arisings from the channel widening. Again there are no retaining structures visible.

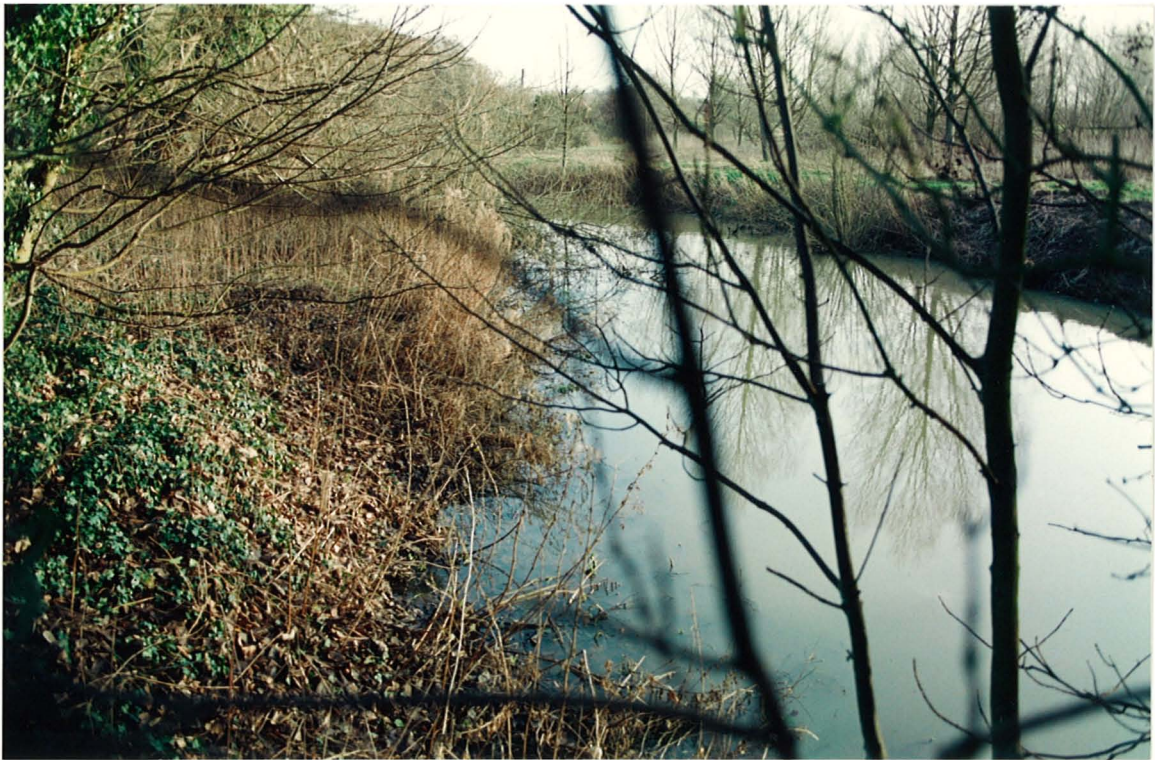
Canal Exit 16

16 Tail Leat (part of RCHM 294)**NGR TL 37420 01640, 37679 01693**

The canal RCHM 294 was constructed in 1806 to supply water to the Gunpowder Press House, the tail leat drained the water into the Old River Lea. The canal and the leat may have been filled in the late 1940s. Examination of the river bank where the leat entered the waterway did not show any damming structures.

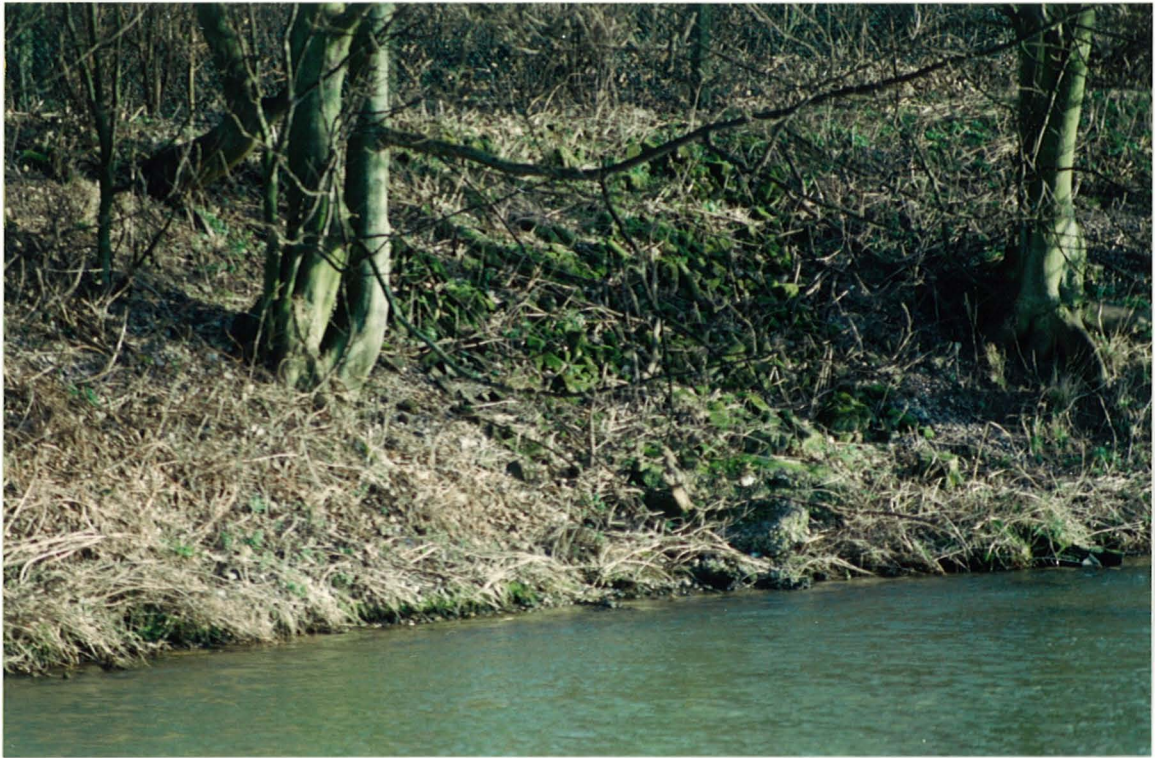
Canal Exit 17

17 Press House Canal RCHM 294**NGR TL 37420 01640, 37679 01693**

The western mouth of the 1806 canal again is banked over by the arisings of the dredging operation in the early 1970s. Examination of Horsemill Stream bank shows rubble tumbling out of the canal mouth unhindered.

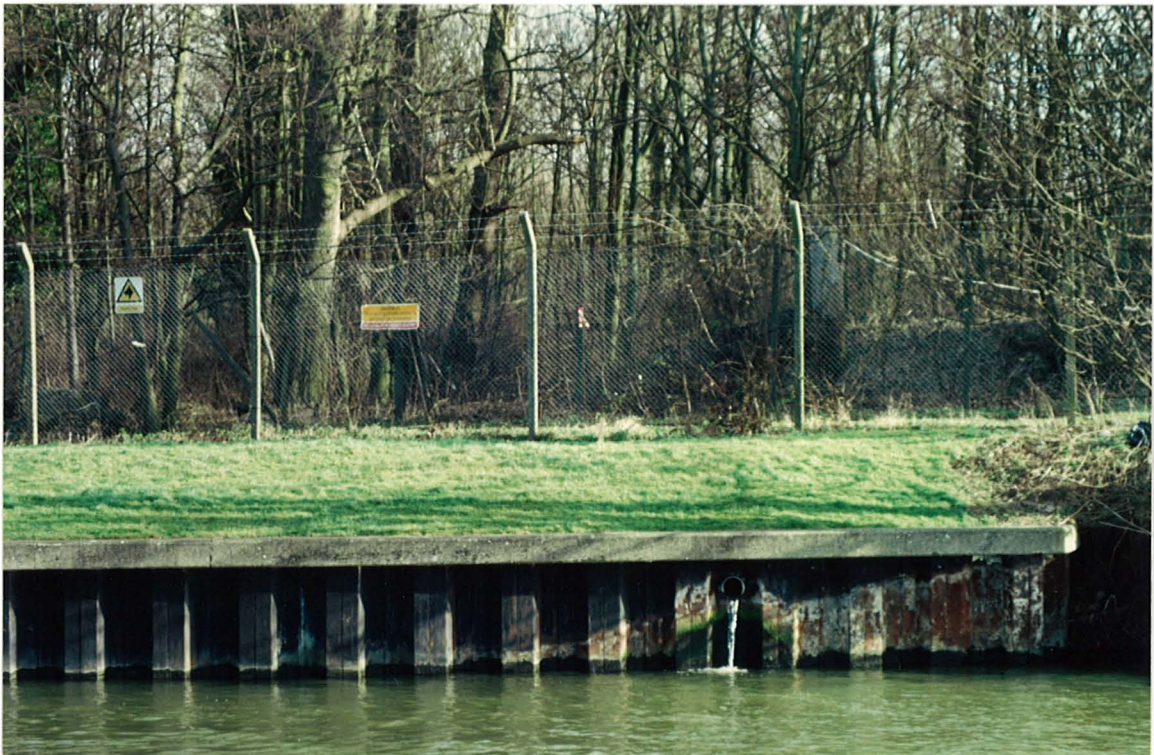
Canal Exit 18

18 Canal/Leat RCHM 297**NGR TL 37406 01750, 37438 01744**

This point, to the south of Edmonsey Sluice is the position of a mill leat powering a granulating house which was built before 1821. As with the previous two examples the mouth of this leat has been covered with river gravels but in this case the bank has steel pilings along it forming part of the sluice.

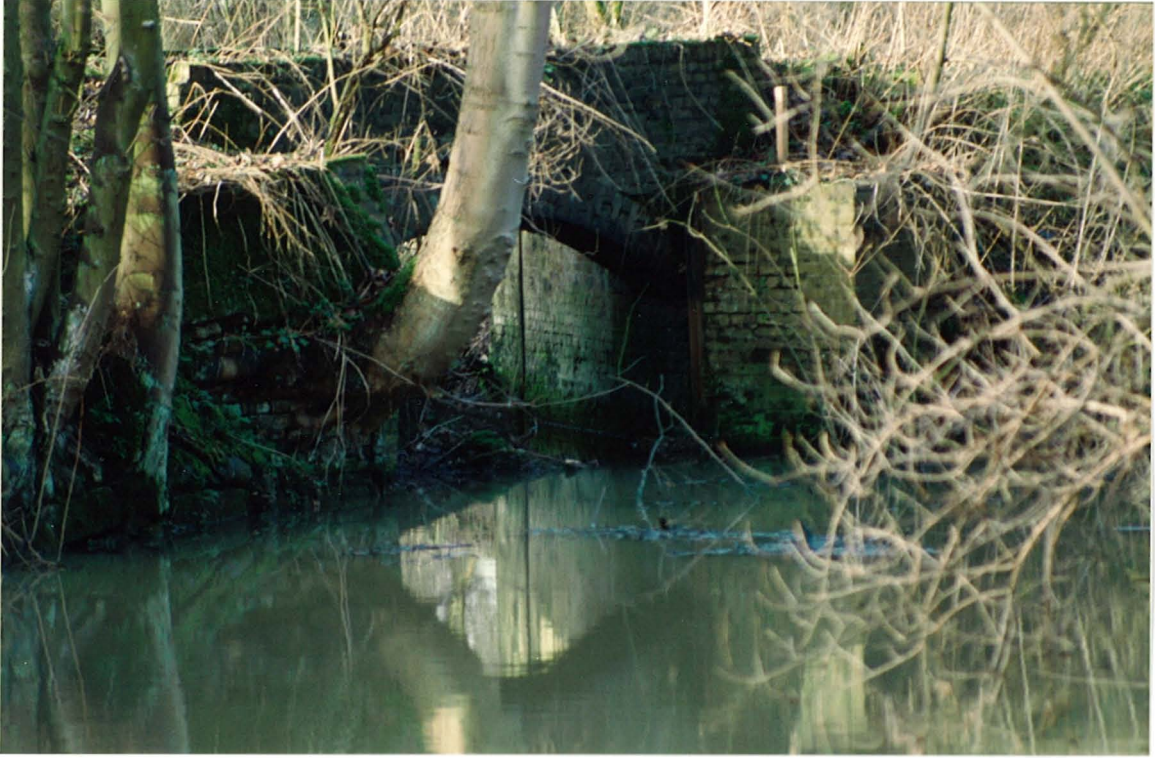
Canal Exit 19

19 Leat RCHM 296**NGR TL 37440 01770, 37517 01796**

This leat was constructed between 1806 and 1827 and is now partially filled. It joined the main north south ditch RCHM 299 with the Old River Lea. This intersection has been bridged but there is no revetment.

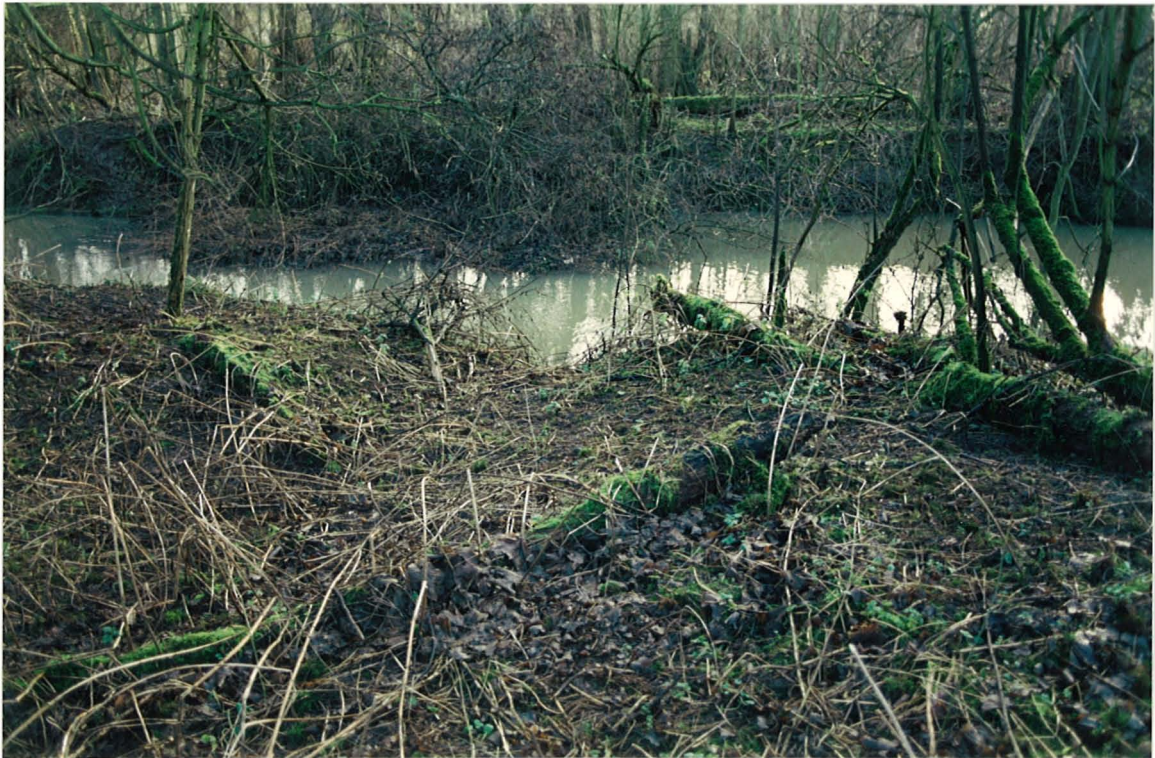
Canal Exit 20

20 Leat RCHM 295**NGR TL 37490 01952, 37513 01909**

This narrow leat probably linked canal RCHM 288 with the Old River Lea, perhaps acting as an overflow. It was built between 1850 and 1886 and now exists as an earthwork. There is no revetment.

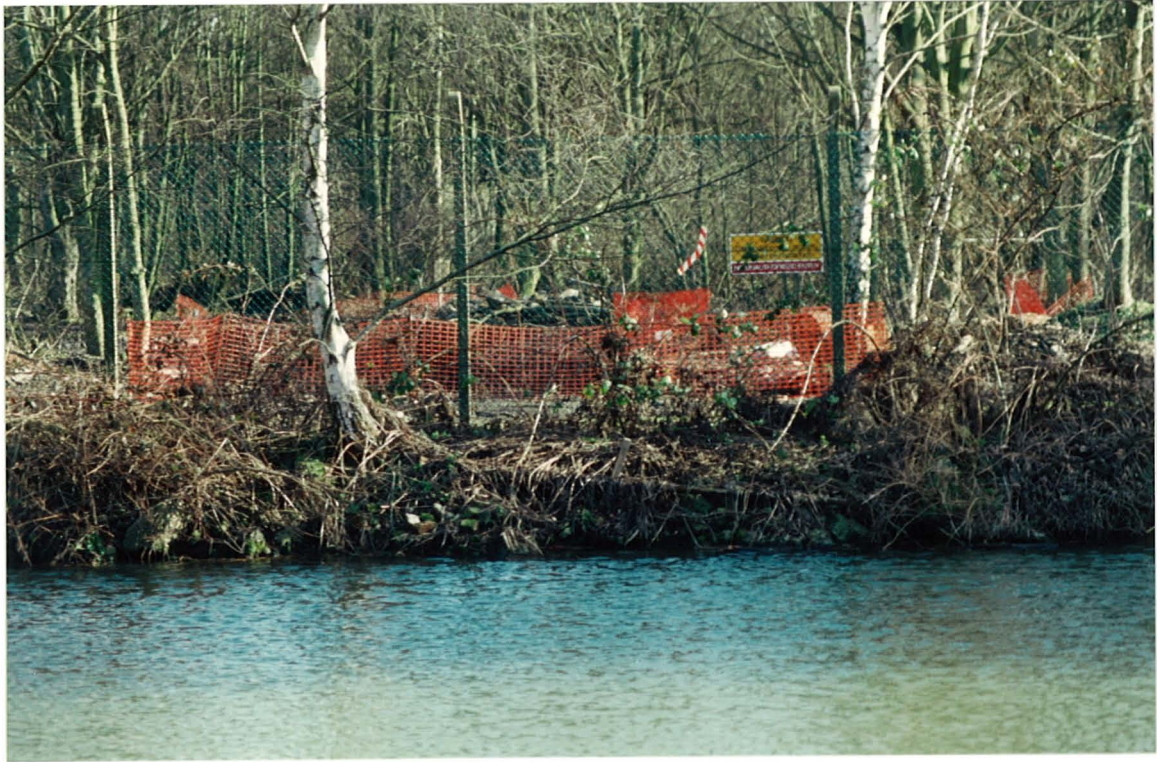
Canal Exit 21

21 Canal RCHM 288**NGR TL 37386 01972, 37530 01956**

Constructed between 1850 and 1886 this canal originally served the gunpowder drying stove 76. It was later incorporated into the high level system. It was filled completely by 1960 with the demolition arisings from the acid factory to the north. The interface with Horsemill Stream has no barrier or damming feature.

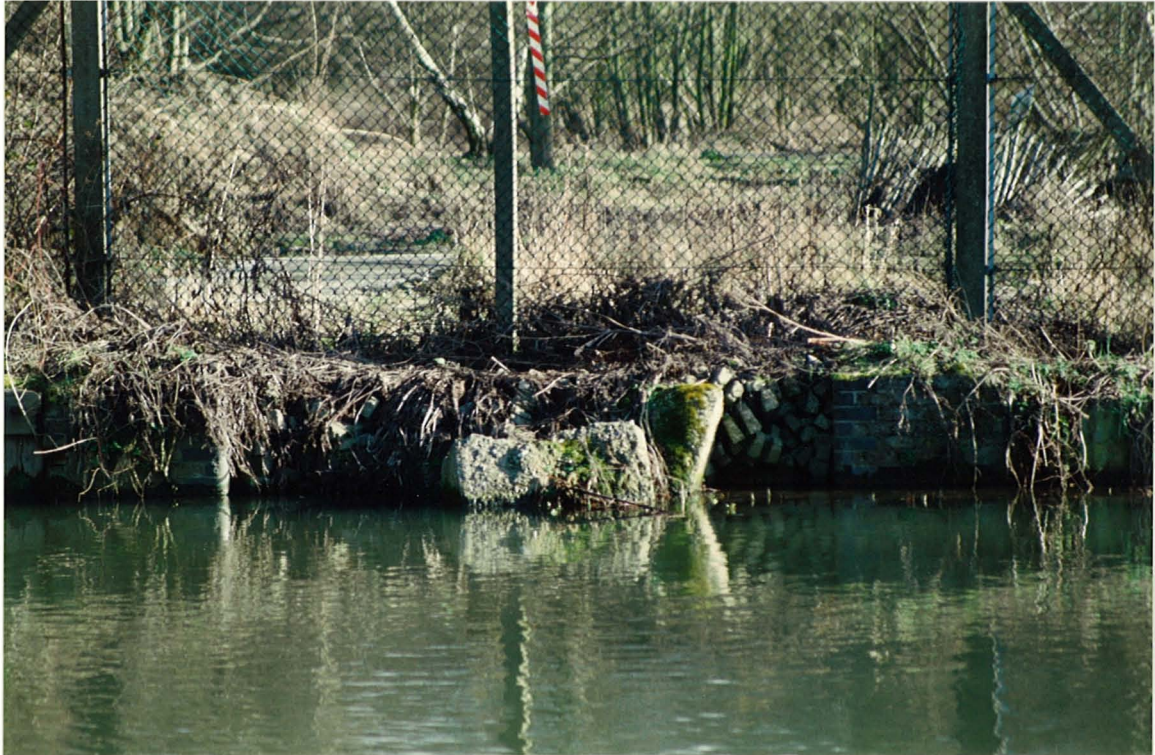
Canal Exit 22

22 Culvert RCHM 183**NGR TL 37402 02066, 37426 02049**

This brick lined culvert or channel powered a granulating house to the north (now surviving as a slab) and fed water into a large pond to the south east. It was constructed between 1875 and 1895 and is now partially filled with rubble. Rubble and concrete blocks can be observed tumbling out of this feature, unchecked, into Horsemill Stream.

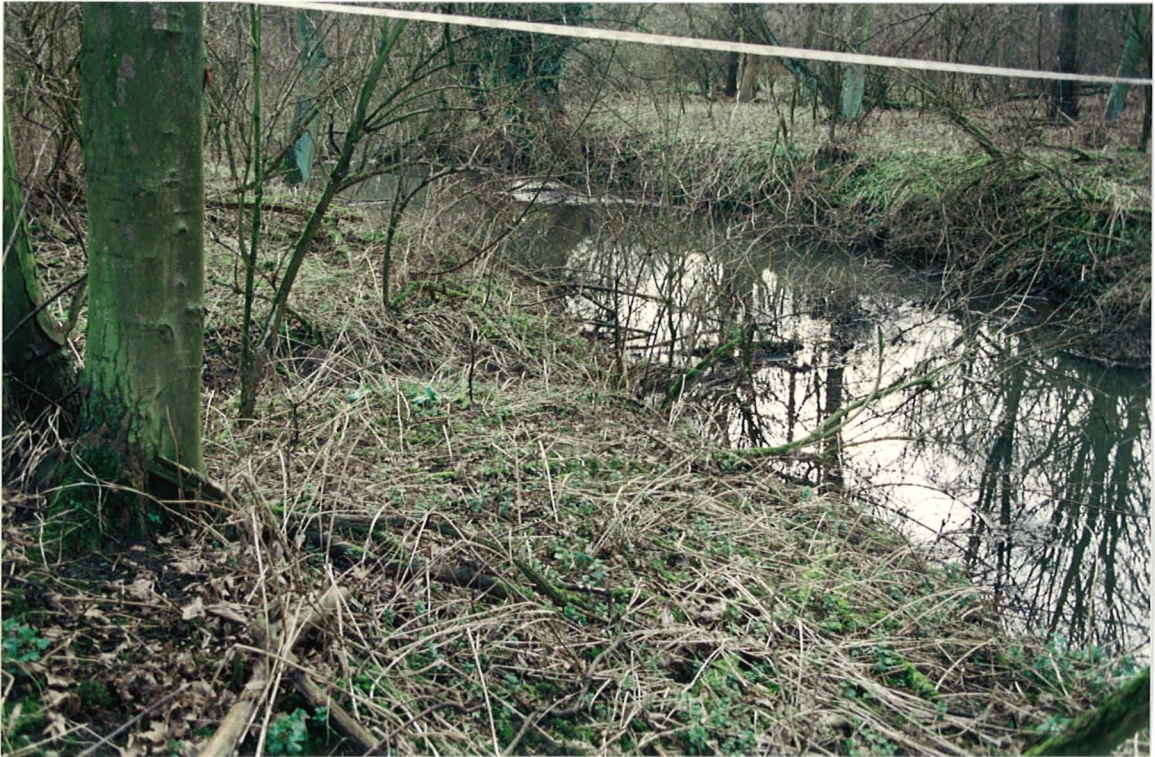
Canal Exit 23

23 Leat RCHM 292**NGR TL 37586 02071, 37627 02088**

This leat powered the dusting house RCHM 275 which was built in 1879, it linked the main high level system with the Old River Lea. The foundations of the dusting house survive and the leat remains as an earthwork which opens out into the river.
