Waltham Abbey Royal Gunpowder Factory
(Former RARDE North Site)

Investigation of the Interfaces Between
Filled Canals and Open Waterways

February 1994

Adam Ford
Consultant Archaeologist

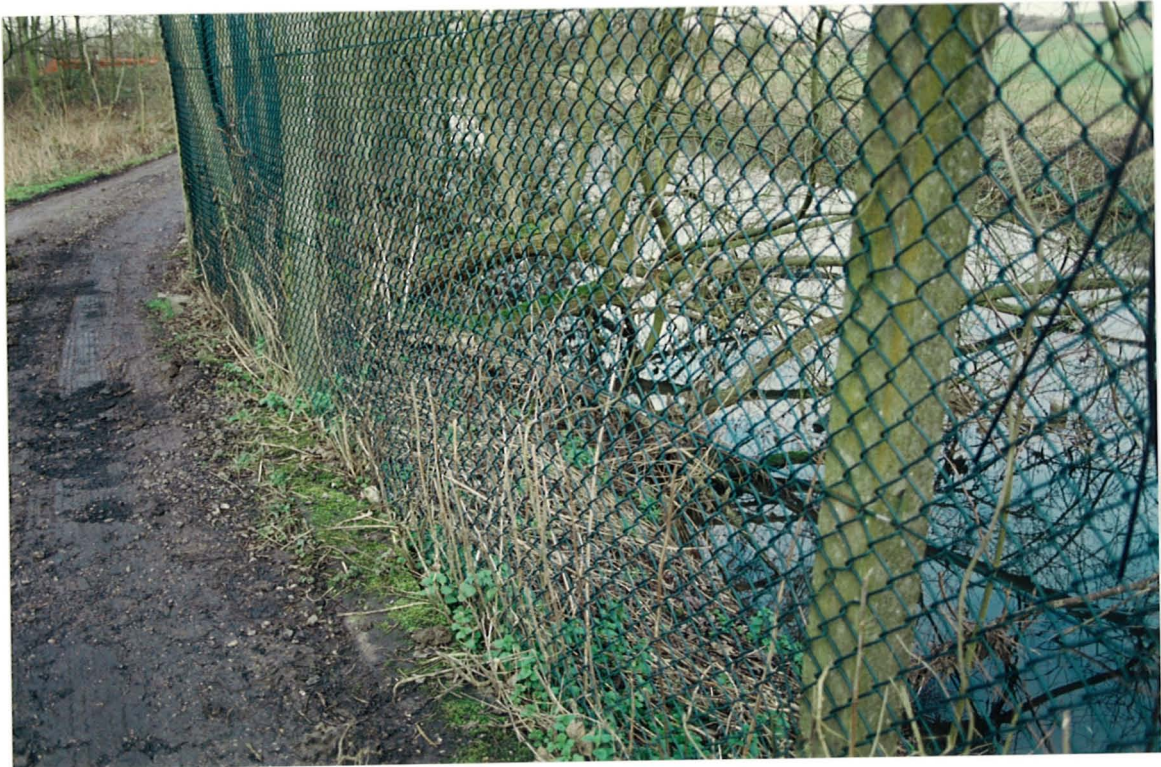
Canal Exit 24

24 Leat RCHM 293**NGR TL 37636 02094, 37680 021108**

Built in 1878 this leat served an undefined gunpowder process building and later, around 1920 a weighing house. To the west it survived as an earthwork, to the east it was filled with rubble and overlain with the present perimeter road. No revetment was observed at the interface with the Cornmill Stream.

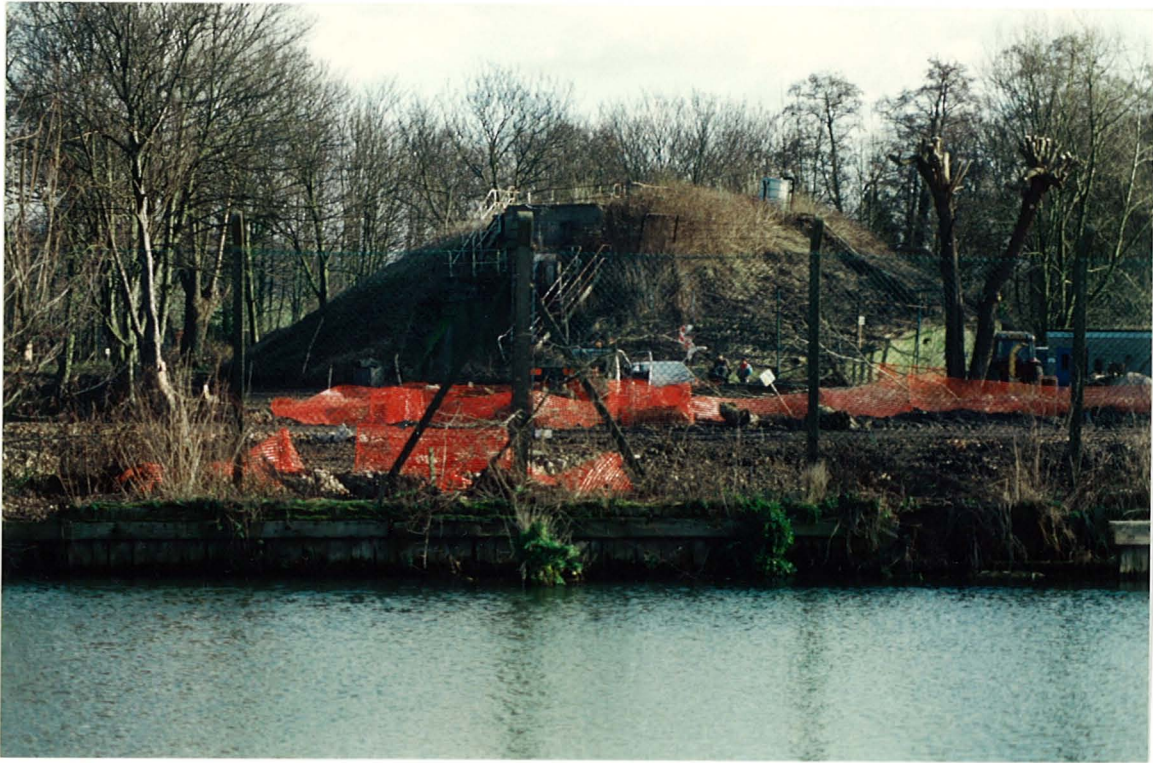
Canal Exit 25

25,26 Stove Canal RCHM 503**NGR TL 37410 02185, 37410 02240****27,29 Stove Canal RCHM 286****NGR TL 37400 02265, 37400 02317**

These positions represent the entrances of two semicircular canals which surrounded gunpowder drying stoves 27 and RCHM 274. They acted as a barrier and as a land drain, but also allowed barges to load and of load gunpowder to the two tray stove buildings on either side of the boiler houses. RCHM 274 dates from 1800 to 1820 and 27 dates to 1884. Prior to the construction of the stove RCHM 274 intersection 26 was the inlet for canal RCHM 291, built between 1801 - 1806 which linked Horsemill Stream with the press house

76. At the turn of the century a canal (RCHM 284) joined the same waterway, this time at the northern return opposite intersection 25. All of these canals were at least partially filled before the end of the First World War. None of them have adequate damming structures at the Horsemill Stream.

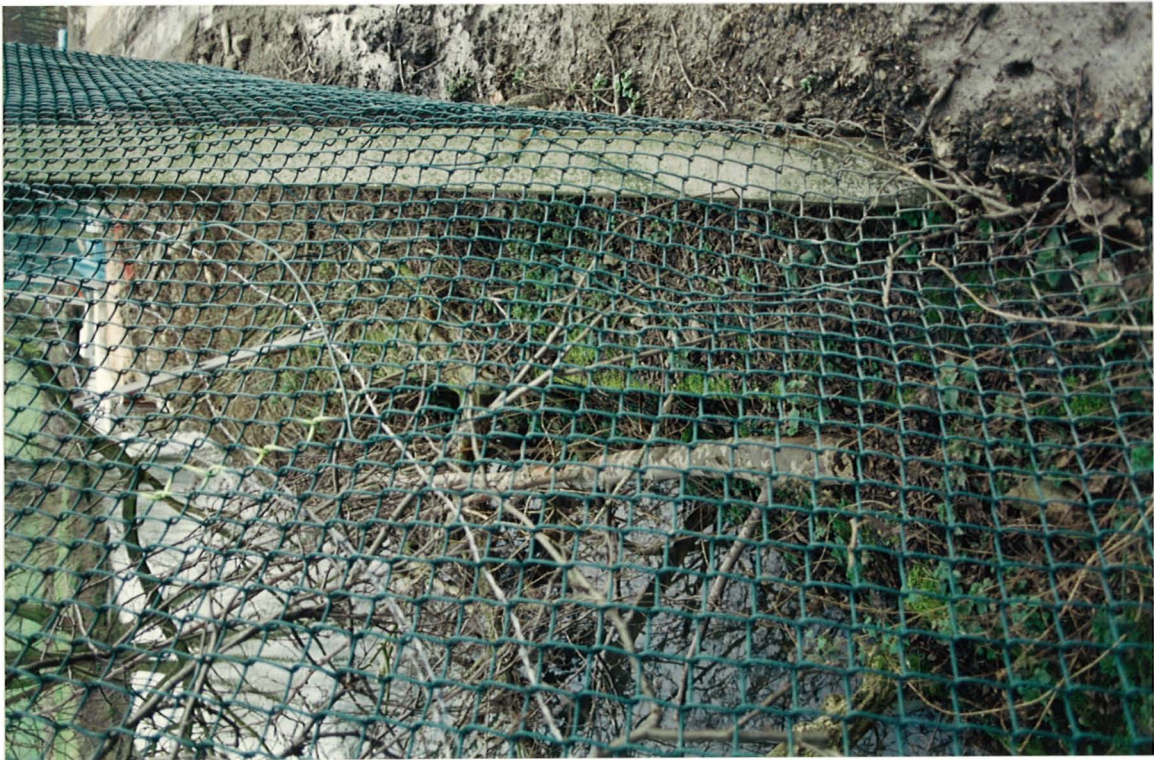
Canal Exit 28

28 Canal/Leat RCHM 504

NGR TL 37620 02220, 37635 02270

This waterway powered the gunpowder granulating house 34 where the present S34 now stands. All that remains of this process building is a brick traverse. The leat was a short narrow channel running from the Cornmill Stream into Newtons Pool, nothing of it remains apart from a slight indentation in the bank of Cornmill Stream and some timber revetments. It was probably filled around the turn of the century when the building became a cordite mixing house.

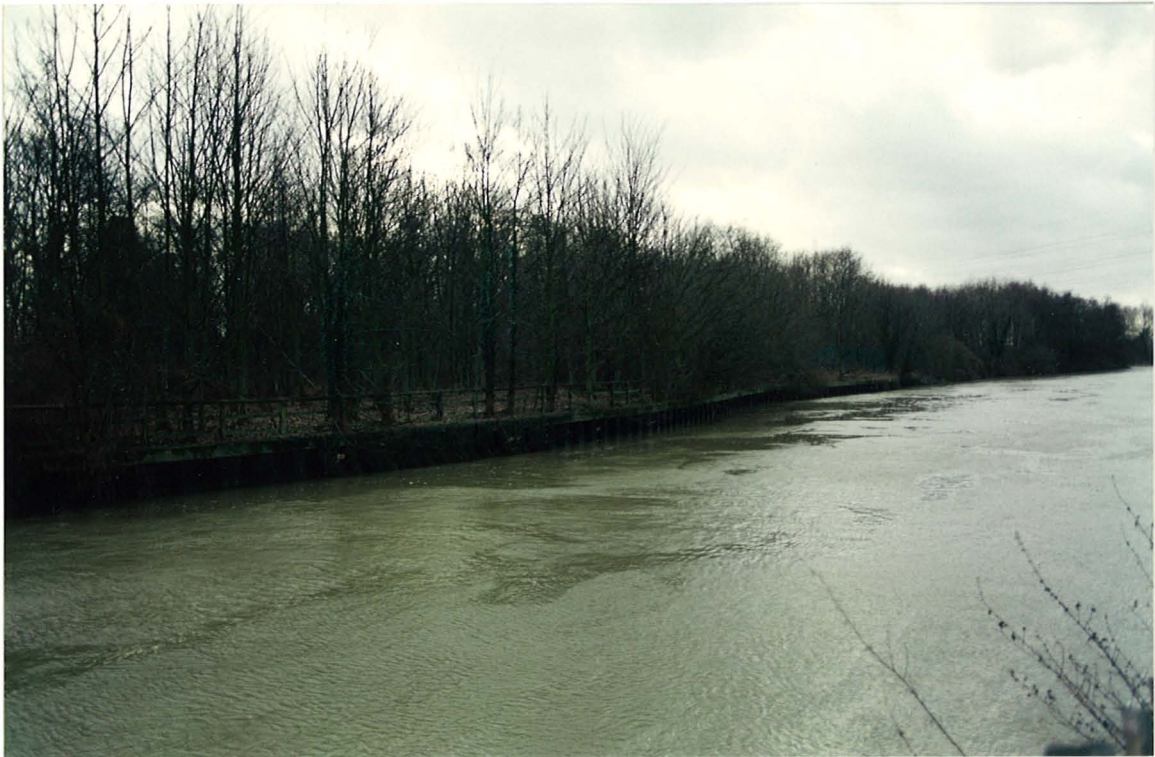
Canal Exit 30

30 Reclaimed Land

This area covers most of the land on the west of the site between the drying stove 27 to the Grand Magazine 1 at the tip of the site. As part of the canalization of Horsemill Stream in the early 1970s this part of the site boundary was straightened which involved reclamation. This resulted in two canals being sealed , RCHM 285 and 281. RCHM 28 is dammed with steel sheet piling the other has no visible retaining structure. The extent of sheet piling is shown on the maps as a thicker line along the boundary.

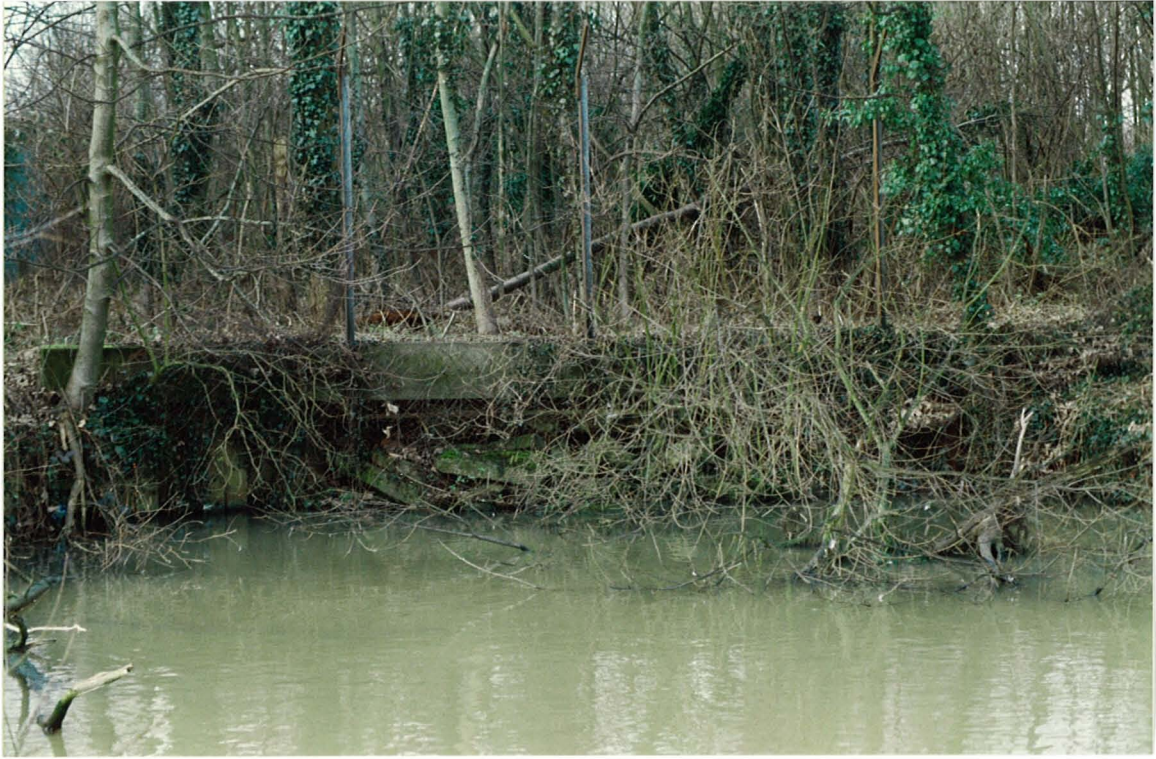
Canal Exit 31

31 Canal RCHM 281

NGR TL 37558 02569, 37626 02523

This is the eastern end of the channel mentioned above. The waterway was originally a natural course which formed Paynes Island on which the Grand Magazine stands. It was later straightened and then filled between 1957 and 1960. As with the western end this opening has been dammed effectively this time with concrete piles.

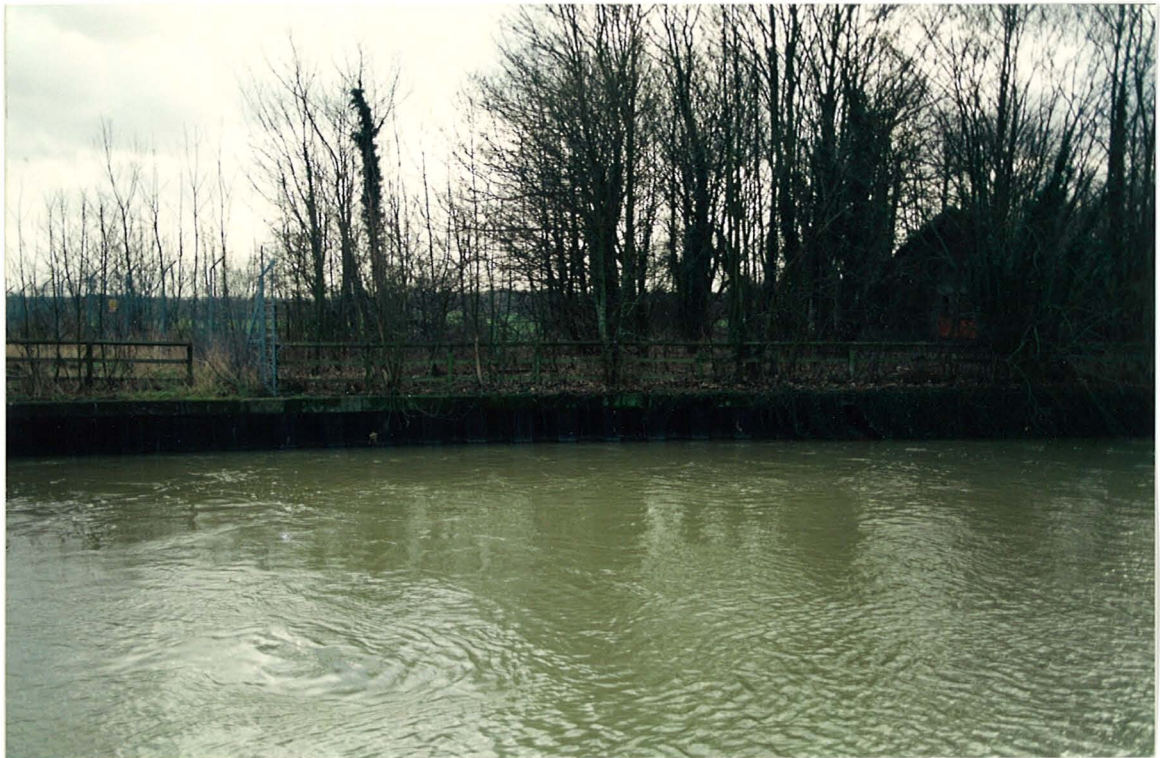
Canal Exit 32

32 Reclaimed Land

This is the very tip of the site and is now outside the boundary. Approximately 50% of the present area is reclaimed land where old waterways have been filled. All sides are steel sheet piled.
