"PROCEEDINGS OF A COURT OF ENQUIRY AND A REPORT BY
MAJOR F L NATHAN, RA., ON THE CIRCUMSTANCES ATTENDING
AN EXPLOSION WHICH OCCURRED AT THE ROYAL GUNPOWDER
FACTORY WALTHAM ABBEY ON THE 15TH DECEMBER, 1902".

Circumstances Attending an Explosion

ROYAL GUNPOWDER FACTORY,

ON THE 15th DECEMBER, 1902.

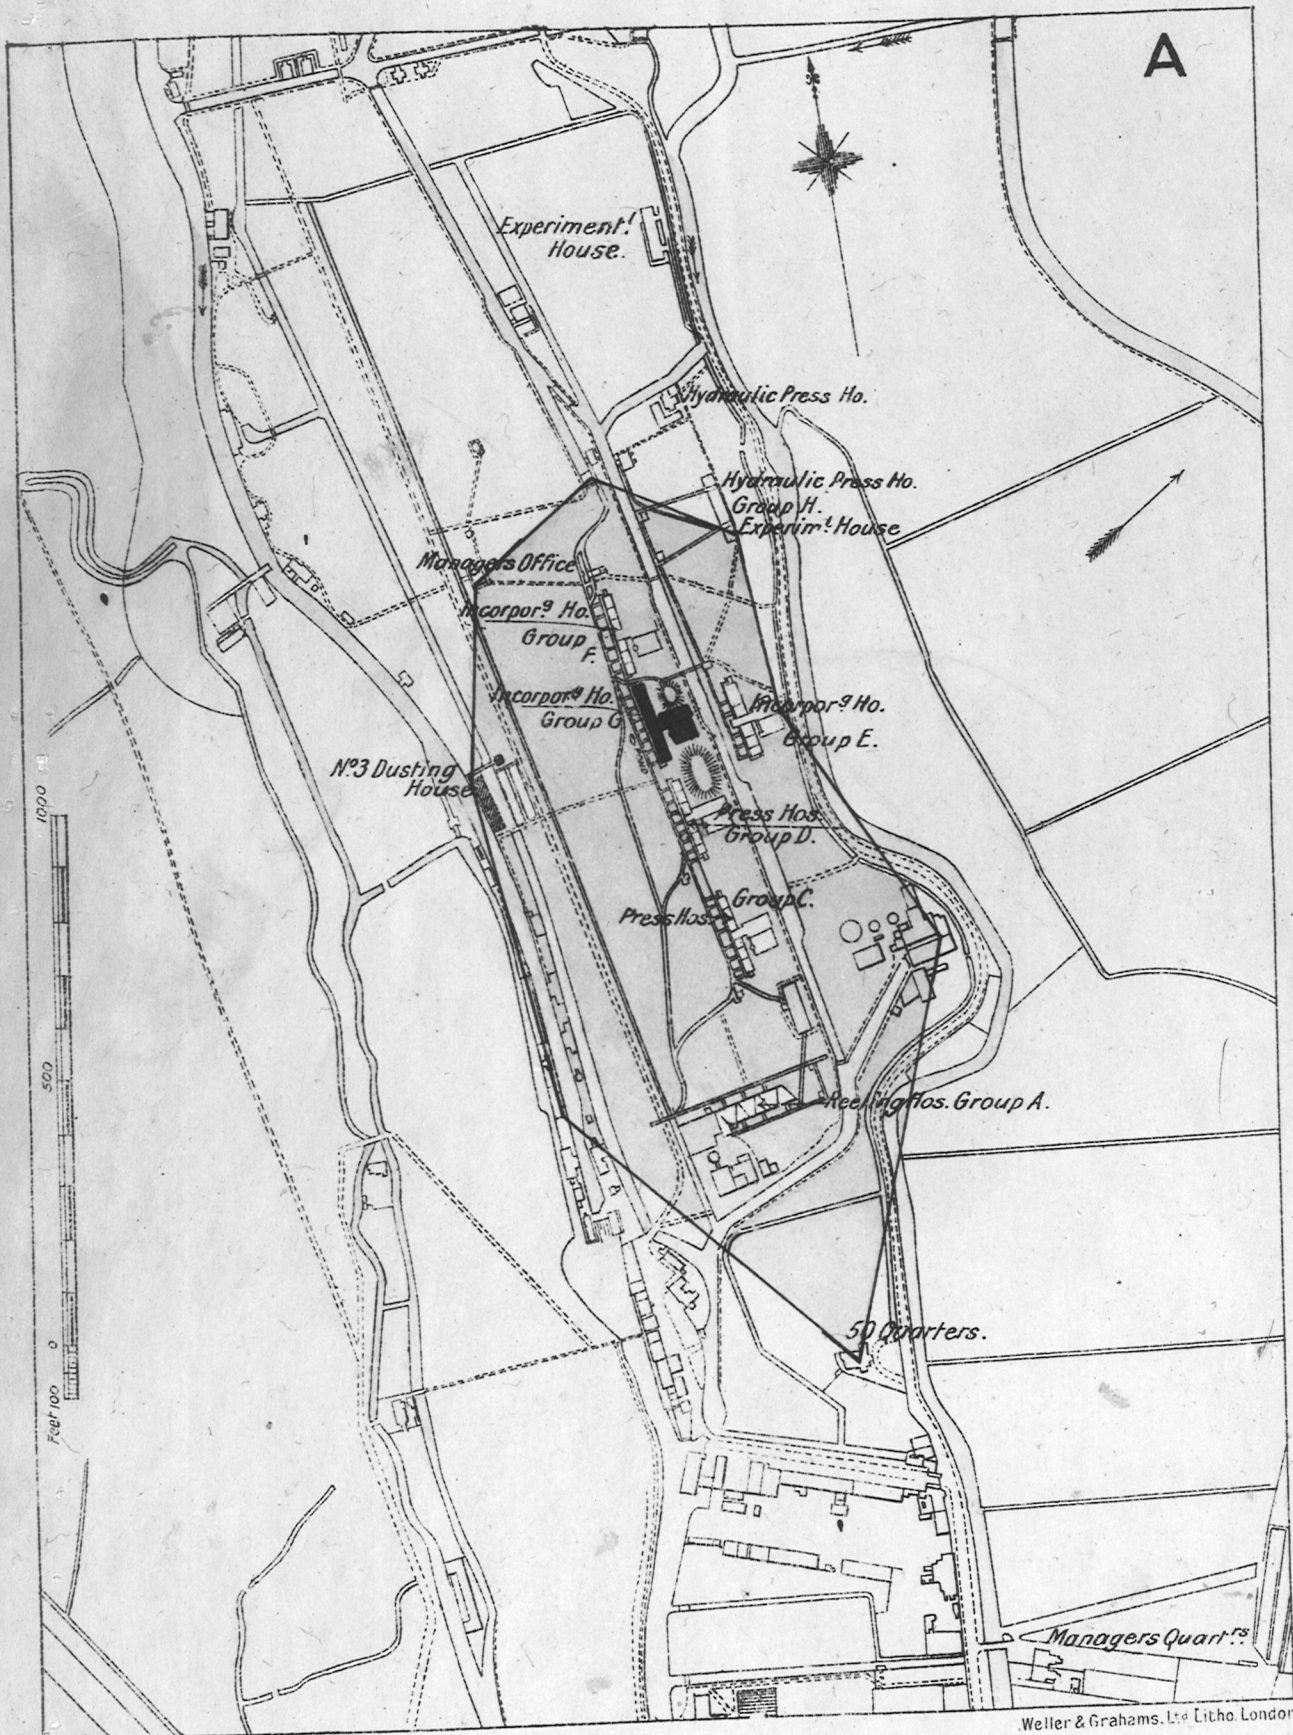
The damages done to buildings in the factory are given in Appendix III. Serious structural damage was only done to Group G, Bays 3, 2, and 1, and to its engine and boiler houses, but this damage was extraordinarily severe in view of the small quantity of explosive (57 lb.) involved. The massive construction of the engine-room wall, and of the partition walls between the bays, no doubt accentuated the damage in the immediate vicinity, but at the same time tended to localise it. It is remarkable that although the partition wall between Bays 3 and 2 fell into the two left-hand incorporating machines in Bay 2, which had only been charged about one hour, yet these charges were unaffected. Slight structural damage to the roofs of the dining room at Group D, and to the engine house at Group F, was done, 170 feet and 210 feet south and north respectively; there was no structural damage done east or west. Minor damages to windows, doors, roofs, group shutters, &c., were done within a radius of 1,230 feet. The zones of damage are shown on Map A.

ENGINE HOUSE AND BAYS 3, 2, 1, GROUP G.

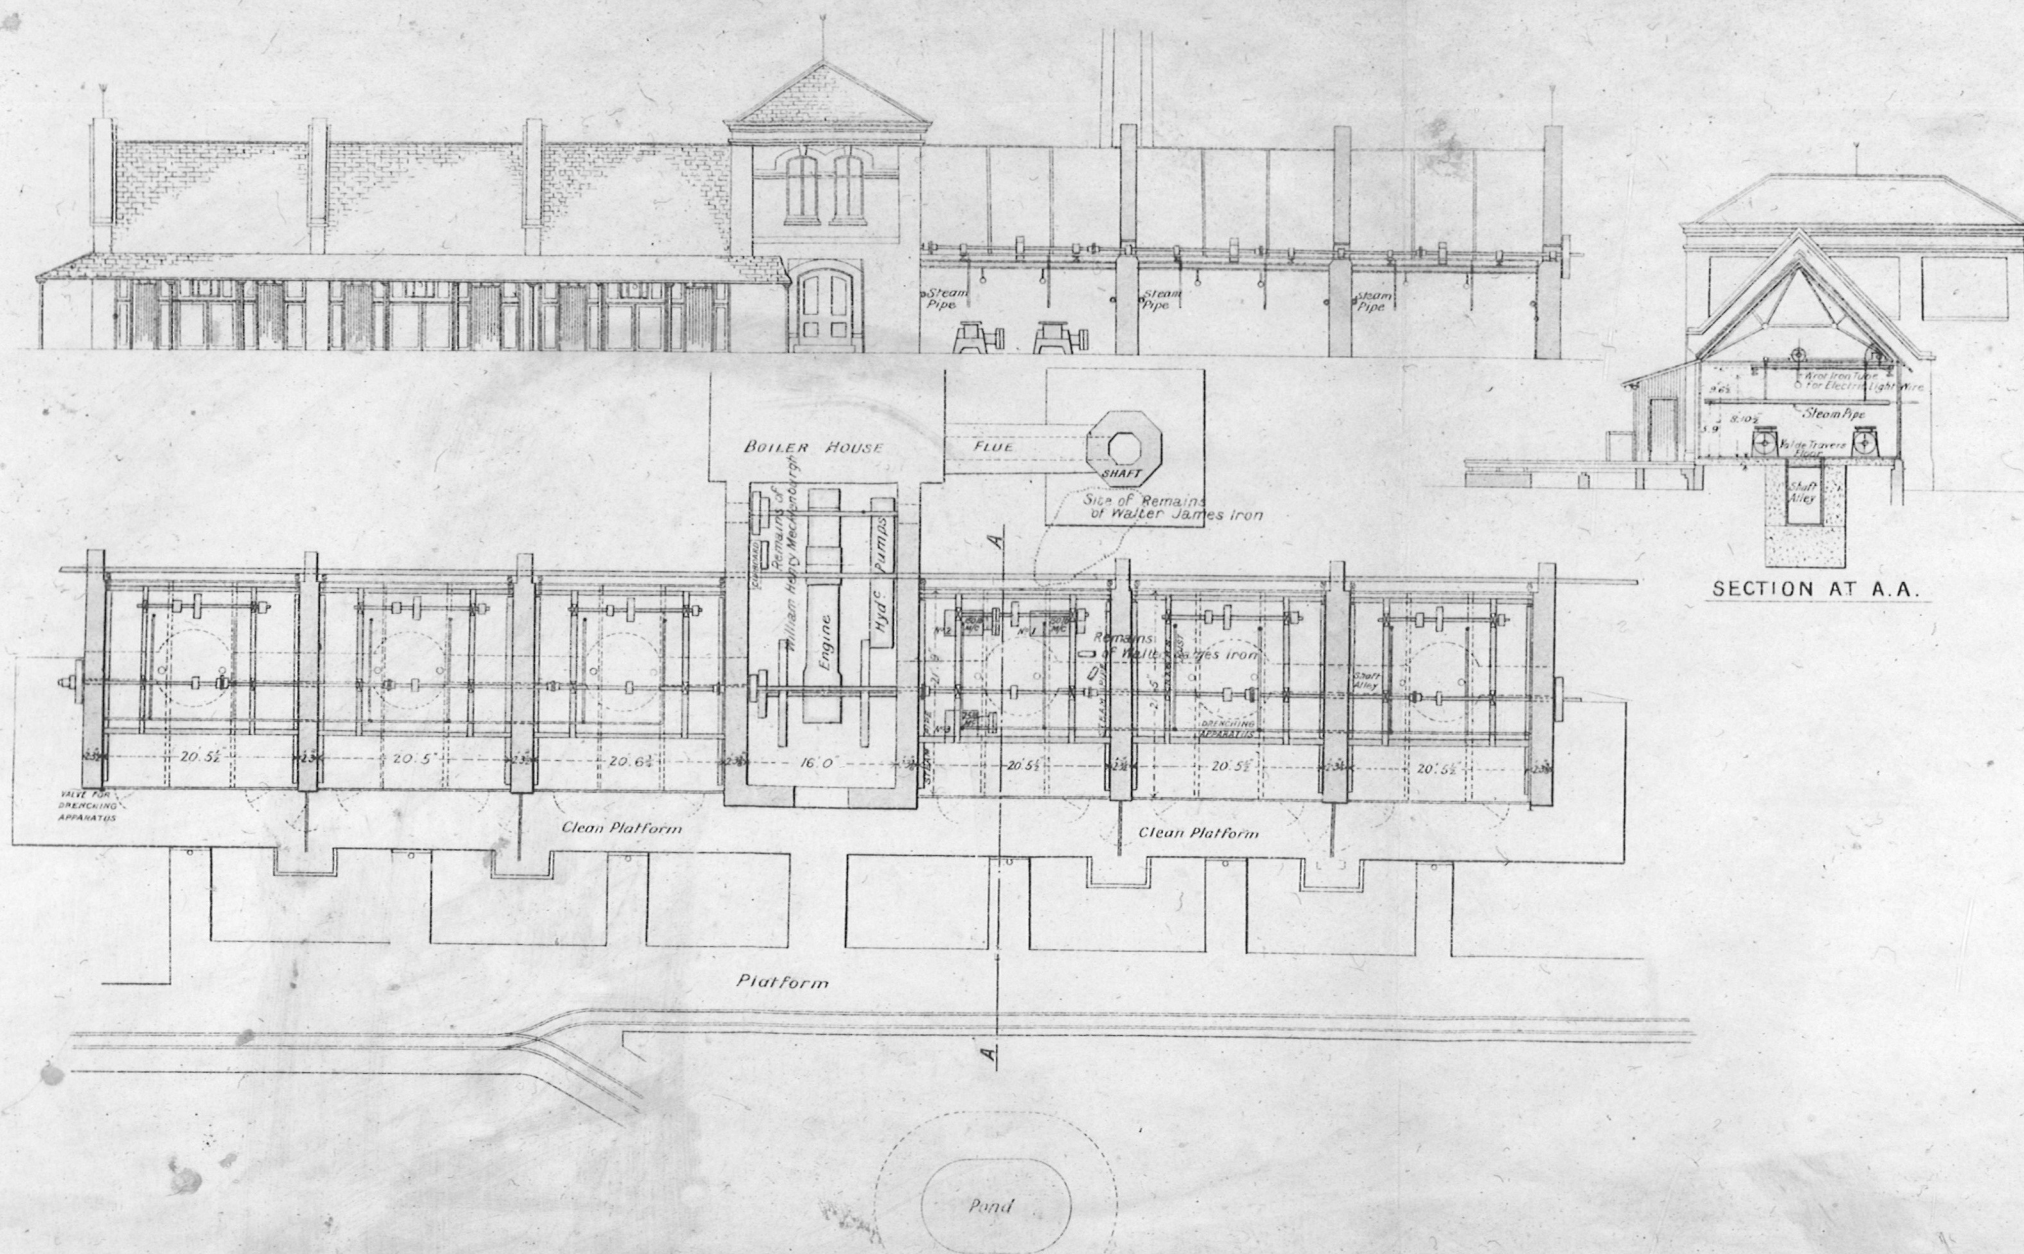
No 914.

GROUP G MILLS FOR MANUFACTURE OF CORDITE.

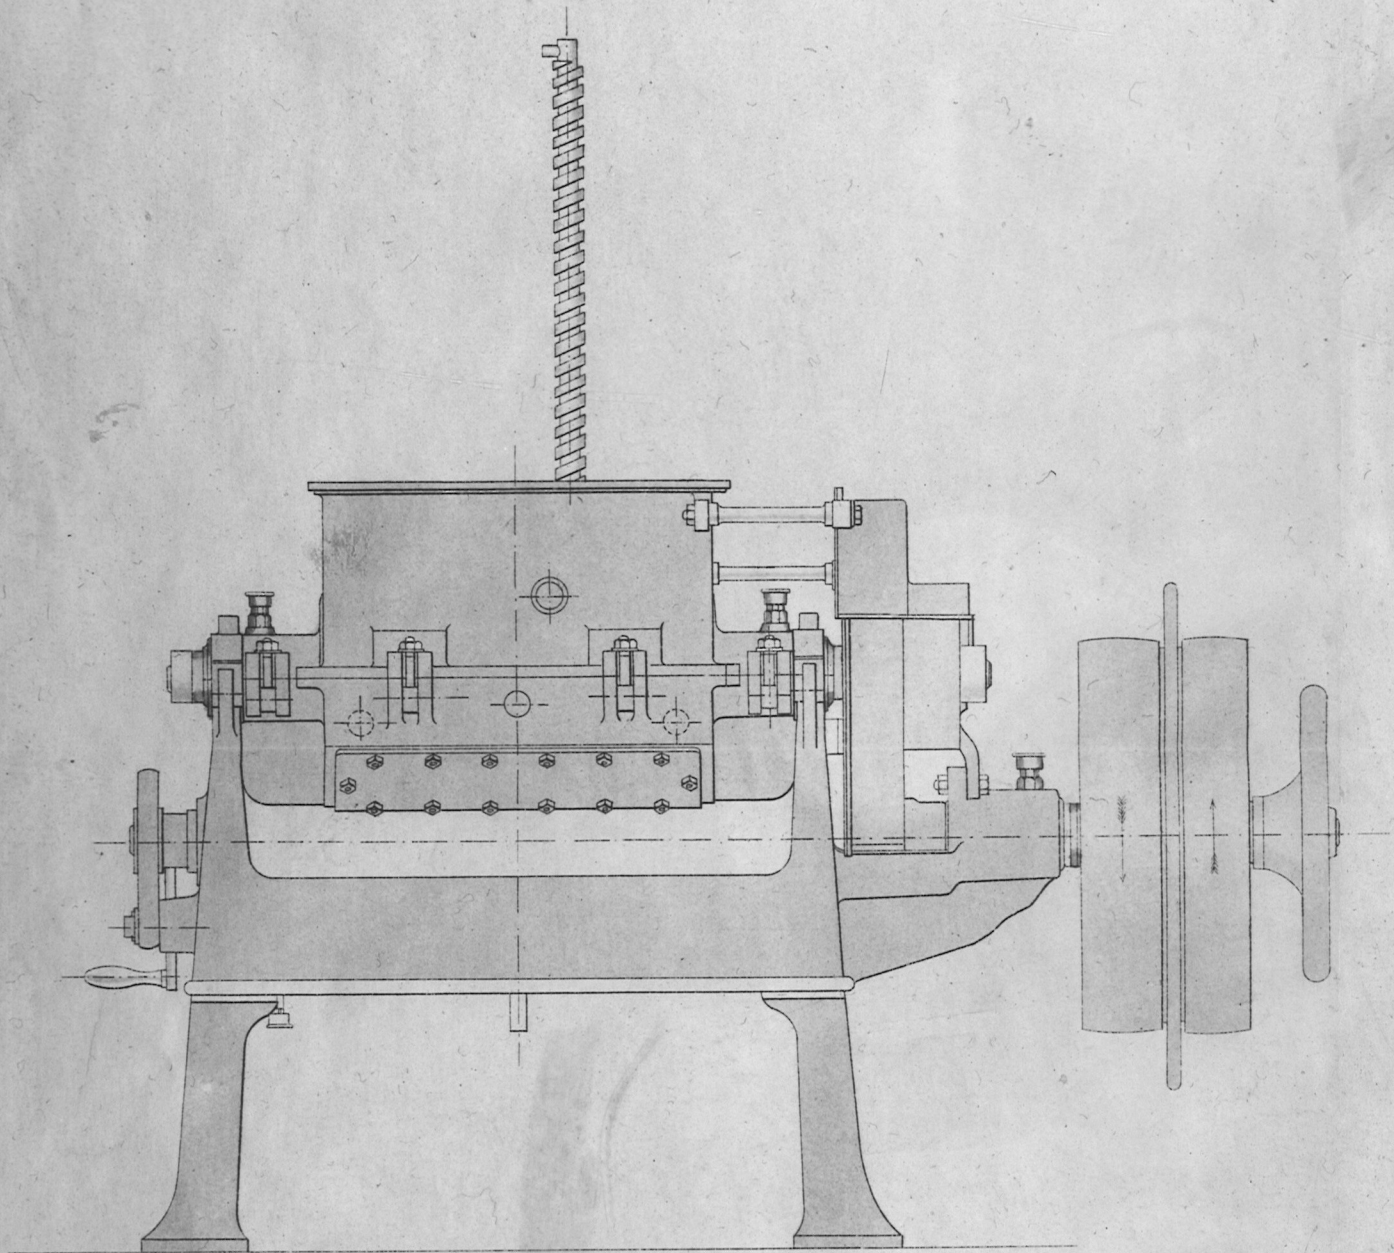
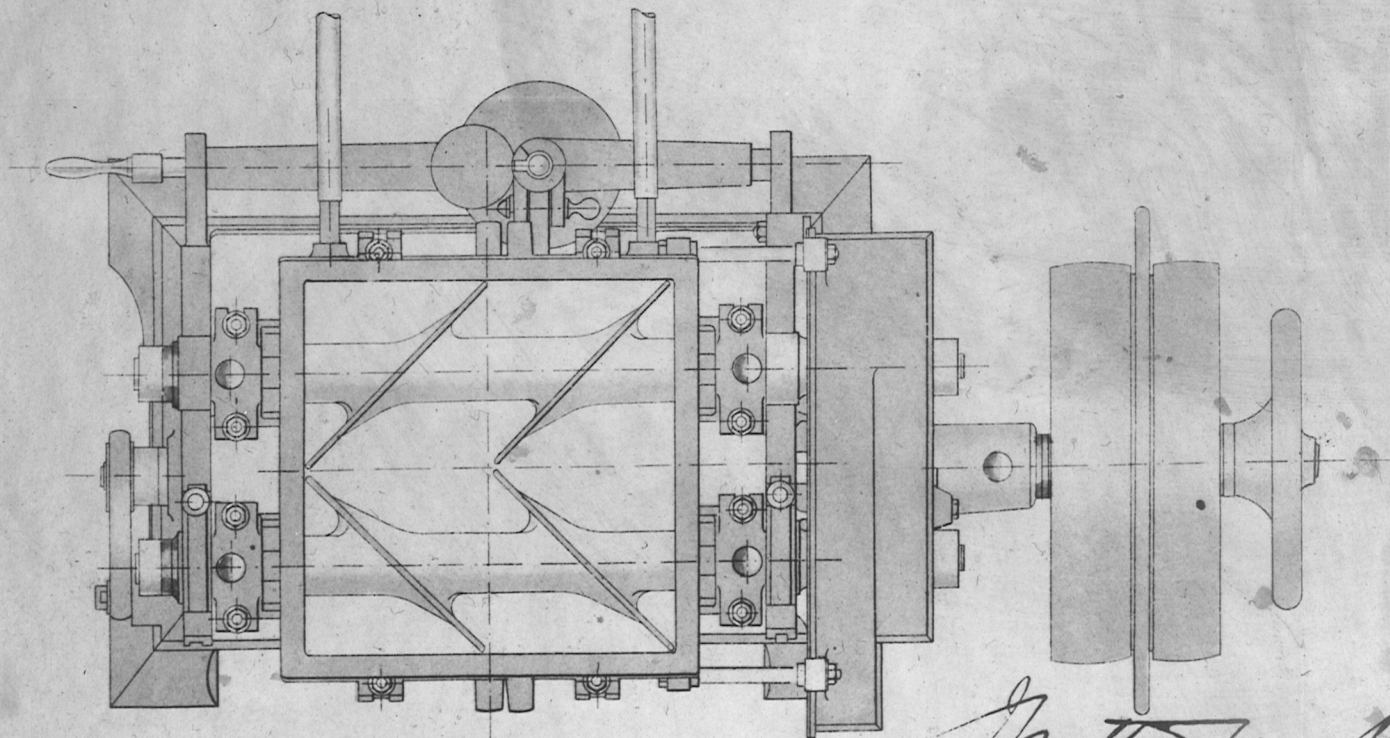
Nº 917.

The possible causes of the explosion are:—

- (1) The presence of some fairly large foreign body (*a*) introduced in the paste, or (*b*) which had fallen into the machine.
- (2) The sudden fracture of one of the blades.
- (3) The absence of acetone in the machine which might allow of sufficient friction to ignite the guncotton and lead to explosion.

INCORPORATING MACHINE FOR CORDITE FACTORY.
