Title:- Report on an Explosion in a Cordite Incorporating House at R.O.F. Bishopton on 20th April, 1945.

Report on an Explosion  
In a Cordite Incorporating House  
at R.O.F. Bishopton  
on 20th April, 1945.

Reported by: D. Cross.

Date: October, 1945

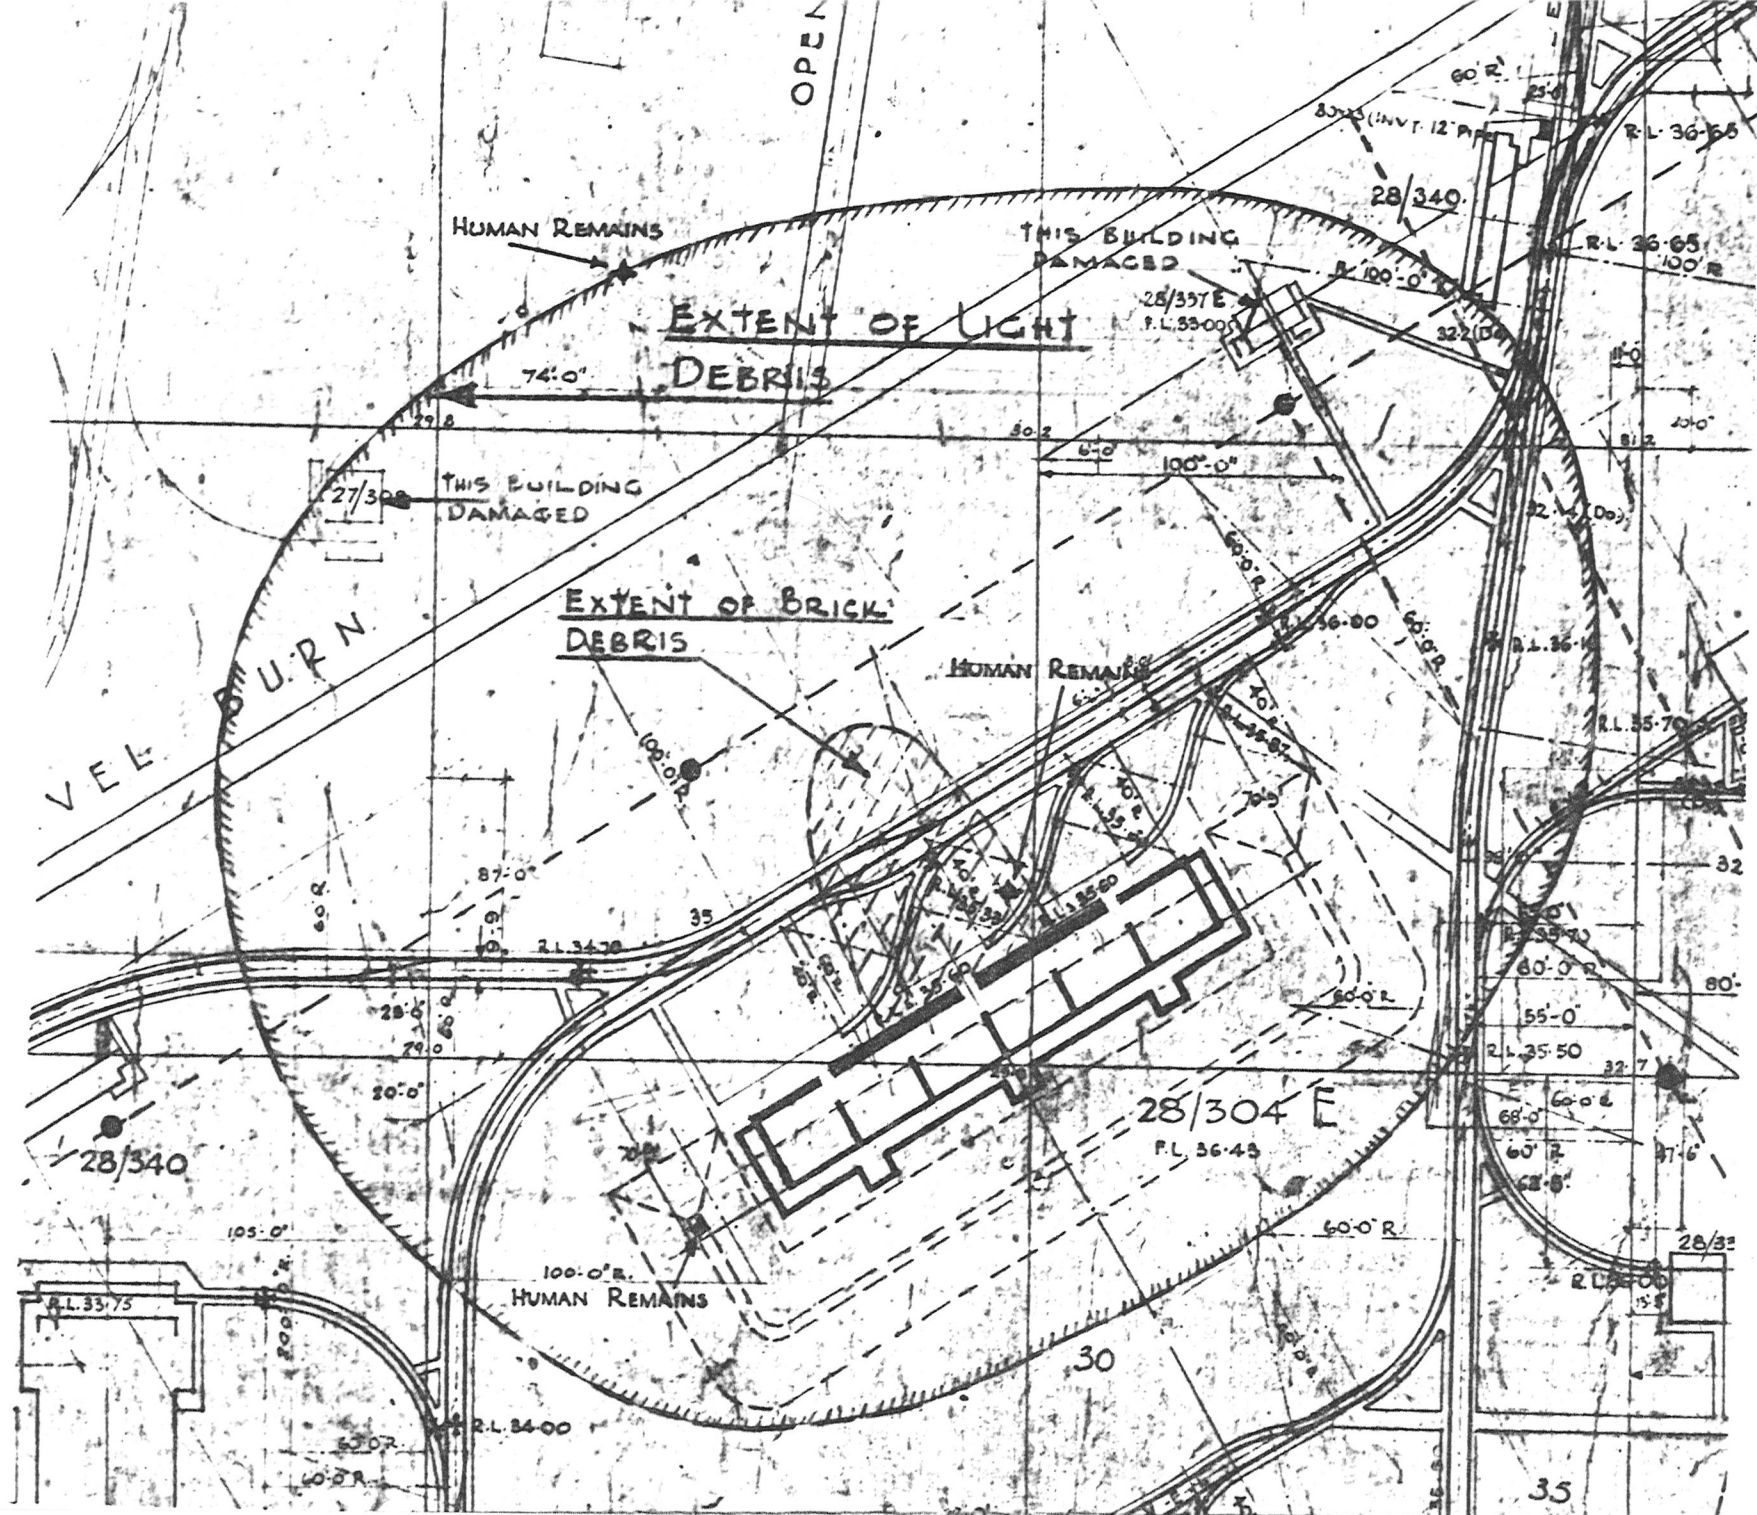
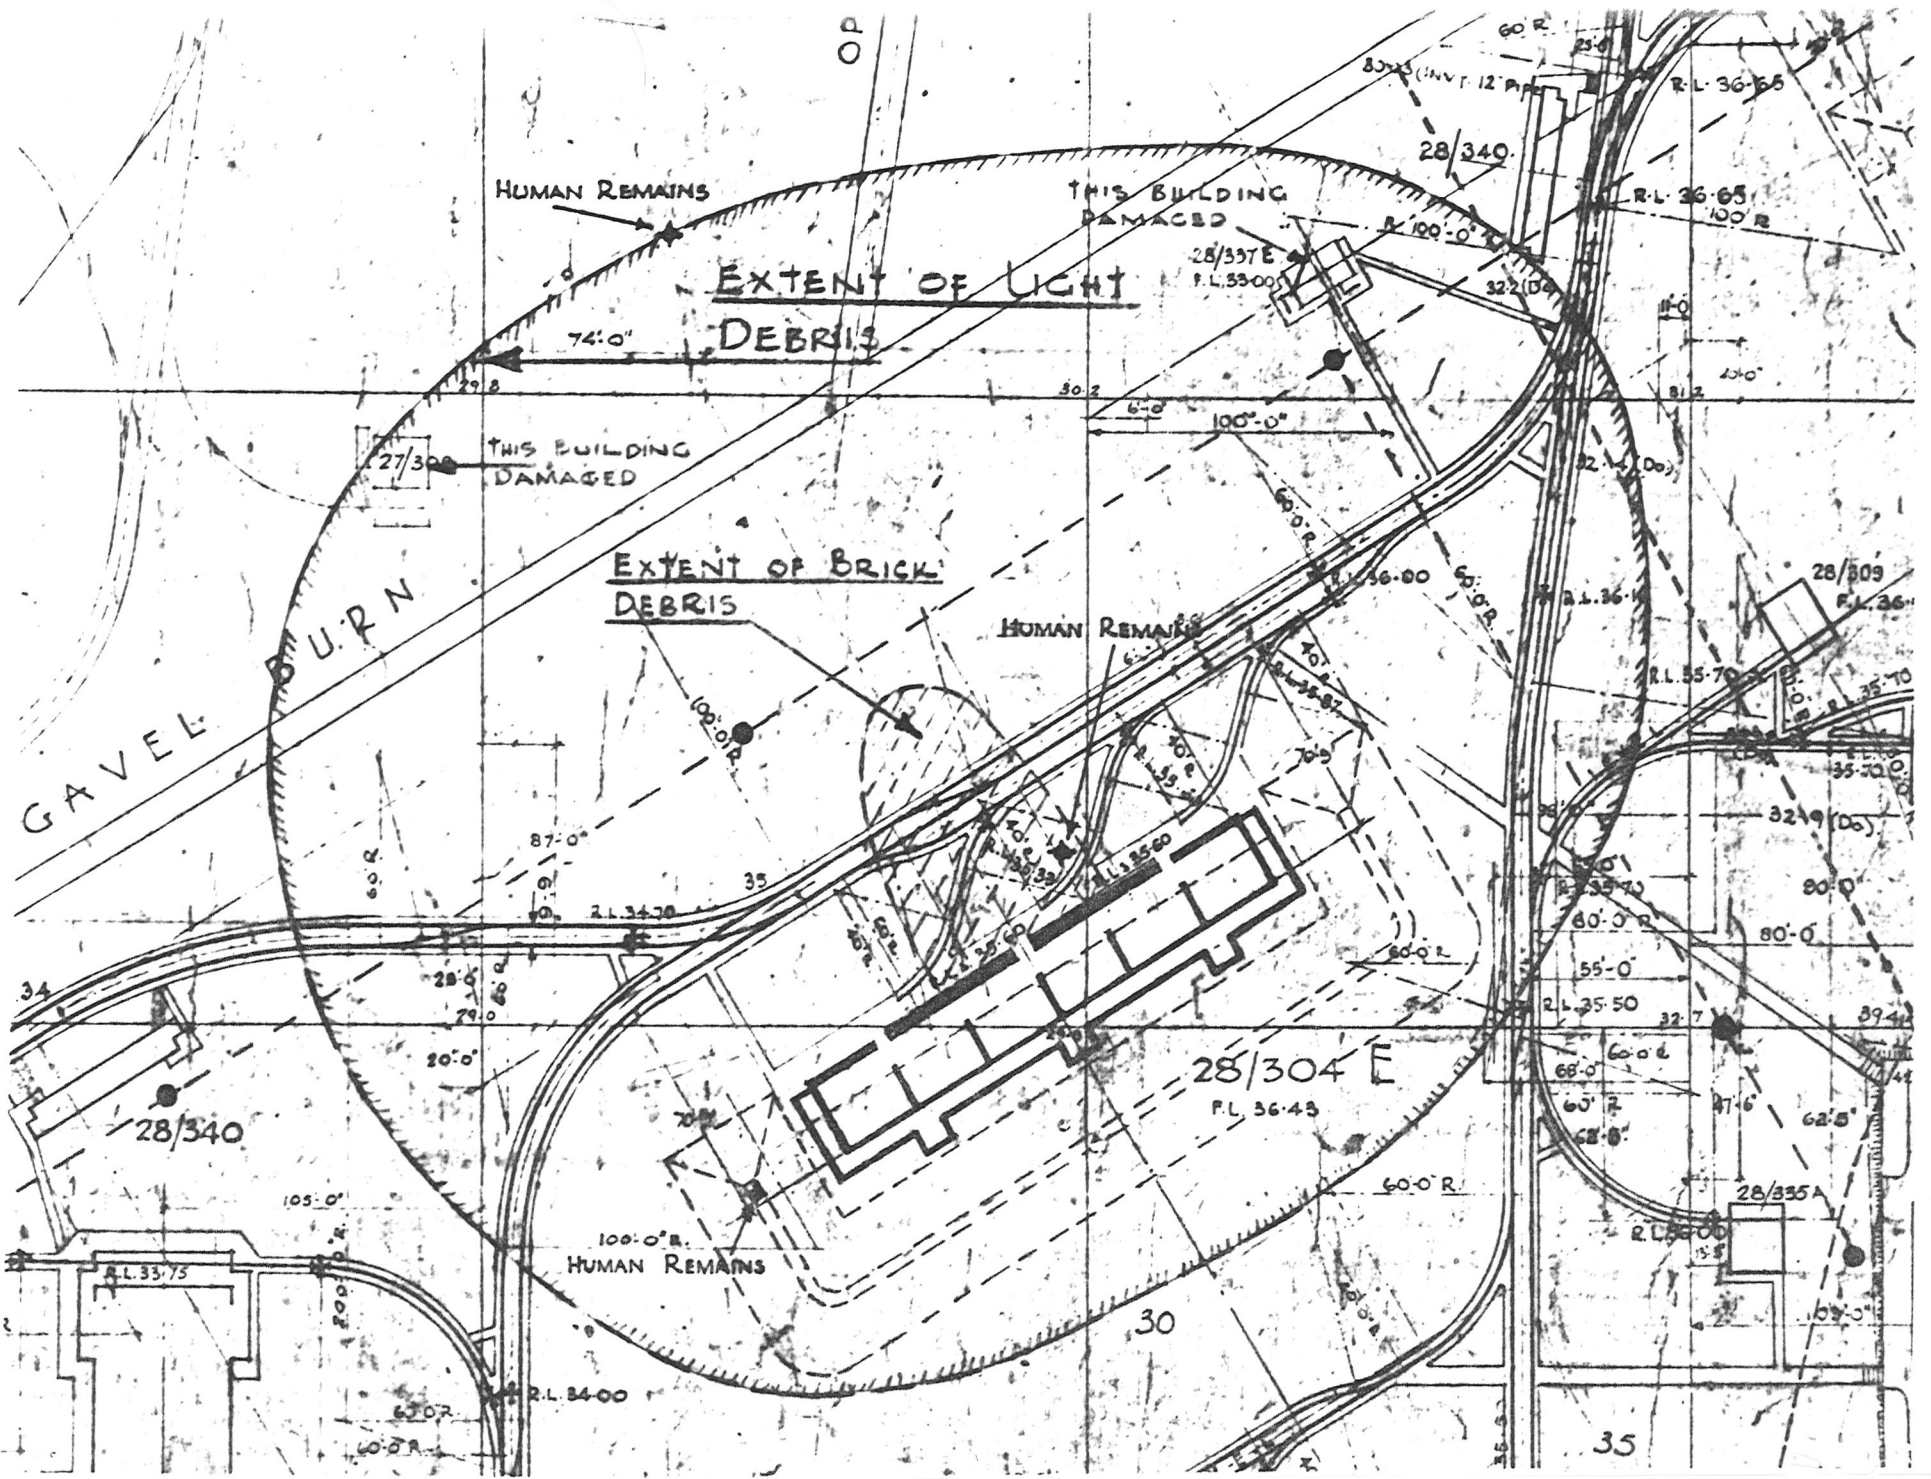
H.O.F. BISHOPTON		DRN BY B.S.
PLAN SHOWING PARTICULARS AFTER		24-4-45
ACCIDENT IN UNIT 28 304E ON 20/4/45.		SCALE 1/8" = 1'-0"
		28/304E
		DRG S-452

PLAN
