Video and Notes  
on Dismantling of  
Round Houses  
S. Site  
Mar 1998

Hertfordshire Arch Trust  
Royal Ordnance Factory  
(Waltham Abbey)  
Ref P779  
Video Footage  
Dismantling Buildings 486 & 544

NITRO-GLYCERINE WASH  
HOUSE DISMANTLING

NITRO-GLYCERINE MIXING  
HOUSE. DISMANTLING

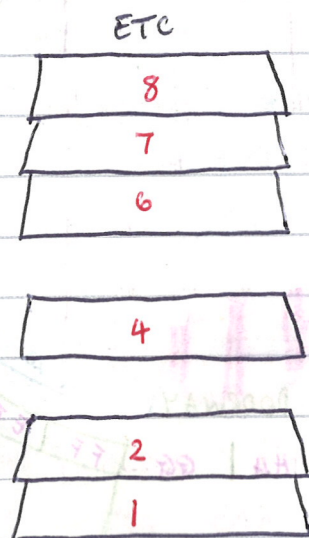
MOST BAYS HAVE SOME PANELS MISSING.  
 BAY G HAS MOST OF ITS PANELS MISSING.  
 BAY H HAS ALL ITS PANELS MISSING.  
 THE NUMBERING SEQUENCE OF THE PANELS  
 IS THE SAME WHETHER THERE ARE PANELS MISSING  
 OR NOT. eg:

UNLIKE BUILDING 486 THIS ONE (544) HAS  
 NO PANELS THAT CROSS MORE THAN ONE  
 BAY.

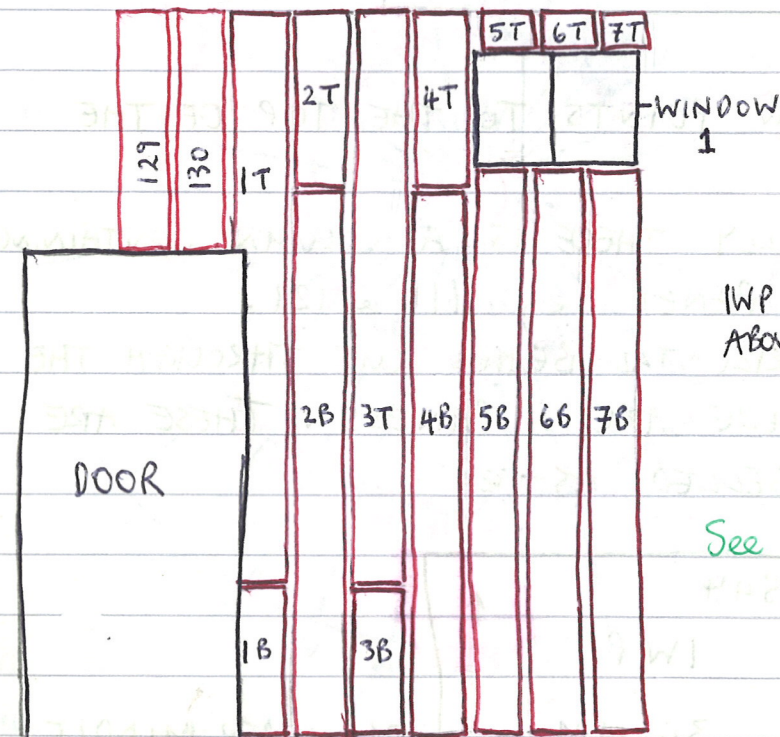
ON THE INSIDE 544 HAS WALLS  
 MADE UP OF VERTICAL PANELS. THESE  
 INTERIOR WALL PANELS (IWP'S) ARE  
 LABELLED UP CLOCKWISE FROM THE EDGE  
 OF THE ENTRANCE DOOR. eg:

THE NUMBERING STARTS AT 1 & MOVES  
 ROUND TO 130. 130 IS THE LAST PANEL  
 & SITS ABOVE THE DOOR. GENERALLY THERE  
 ARE 2 PANELS IN EACH COLUMN LABELLED:  
 1T (1 TOP) AND 1B (1 BOTTOM)  
 2T (2 TOP) AND 2B (2 BOTTOM)

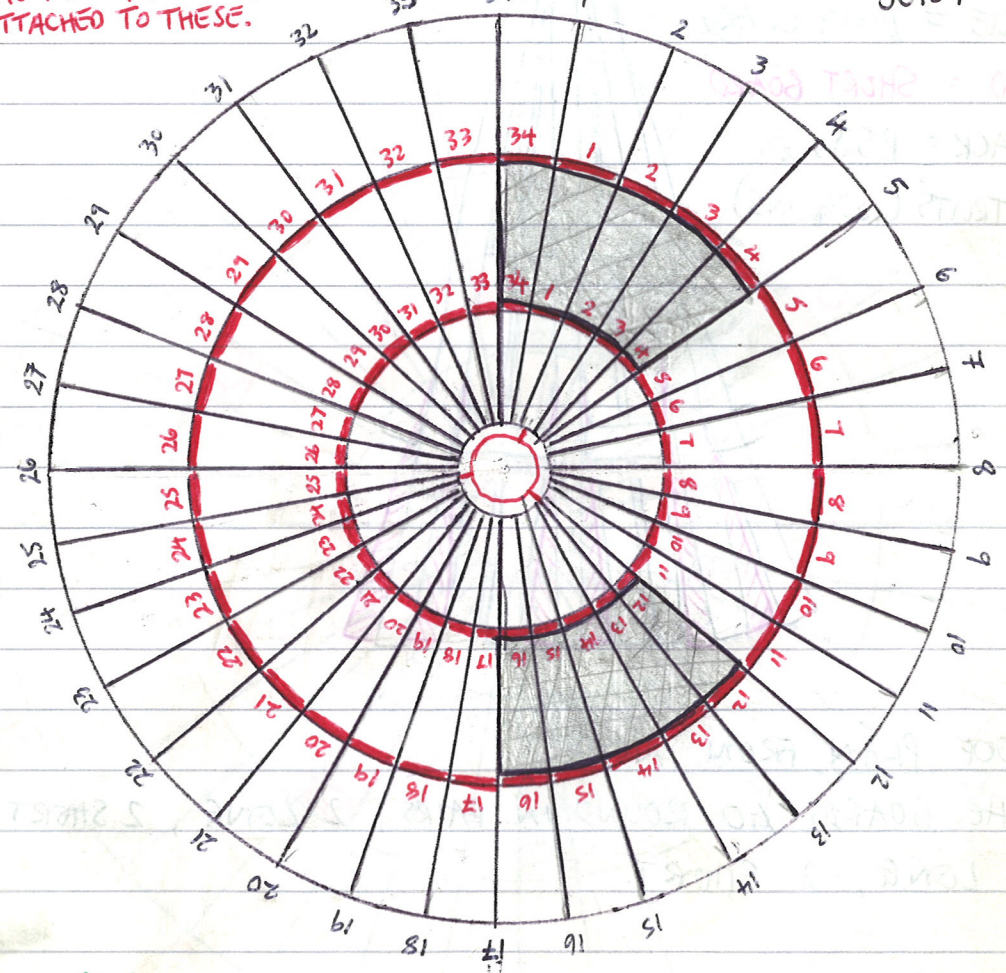
PLAN OF ROOF. NUMBER 1 RSTJ IS SITUATED ABOVE THE RIGHT HAND EDGE OF THE DOOR. THE NUMBERS GO ROUND CLOCK WISE AND END AT 34. 34 IS SITUATED ABOVE THE CENTRE OF THE DOOR.

SHADING IS WHERE SKYLIGHTS WERE BUILT IN.

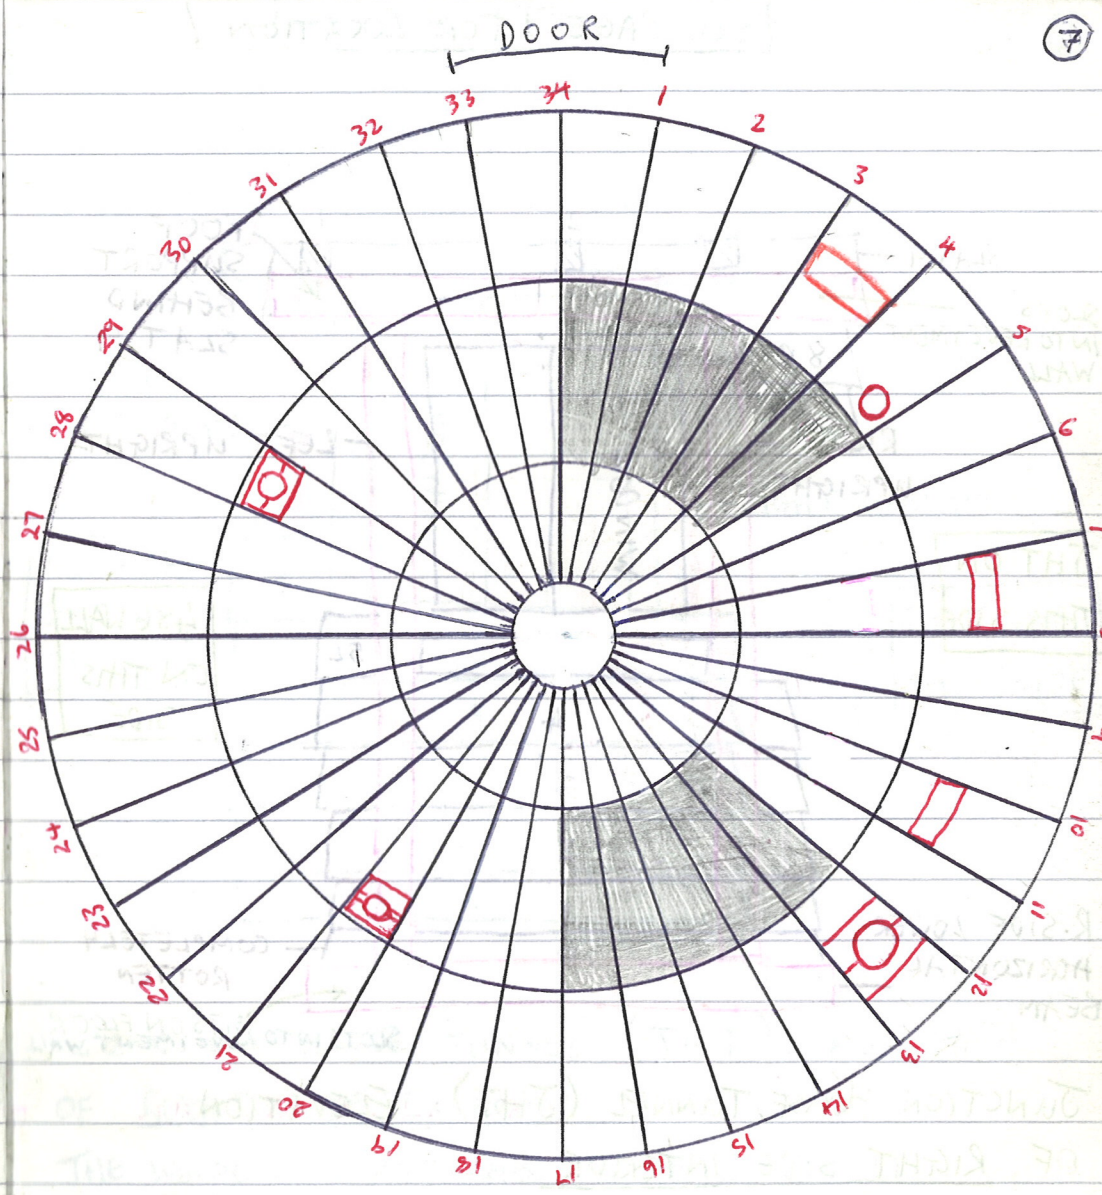
ROOF PLAN SHOWING WOODEN HORIZONTAL PANELS  
AND CIRCULAR LIGHT FITTINGS.

Shading shows location of sky-lights.

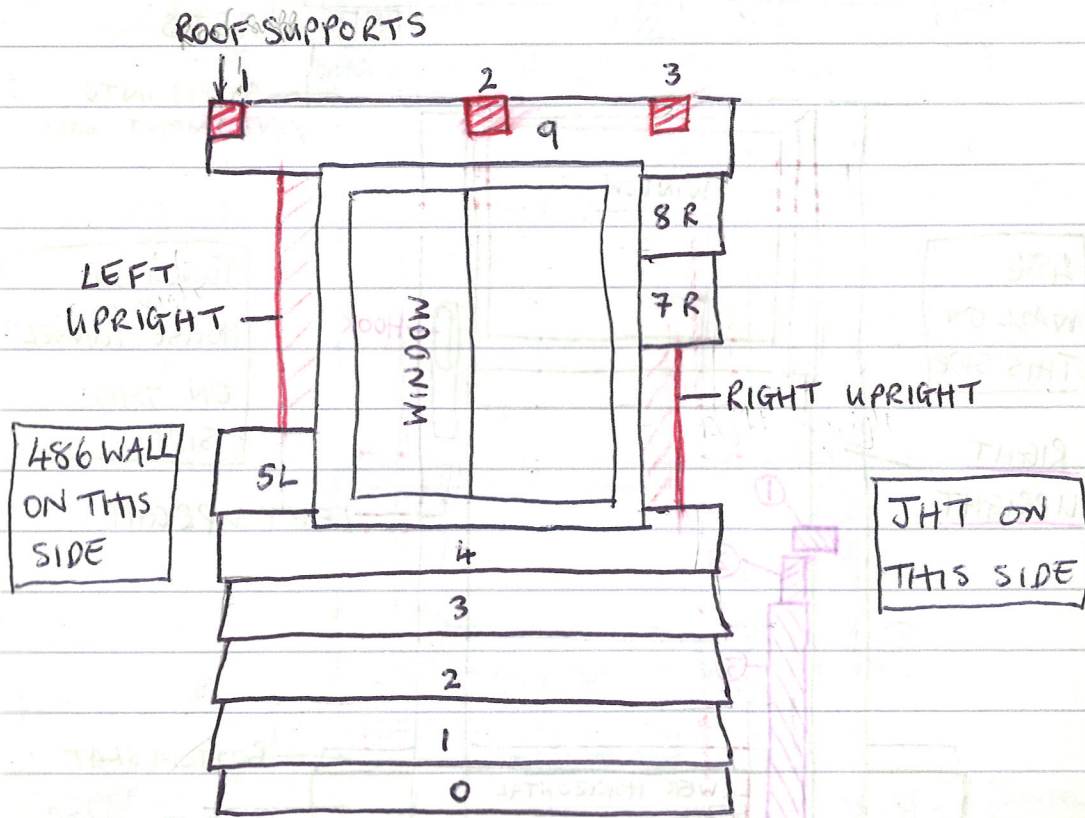
JUNCTION HOUSE TUNNEL (JHT). ELEVATION OF RIGHT SIDE EXTERIOR

JHT LEFT SIDE INTERIOR & EXTERIOR WOULD HAVE BEEN THE SAME AS THE RIGHT SIDE. ALL SLATS HAVE FALLEN OFF THE EXTERIOR.

THE WINDOW IS ATTACHED TO THE 2 UPRIGHTS.

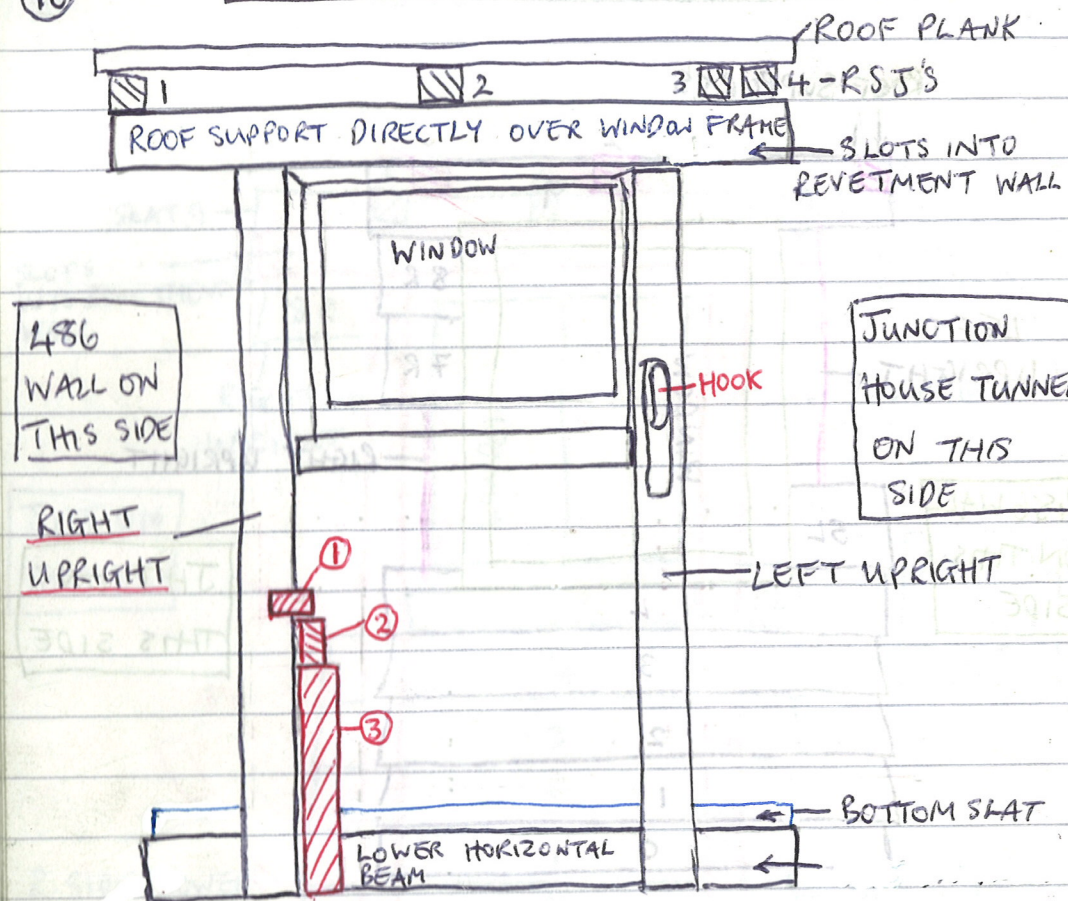
JUNCTION HOUSE TUNNEL LEFT SIDE INTERIOR

SHOWING SUPPORT ARM IN RED WHICH IS ATTACHED TO RIGHT UPRIGHT & MAIN FRAME

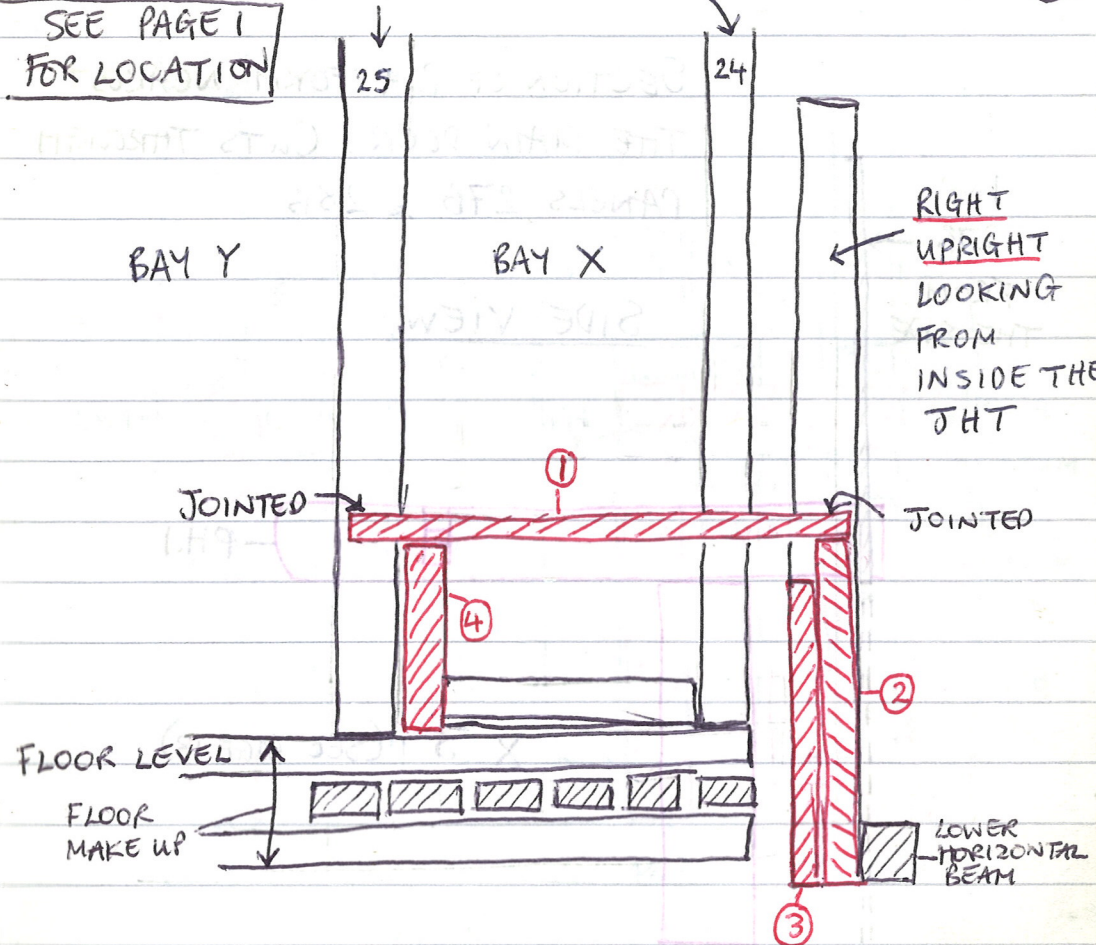
ELEVATION SHOWING THE ARM USED TO SUPPORT JHT (LEFT SIDE) RIGHT UPRIGHT.

THIS IS THE VIEW LOOKING INTO SH4 THROUGH BAY X FROM INSIDE THE JUNCTION HOUSE TUNNEL.

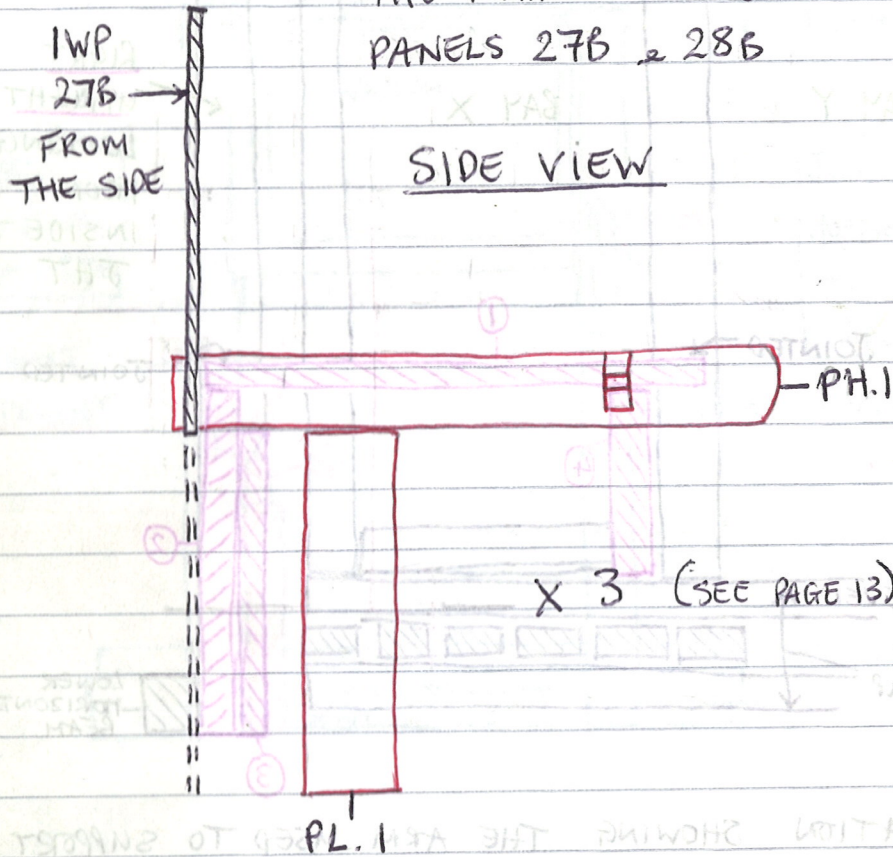
SECTION OF PLATFORM NEAREST THE MAIN DOOR. CUTS THROUGH PANELS 27B & 28B

IWP'S 29, 30, 31 ARE ALL MISSING & WILL NEED REPLACING.

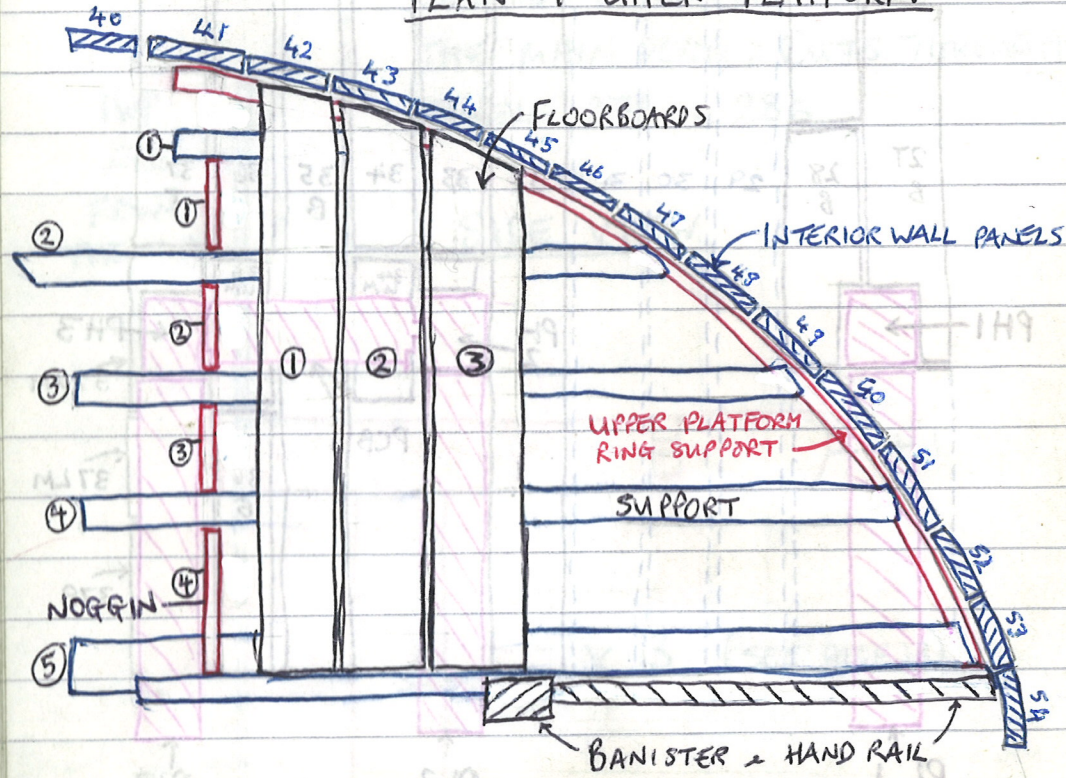
### PLAN OF UPPER PLATFORM

PLATFORM SET INTO THE WALL WITH NO SUPPORT DOWN TO THE GROUND. BARREL 'A' SITS UNDER THIS.

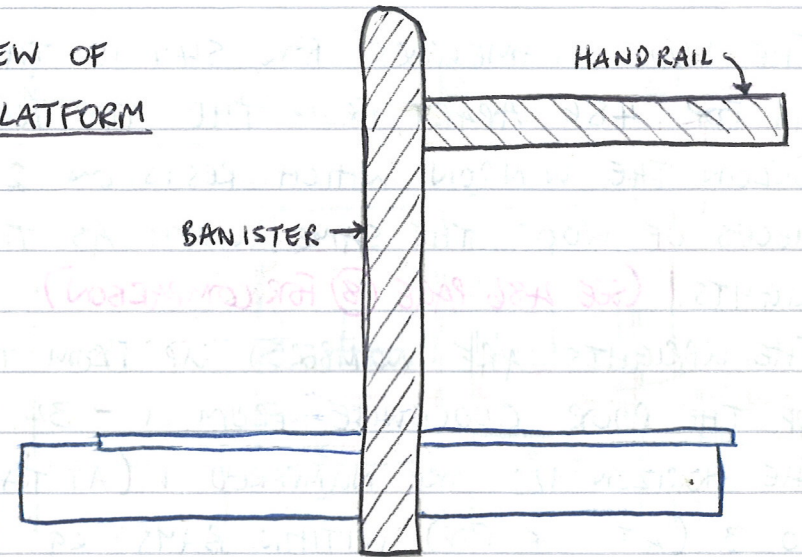
### SIDE VIEW OF UPPER PLATFORM

THE HAND RAIL RESTS ON THE SILL OF WINDOW 8 IN THE BOTTOM RIGHT CORNER.

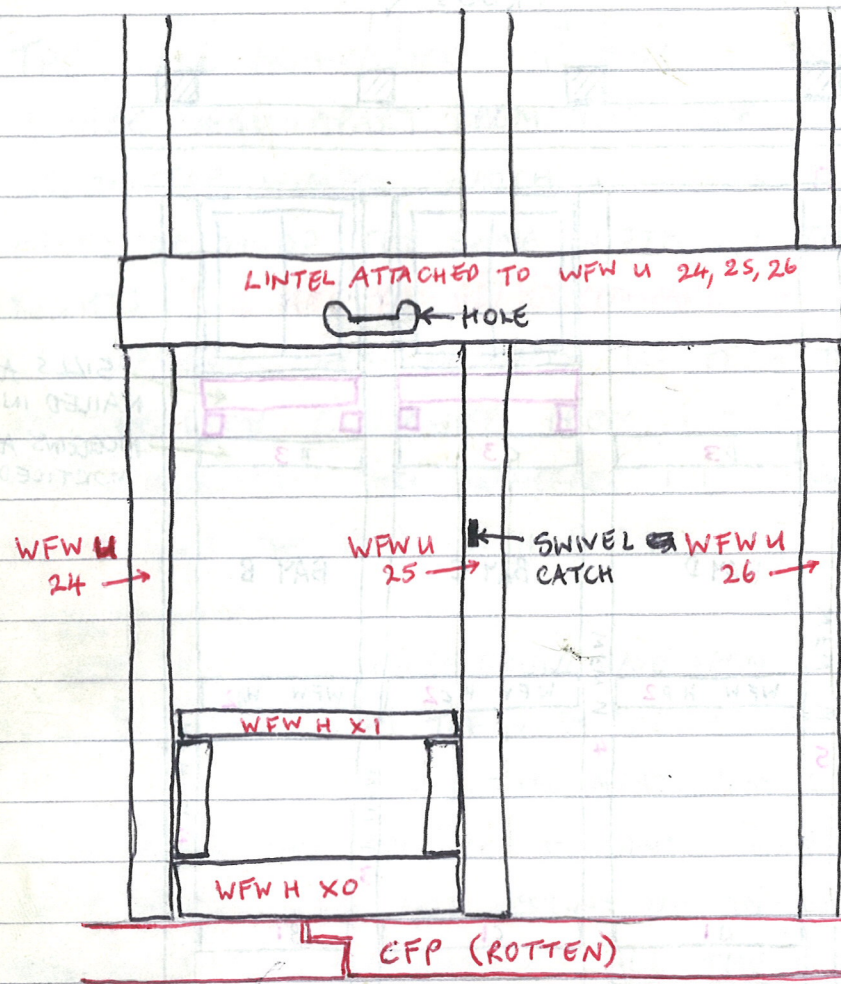
THESE 3 UPRIGHTS WERE COVERED IN A THIN WOODEN CLADDING. THE WHOLE THING FORMED SOME SORT OF DOORWAY INTO THE JHT.

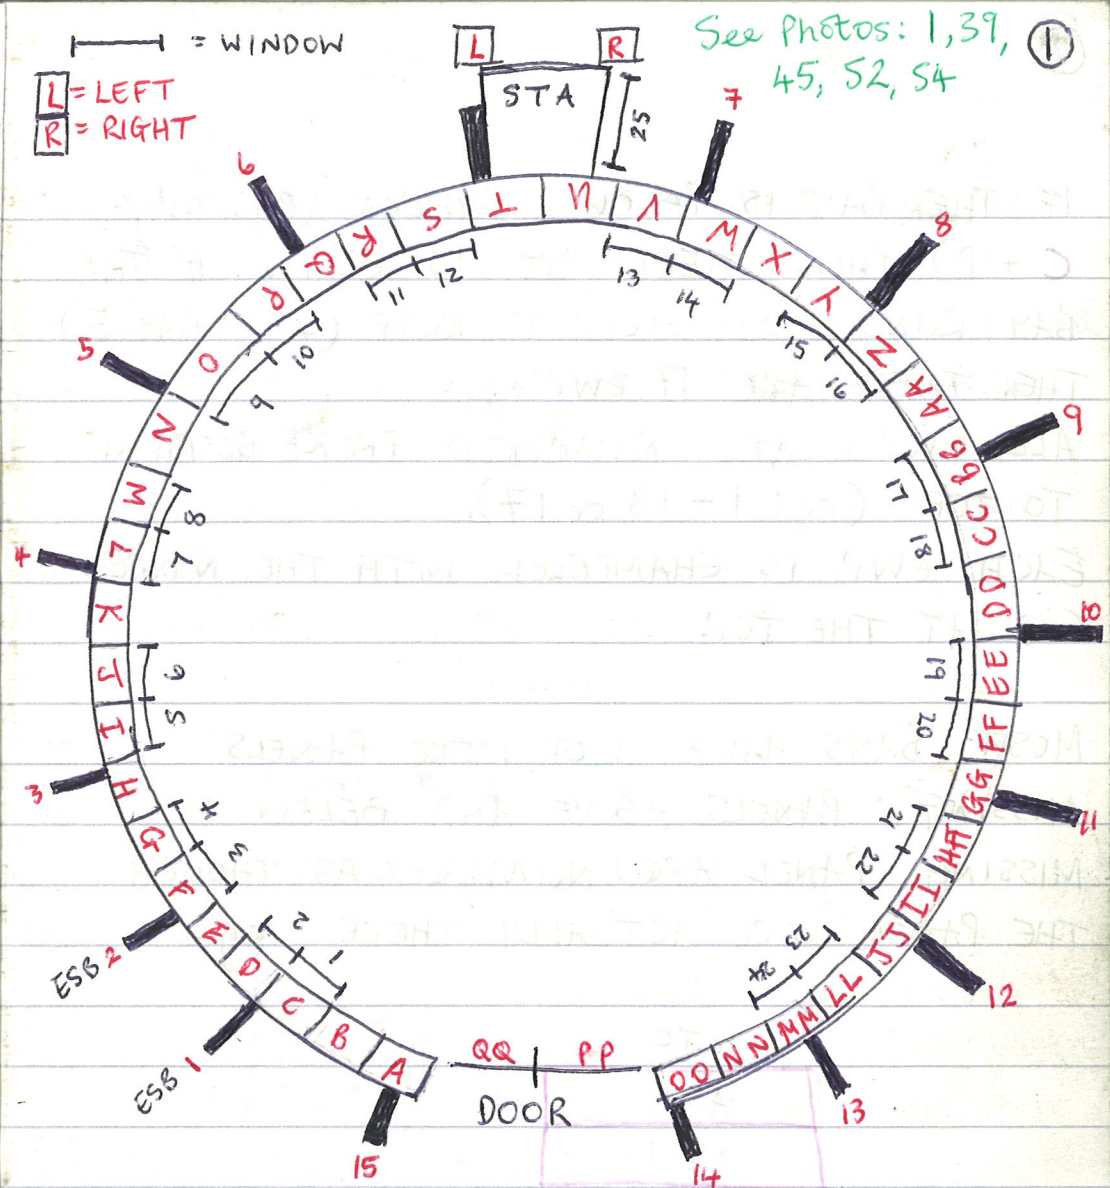
PLAN SHOWING LAYOUT OF EXTERNAL WALL PANEL BAYS, AND LOCATION OF WINDOWS; EXTERNAL SUPPORT BEAMS; SMALL TUNNEL ACCESS.

EACH BAY HAS A LETTER AND CONSISTS OF EITHER 13 OR 17 EXTERNAL WALL PANELS — EWP'S.

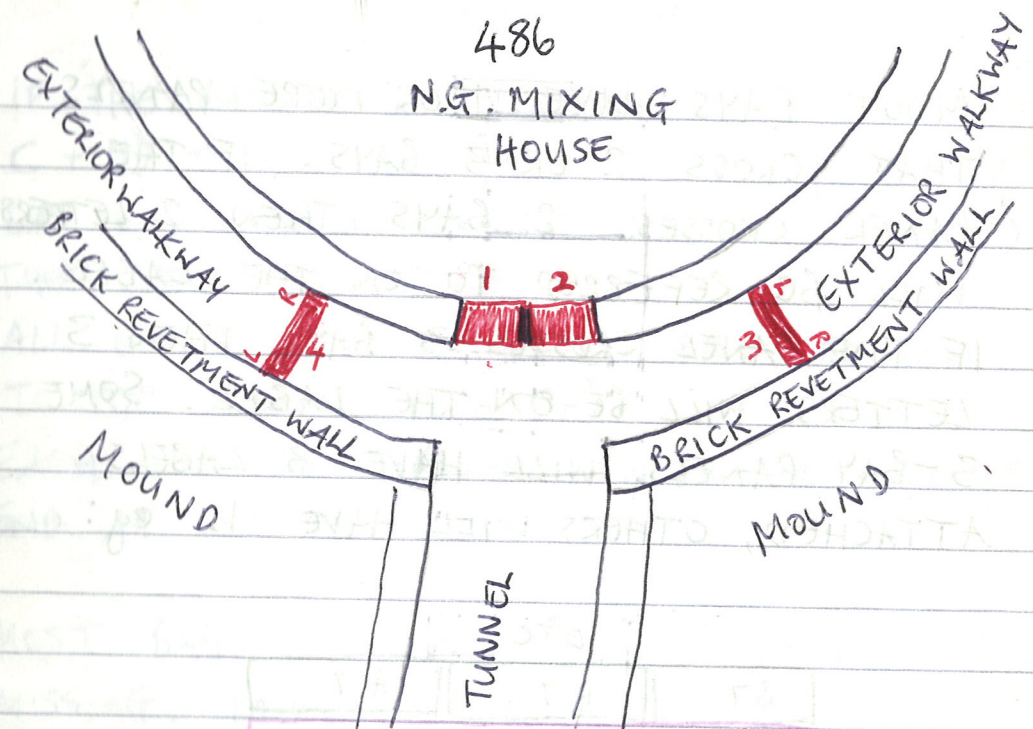
See Photos: 35, 51, 64  
PLAN SHOWING LOCATION OF DOORS 1-4.

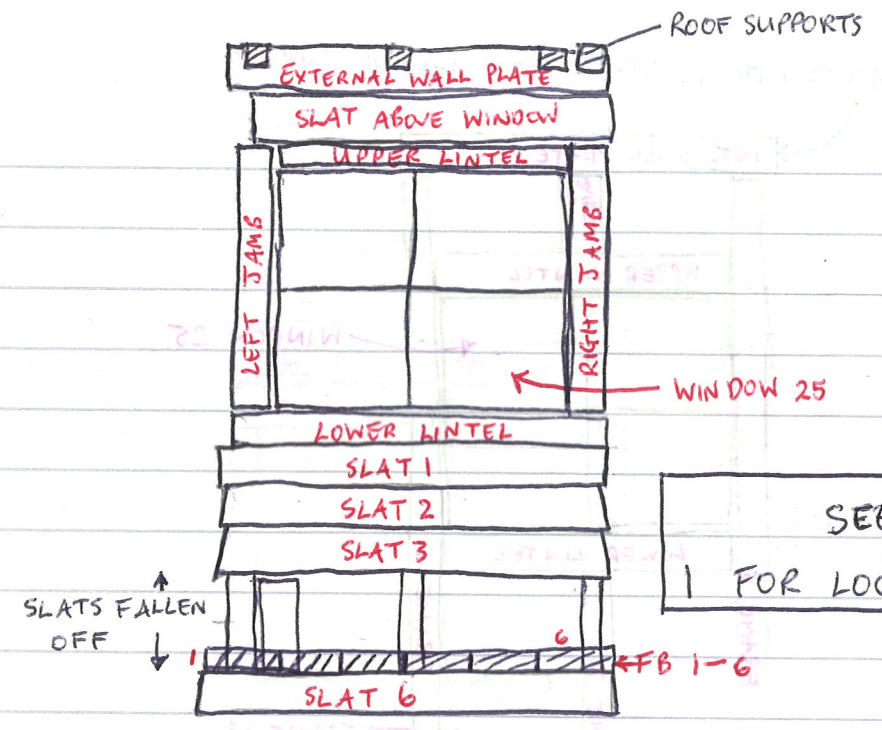
OUTER ELEVATION OF SMALL TUNNEL ACCESS (STA) - RIGHT SIDE.

SLAT 6 COVERS UPPER & LOWER FLOOR SUPPORTS

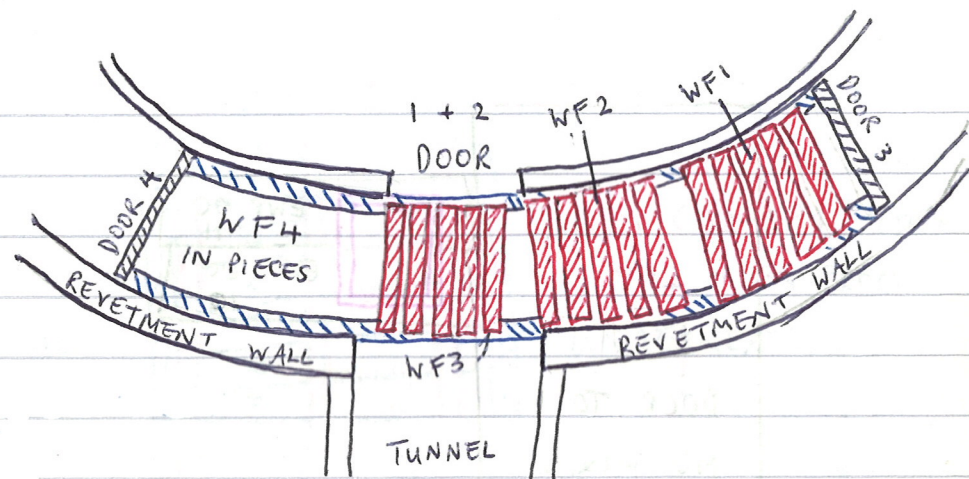
PLAN SHOWING POSITION OF WALKWAY FLOORING (WF)  
 THE WALKWAY FLOORING CONSISTS OF 4 SEPARATE SETS OF PLANKING HELD TOGETHER BY 2 SMALLER PIECES OF WOOD UNDERNEATH

THE 4TH SET HAS BEEN BROKEN UP IN THE PAST. THE INDIVIDUAL PIECES HAVE BEEN LABELLED 486 WF.

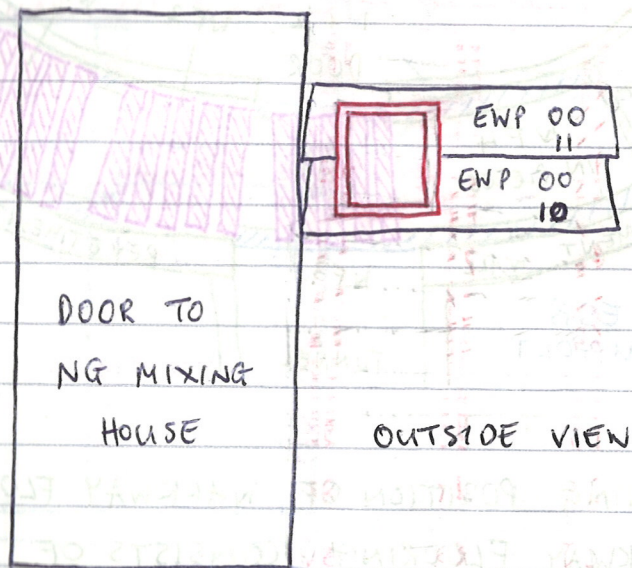
ELEVATION SHOWING LOCATION OF PEEPHOLE INTO MIXING HOUSE. THIS CONSISTS OF A GLASS WINDOW IN A FRAME WITH A DOOR ON THE OUTSIDE. THE FRAME CUTS THROUGH EXTERNAL WALL PANELS (EWP) 00 11 AND 00 10.

PEEPHOLE HAS COME OUT AS A COMPLETE BOX WHICH FITS INTO THE FRAMEWORK & SITS ON ONE OF THE WFW ~~WALL~~ HORIZONTAL

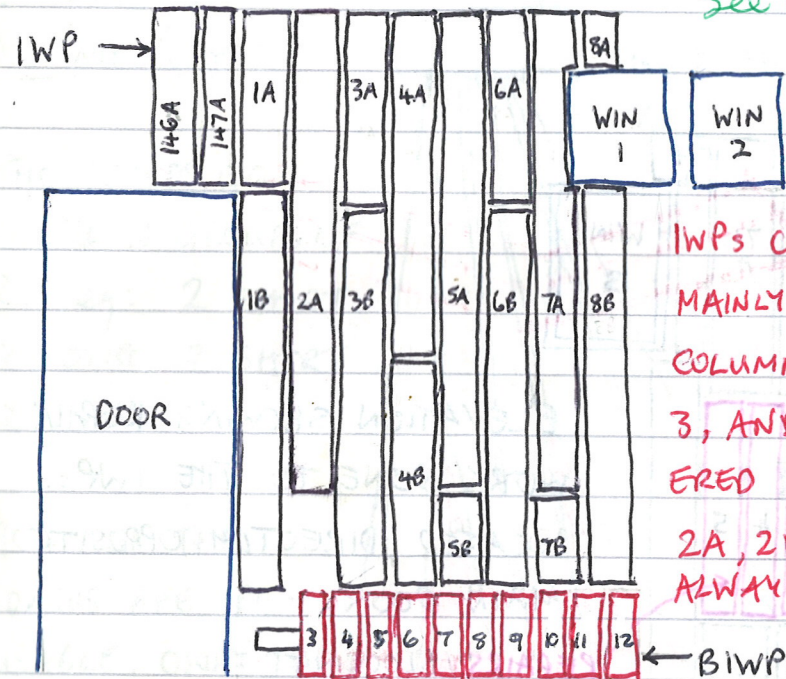
13  
ELEVATION OF INTERNAL WALL PANELS (IWPs) AND BOTTOM INTERNAL WALL PANELS (BIWPs)  
BOTH SETS START AT THE DOOR & GO CLOCKWISE  
IWPs GO FROM 1-147. See Photo: 39, 41

IWPs CONSIST OF MAINLY 2 PANELS IN A COLUMN, OCCASIONALLY 3, AND ARE NUMBERED eg: 1A, 1B, 1C 2A, 2B, 2C. A IS ALWAYS AT THE TOP

(1 & 2 ARE MISSING) AND GO ROUND TO 228.

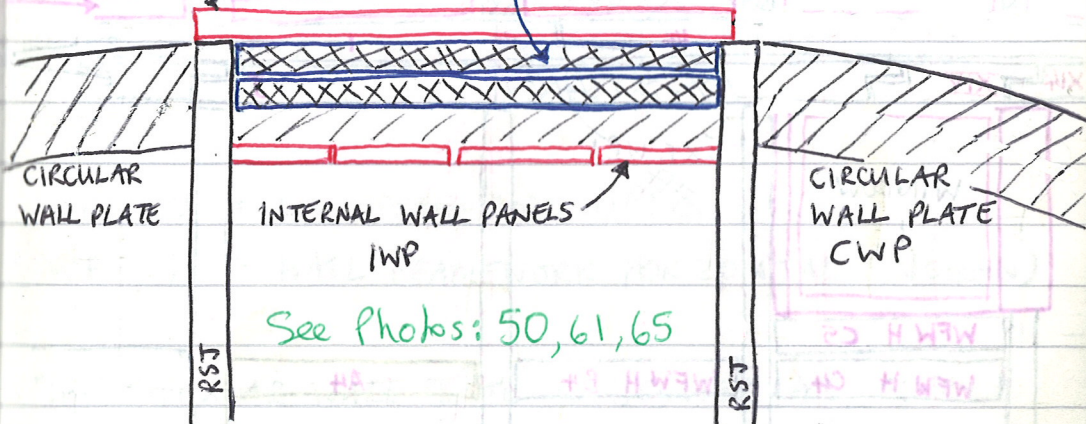
VIEW LOOKING DOWN ON WHERE THE ROOF RSJS SIT ON THE CIRCULAR WALL PLATE.

THE 2 BLUE BEAMS (NOGGINS?) JUST SIT BETWEEN THE RSJS ON TOP OF THE CWP PROBABLY TO PREVENT MOVEMENT FROM SIDE TO SIDE. ALSO THE ROOF BOARDS REST ON THEM. THIS IS TO PREVENT THE IWPs TAKING THE FULL WEIGHT OF THE BOARDS.

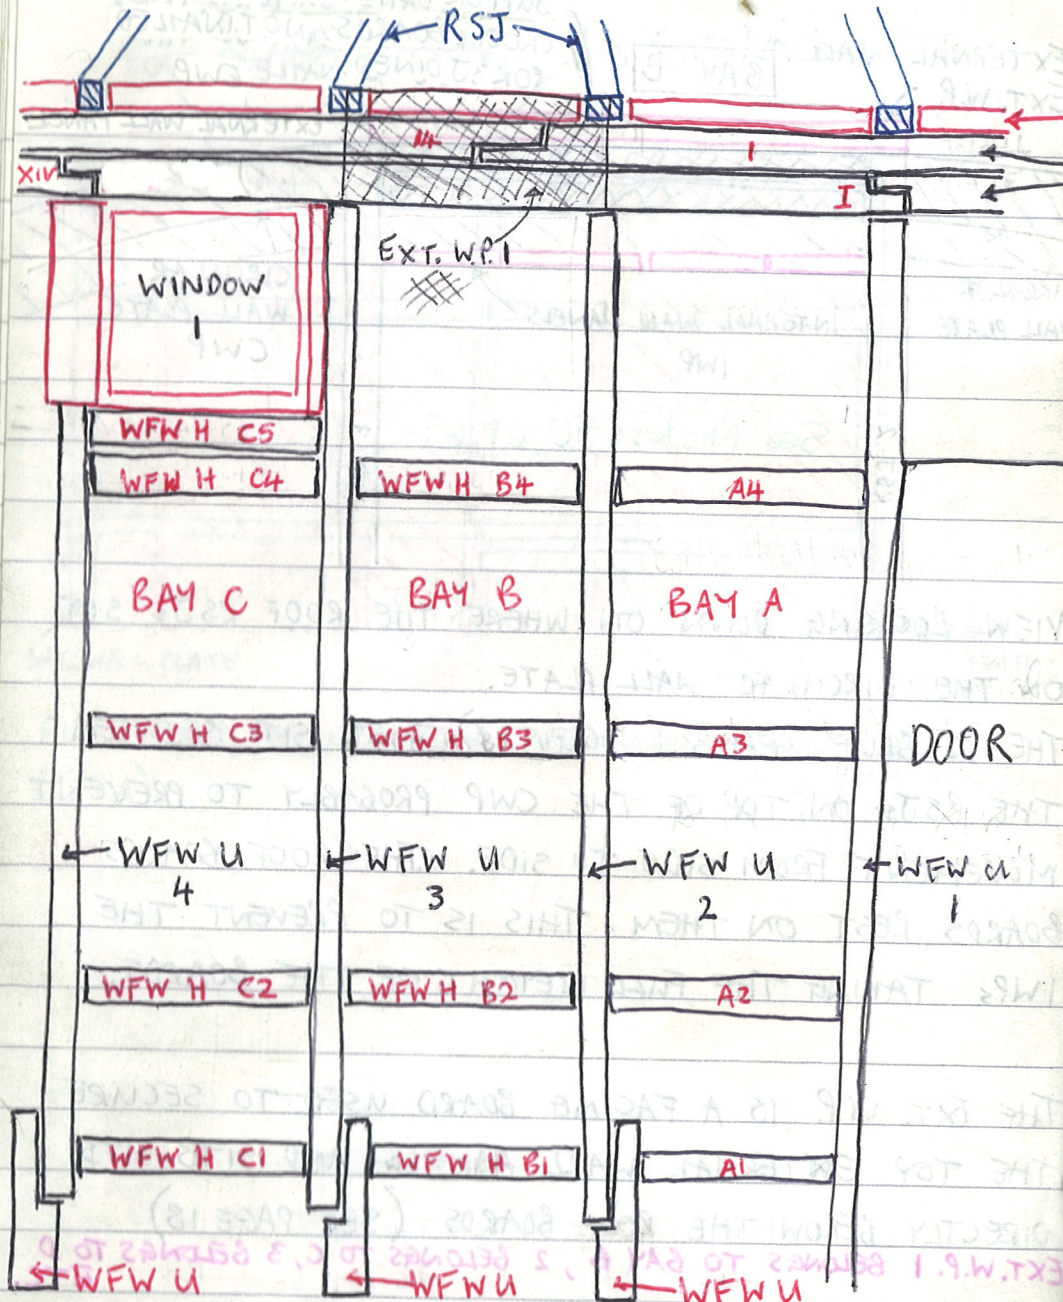
ELEVATION OF OUTSIDE VIEW OF FRAMEWORK

THE CIRCULAR WALL PLATE IS JOINTED AT EVERY 3RD BAY. THE LOWER JOINTS ARE MARKED BY ROMAN NUMERALS BEGINNING AT I AT THE DOOR EDGE AND MOVING ROUND CLOCKWISE TO NUMBER XIV. THE ROMAN NUMERALS ARE SCRATCHED ONTO THE CWP ON THE INSIDE OF THE BUILDING. THE TOP CWP IS LABELLED UP 1-14. (INSIDE) WHERE THERE IS A WINDOW THERE IS A 5TH NOGGIN. THE FRAMEWORK IS DIVIDED INTO THE SAME BAYS AS USED FOR THE EWPs, A - 00. THE UPRIGHTS BEGIN AT 1 AT THE DOOR EDGE AND MOVE ROUND TO 42, CLOCKWISE. THE HORIZONTALS (NOGGINS) ARE MARKED WITH THE LETTER FOR THAT BAY AND A NUMBER FROM 1-5. 1 IS AT THE BOTTOM. 5 IS AT THE TOP BELOW A WINDOW.

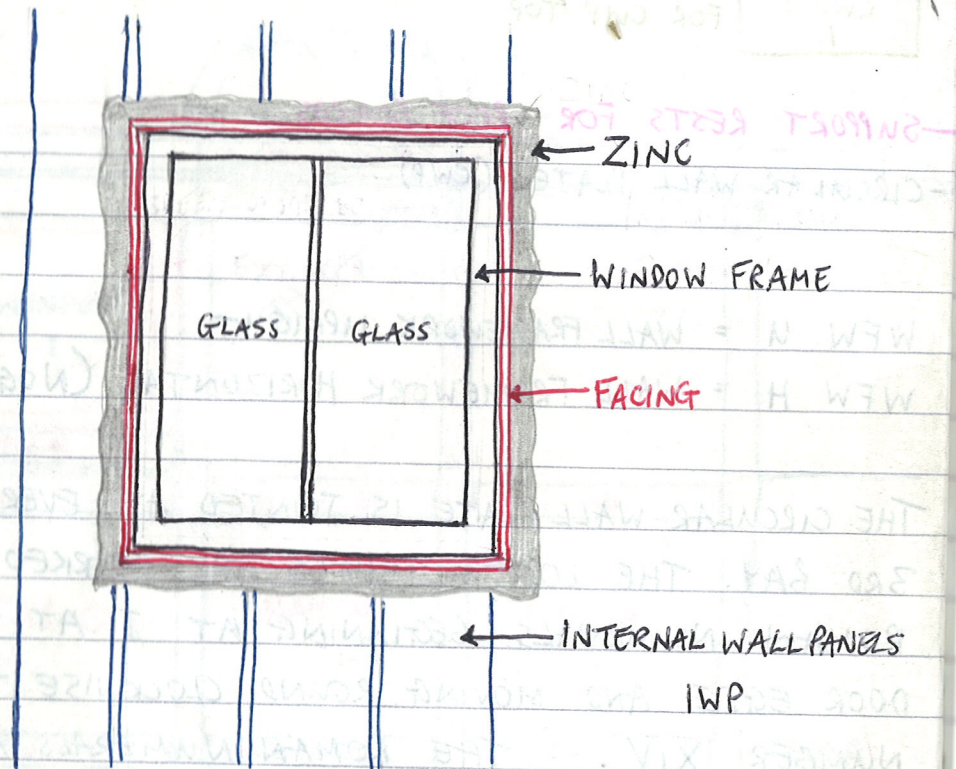
ELEVATION OF WINDOW FROM INSIDE

THE ZINC COVERING THE IWPs WAS TUCKED IN BETWEEN THE FACING AND THE EDGE OF THE IWPs.

SOME WINDOWS ARE HINGED & SWING FROM THE TOP. OTHERS OPEN ON A CENTRAL PIVOT.

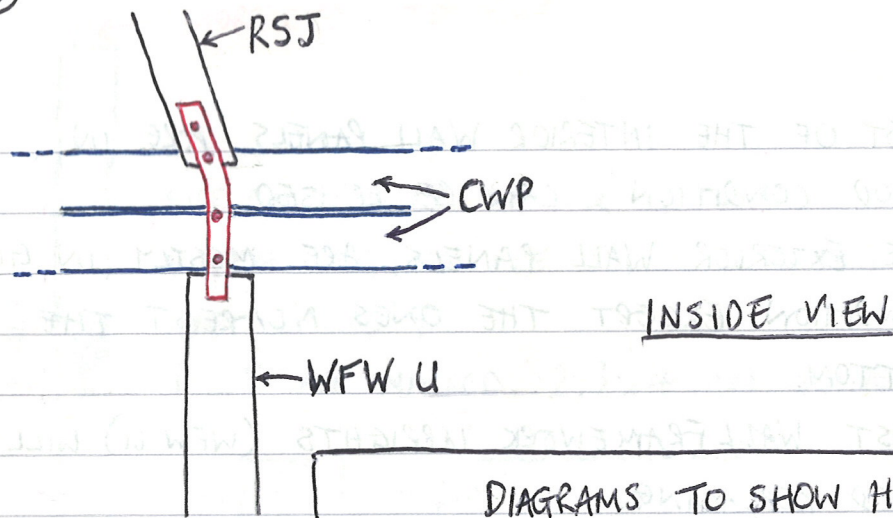
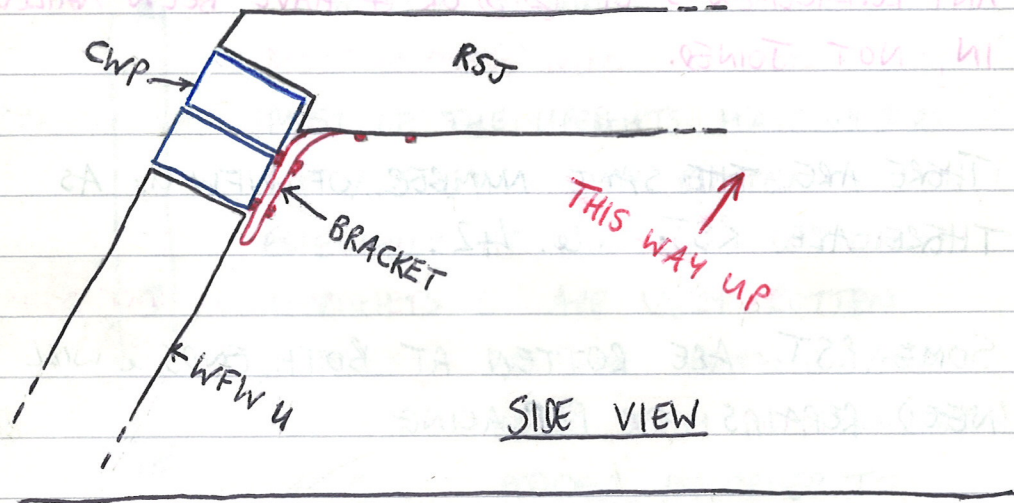
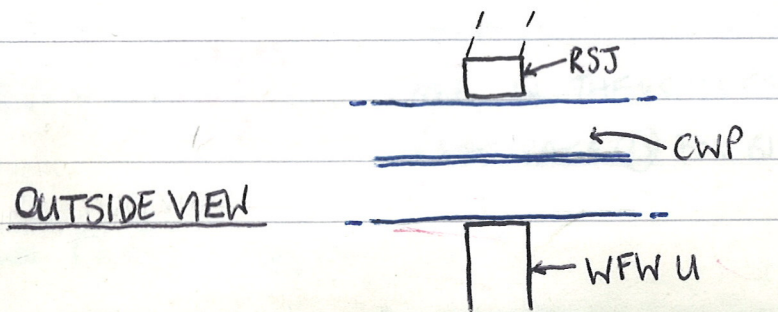
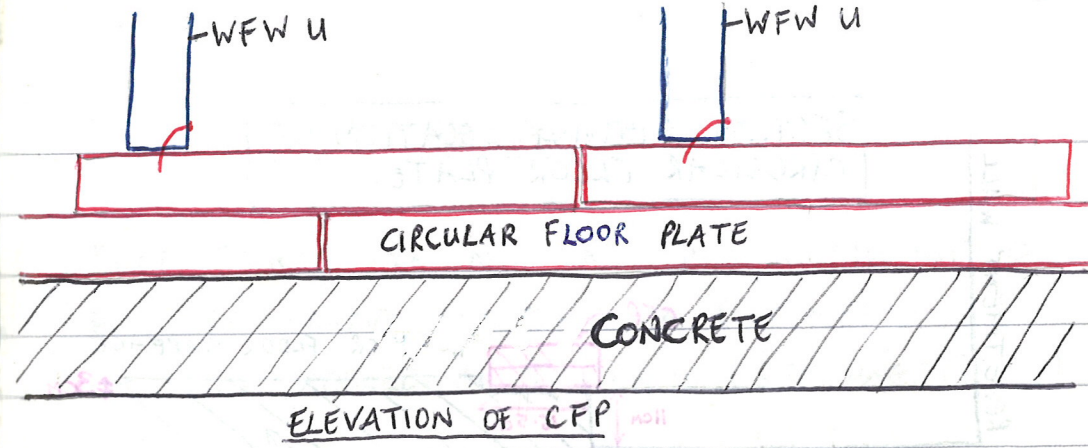
SOME RSJs ARE ROTTEN AT BOTH ENDS & WILL NEED REPAIRS OR REPLACING.

DIAGRAMS TO SHOW HOW RSJS ARE ATTACHED TO THE CWP.

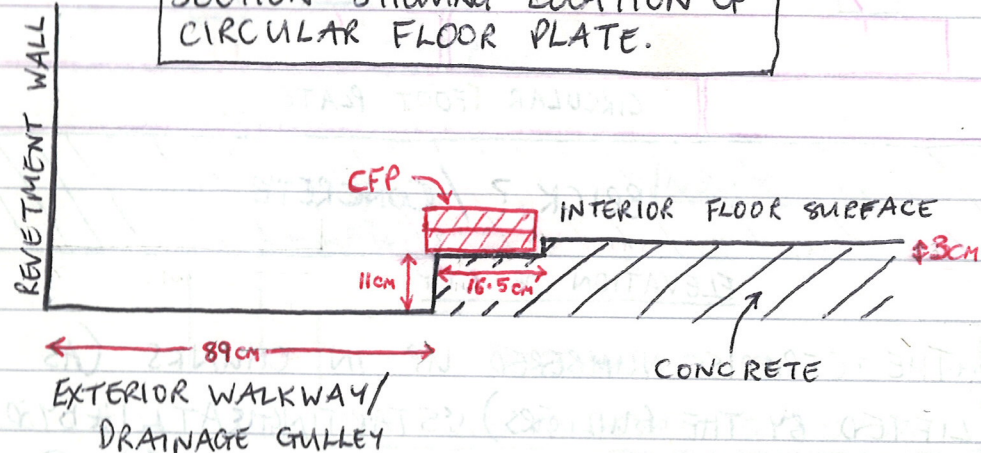
SECTION SHOWING LOCATION OF CIRCULAR FLOOR PLATE.

SOME OF THE CFP IS NUMBERED UP IN CHUNKS (AS LIFTED BY THE BUILDERS) SOME IS JUST LABELLED 4566 CFP. IT IS TO BE FOUND ON PALLETS (17) & (18). THE TOP & BOTTOM PIECES ARE NAILED TOGETHER, NOT JOINTED LIKE THE CWP (SEE PAGE 18). THE WFW UPRIGHTS SIT ON THE CFP & ARE NAILED ON. THE ORIGINAL UPRIGHTS WOULD HAVE BEEN MORTICED ONTO THE CFP AS IN BUILDING S44, BUT BECAUSE THE BASE OF EACH ONE IS A REPAIR THEY HAVE JUST BEEN NAILED.

THE CFP SITS ON A LEDGE & SLIGHTLY OVERHANGS THE EXTERNAL WALKWAY & DOES NOT QUITE TOUCH THE EDGE OF THE INTERIOR FLOOR SURFACE. (THERE IS A GAP OF ABOUT 3cm ALL THE WAY AROUND). THE CFP IS ATTACHED TO THE CONCRETE BASE BY 6 LARGE IRON BOLTS EVENLY SPACED.
