**THE ROYAL GUNPOWDER FACTORY**

**WALTHAM ABBEY**

**Quinton Hill - South Site**

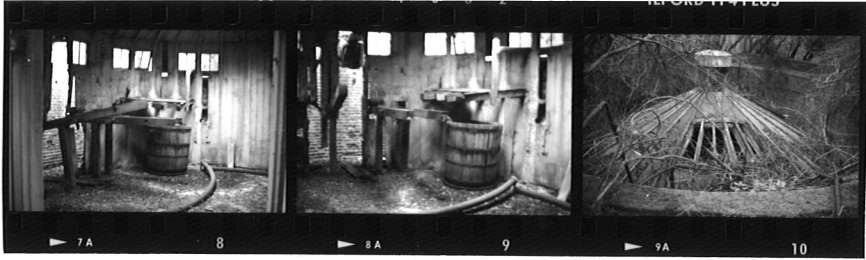
NUMBER N544	OLD SERIES 483	RCHME NUMBER	N.G.R.
NAME/FUNCTION Washing house		START DATE 1894	END DATE

- 1) CONSTRUCTIONAL MATERIAL  
Timber
- 2) ROOF MATERIALS AND STRUCTURE  
Timber covered by galvanised metal sheet.
- 3) POWER SOURCE  
Electric lighting and steam heating.
- 4) DIMENSIONS i) L      ii) W      iii) HT      iv) DIA
- 5) The roundhouse is protected by an earthen bank revetted on the interior by a circular brick wall. The building is entered from the south west along a curving brick vaulted passage protected by a wooden slatted door at the entrance. The floor of the passage is asphalt covered. The passage is lit by electric lights, the wires encased in small diameter ferrous metal pipes.

The roundhouse is entered through double doors hung on brass butterfly hinges. The building is of timber frame construction with a weather boarded exterior and its interior walls are lined by vertical wooden boards. At the northern side of the building is a raised wooden platform, the horizontal supports of which pass through the roundhouse wall and are set into the brickwork revetment. Beneath this platform although not necessarily insitu is a stave built barrel bound by iron hoops fixed by copper nails. The height of this barrel is 1.22m within an internal diameter of 0.98m. The barrel has two drain holes one at the base and one 15cm up from the bottom. Around the lip of the barrel are a series of small pegs that may have been used to secure a cover. Another barrel within the building is identical excepting an internal diameter of 96cm.

The roof consists of rafters resting directly on the wall plate joining in a crown at the apex of the roof. The rafters are braced against any lateral movement by short spacing timbers. The roof is timber boarded covered externally by galvanised metal sheeting.
